Assessing and Controlling Corrosion in Air-Cooled Condensers

R. Barry Dooley, J. Denis Aspden, Andrew G. Howell, and Francois du Preez

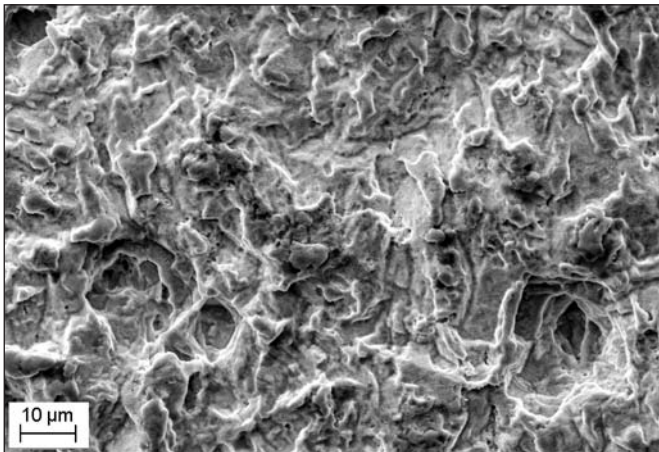
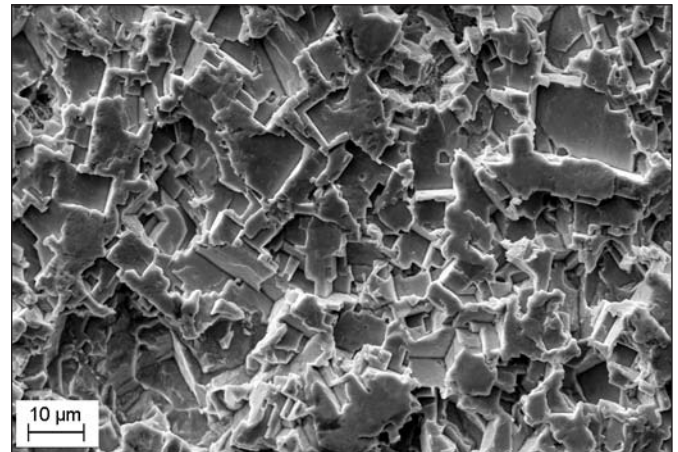
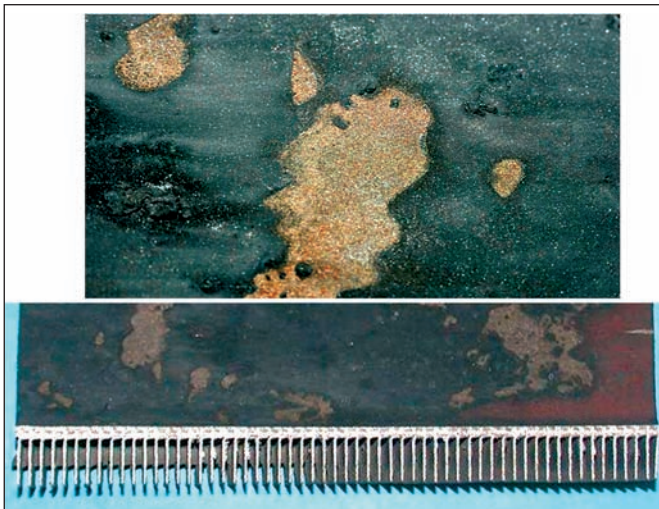
Figure 1:

Figure 1 shows one of the two ACC tubes which have been subjected to a metallurgical analysis. The low magnification photograph of the surface of the ACC tube near to the tube entry clearly shows the adjacent black and white areas. The other two parts of the figure show details of the black areas, which are essentially deposited magnetite (upper part, left), and the white bare metal area, which has an intergranular appearance (upper part, right).

Details from the examination of an ACC tube section within about 38 cm (15 in) from the tube entry in the upper duct. The lower photograph shows the adjacent white and black areas on the tube surface. The two upper parts of the figure show surface metallographs of the black area after cleaning of the surface (left) and white bare metal (right).

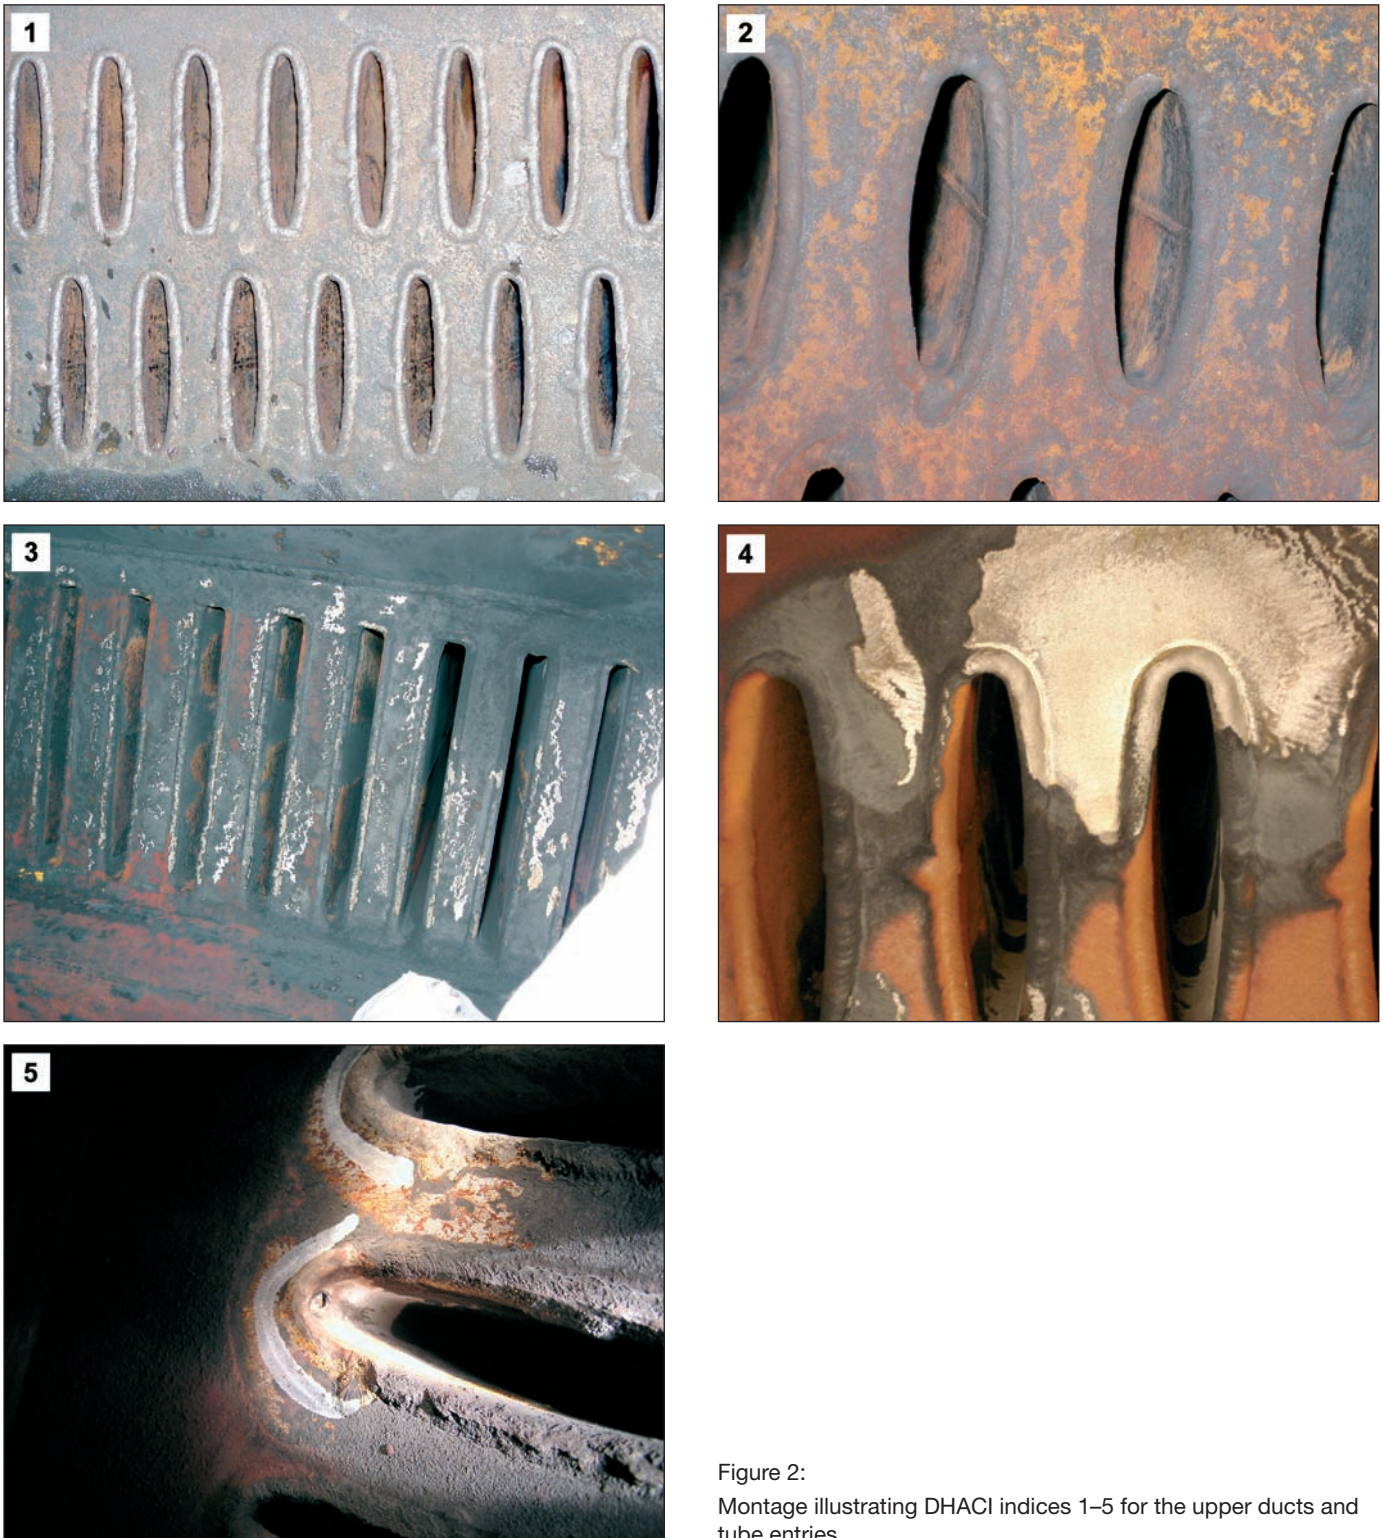
Upper Section (upper duct/header, ACC A-frame tube entries). Index: 1, 2, 3, 4 or 5. Examples are shown in Figure 2.

1. Tube entries in relatively good shape; possibly some areas with dark deposits in first few inches of tube interior. No corrosion or FAC.
2. Various black/grey deposits on tube entries as well as flash rust areas, but no white bare metal areas. Minimal corrosion/FAC.
3. Few white bare metal areas on a number of tube entries. Some black areas of deposit. Mild corrosion/FAC.
4. Serious white (bare metal) areas on/at numerous tube entries. Extensive areas of black deposition adjacent to white areas within tubes. Serious corrosion/FAC.
5. Most serious. Holes in the tubing or welding. Obvious corrosion on many tube entries.

Figure 2:
Montage illustrating DHACI indices 1–5 for the upper ducts and tube entries.

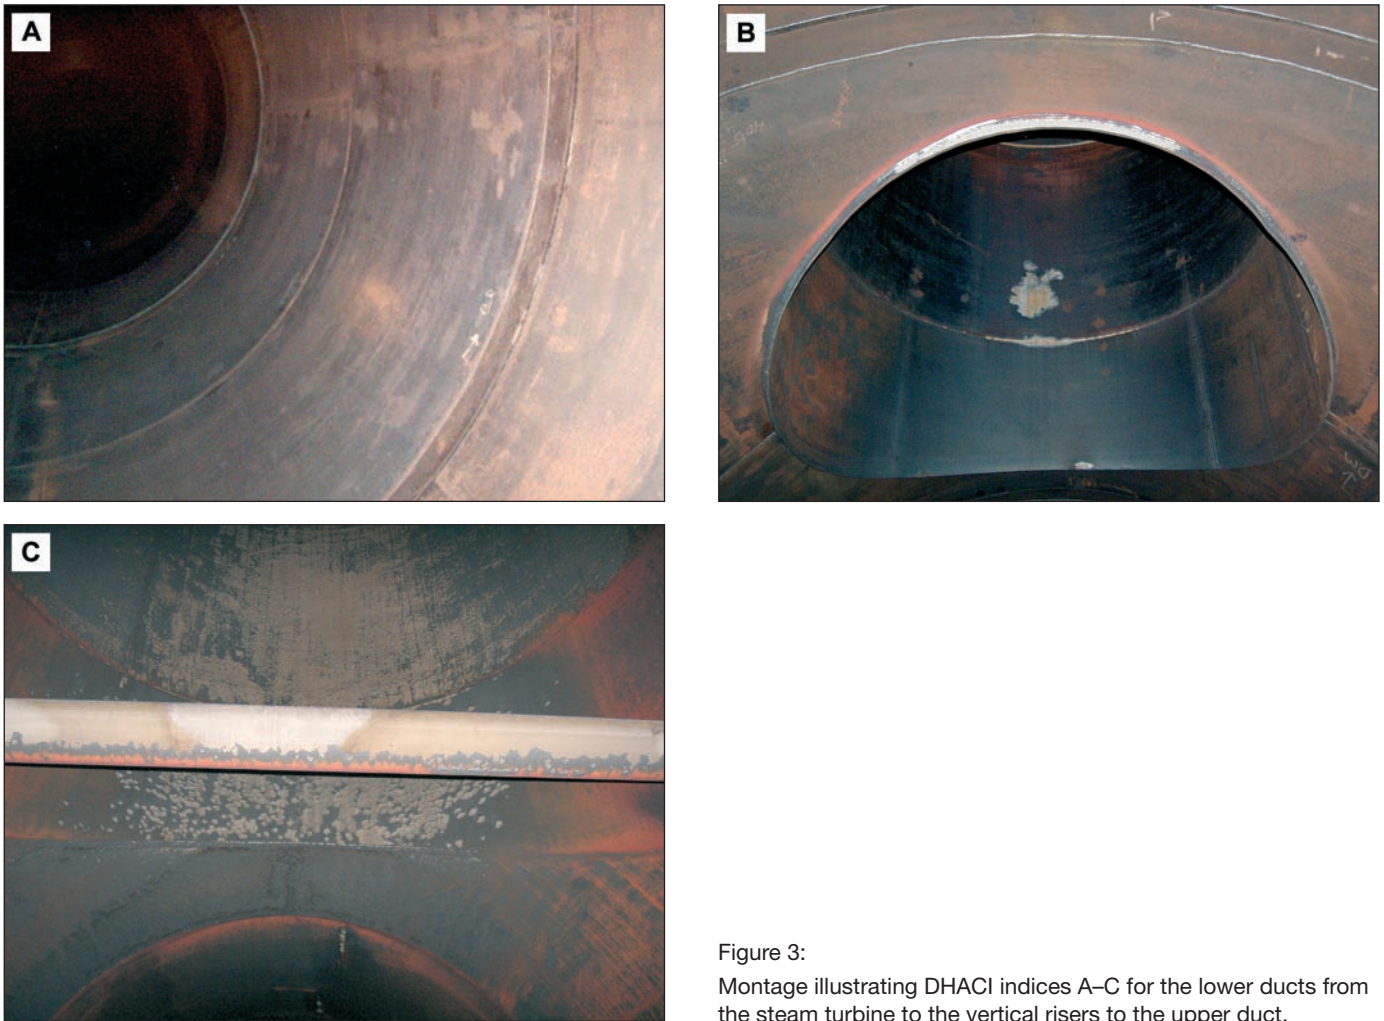
Figure 3:

Lower Section (turbine exhaust, lower distribution duct, risers); rate A, B or C. Examples are shown in [Figure 3](#).

- Ducts have no indication of damage and are grey in color.
- Minor white (bare metal) areas on generally grey ducts. Some 'tiger striping' appearance with darker grey/black areas demonstrating two-phase flow-accelerated damage. Overall assessment is 'mild damage'.
- Multiple, widespread areas of bare metal in the turbine exhaust and at abrupt changes in flow direction (e.g. where steam flow enters vertical riser from lower distribution duct). White (bare metal) areas are evident indicators of metal loss. Severe local damage exists.

Montage illustrating DHACI indices A–C for the lower ducts from the steam turbine to the vertical risers to the upper duct.

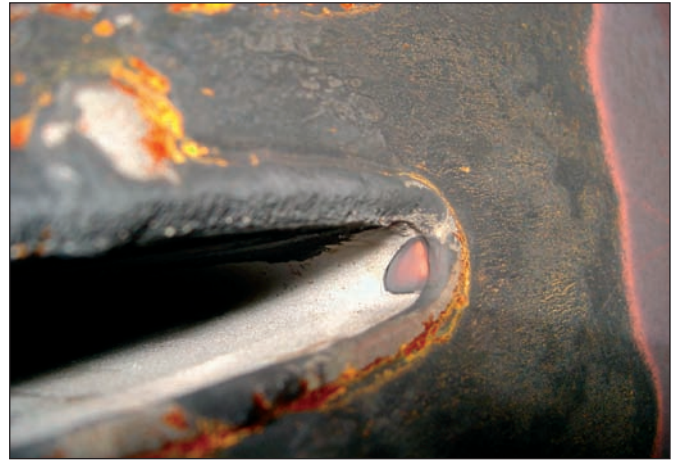
Of immediate concern during the initial Matimba inspections was the perforation of the relatively thin wall, 1.5 mm (0.059 in), of the elliptical fin tube at the tube entry. Any perforations would result in an air leak into the vacuum space with an adverse effect on condenser performance. [Figure 9](#) shows a perforation in a tube entry surrounded by a large white corroded area. This white area is the same as the "bare metal areas" described in the introduction and is shown in more detail in [Figure 1](#).

Figure 9:
Through-wall penetration of the tube wall immediately below the seal weld at the tube entry. Also note the loss in material of the seal weld. This is recorded as DHACI 5.

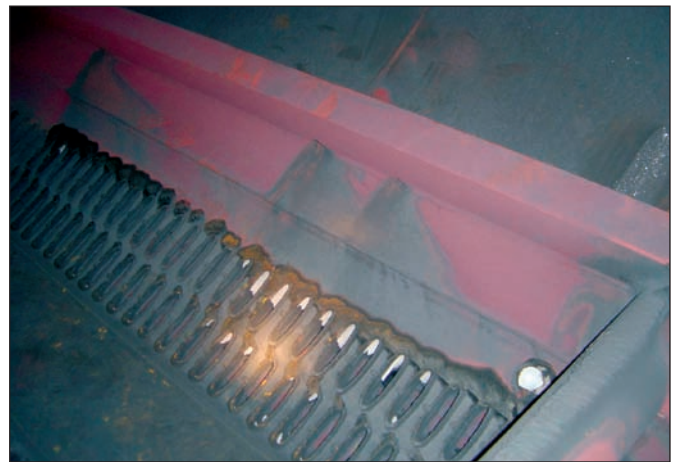
[Figure 10](#) shows patches of white corroded areas in a number of tube entries in a location of high liquid concentration caused by the two drain holes in the channel immediately above the tube entries. These white areas have

Figure 10:
White bare metal areas at a number of tube entries which are immediately below a drain hole in a channel on the duct surface. This is recorded as DHACI 3.

been described in the introduction and are shown in [Figure 1](#). The surrounding dark grey areas are the same as the black deposited areas also described in relation to [Figure 1](#).

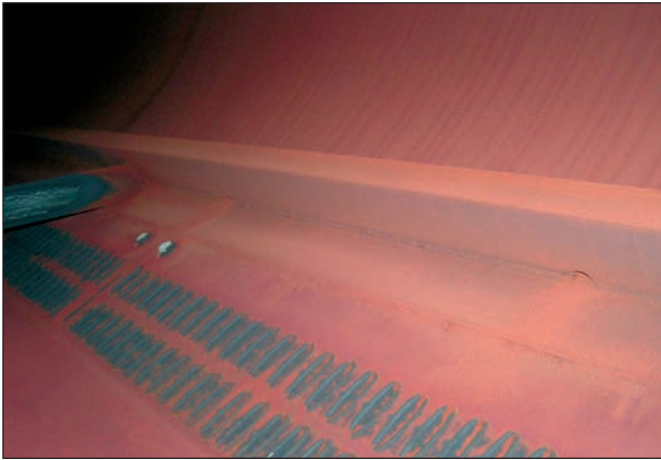
Whilst the desired pH for operation at Matimba Power Station was 9.8 for the protection of the ACC, there was a period of operation when the pH had to be reduced to 9.4 because of problems related to the ability of the condensate polishing plant to operate in the ammonium form. This lasted for approximately two years and the resulting damage to the ACC is evident in [Figures 9 and 10](#). Tube entries, rated at DHACI 1, with no visible white bare metal areas (FAC) are shown in [Figure 11](#), which illustrates the improvement when a plant is operated at a pH of 9.8. Such significant improvements can occur in approximately two years.

Figure 11:
Well-protected tube entries with no white bare metal areas and a well passivated red duct surface in an ACC operating with a pH between 9.6 and 10. This is recorded as DHACI 1.

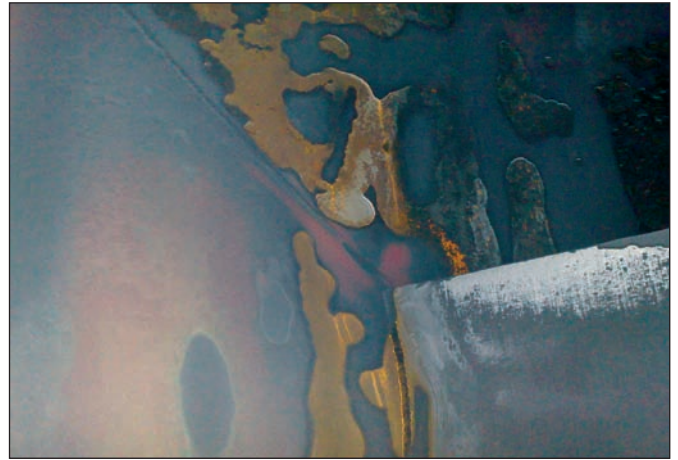
Figure 12:
Localized area of significant wall loss in the lower exhaust duct. DHACI C.

boundary of the ACC but will contribute to the iron transport in the condensate. However, in localized areas significant material loss can be experienced, generally in areas of highly disturbed flow or high liquid phase concentration. An example of such an area in the lower ducting, immediately downstream of the trailing edge of a guide vane in a bend, is shown in [Figure 12](#). The figure shows a corroded area where material loss of about 3 mm (0.117 in) is experienced after a total exposure of 146 000 operating hours.

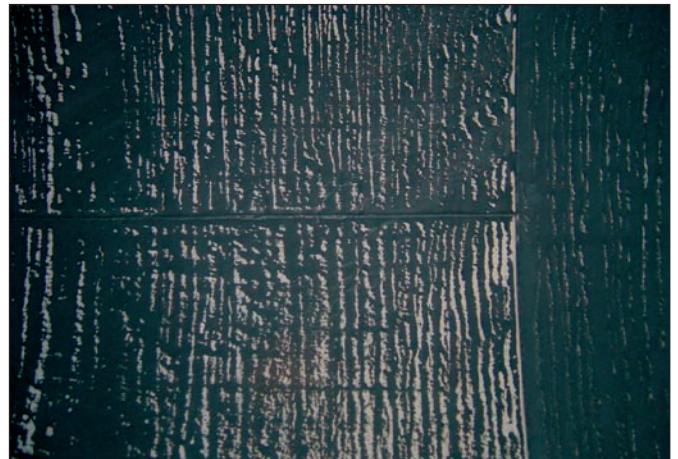
The corrosion in [Figure 12](#) is an exception, and generally minor wall loss is associated with the corroded areas. Such an example is given in [Figure 13](#), which shows some 'tiger striping' appearance with darker grey/black areas demonstrating two-phase flow-accelerated damage.

Figure 13:
Minor bare metal (white) areas on black background as observed in the duct section H1 (see [Figure 6](#)). DHACI B.

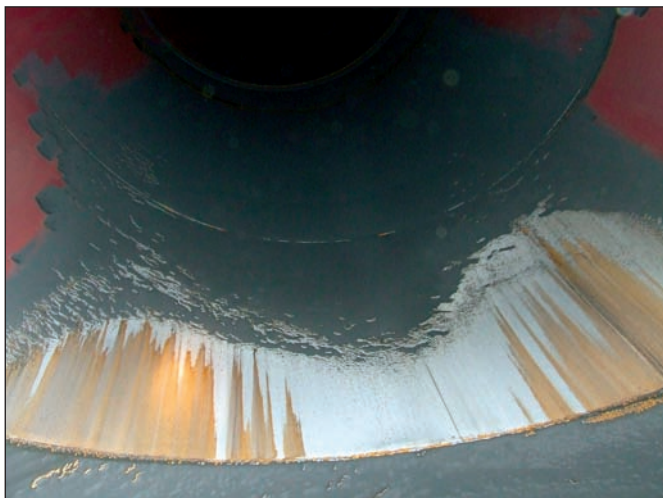
Figure 14:
Corrosion pattern in branch H2-V3 (Figure 7). DHACI C.

The effect of the moisture content in the exhaust steam is well illustrated in Figure 14, which shows the branch H2-V3. On the downstream side of the branch a large bare metal area is visible with patches of flash rust, while the rest of the branch circumference is well protected with a stable oxide layer. Due to centrifugal action the free moisture in the exhaust steam impinges on the downstream side of the branch, resulting in the corrosion pattern shown in the figure.
