FAILURE INVESTIGATION OF LARGE WIND TURBINE TRANSMISSION HOUSINGS

Peter C. Riccardella, George J. Licina, Darryl A. Rosario, Richard L. Bax

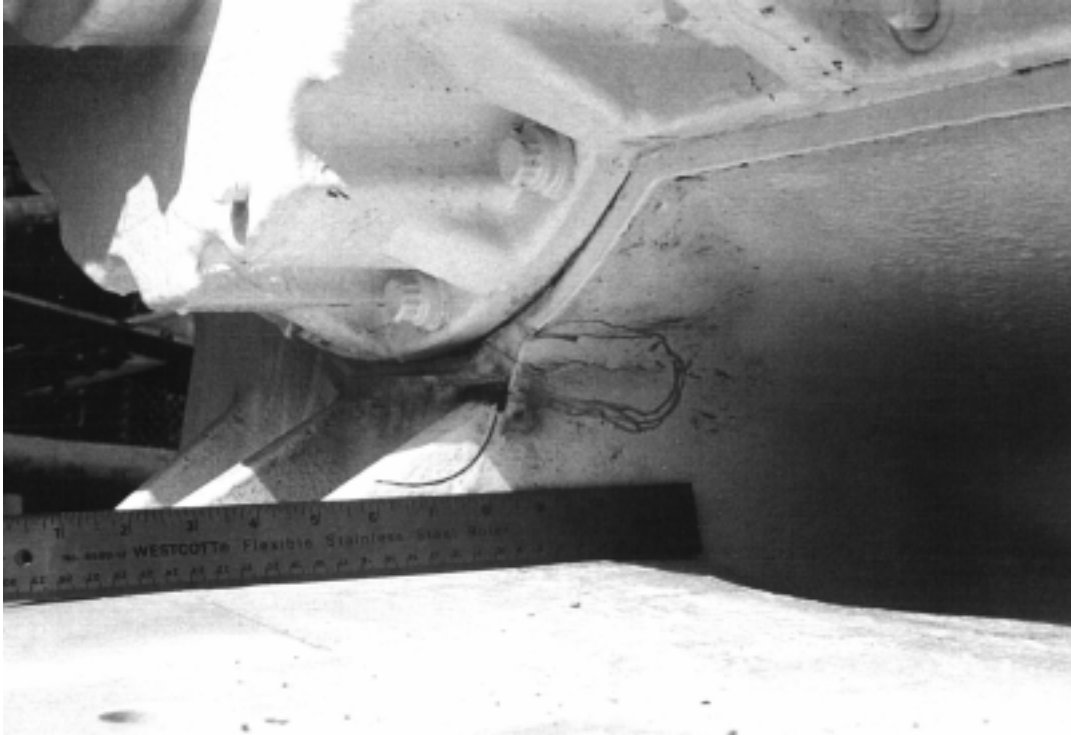
The ductile cast iron transmission housings of the large, 410 KW wind turbines produced by a major U.S. manufacturer were failing at an alarmingly high rate after only short operating periods (one or two wind seasons). As illustrated in Figs. 1 and 2, the failures initiated as corner cracks at a gusseted transition section between the main turbine housing and a heavy base plate used to affix the turbine to the tower. Once initiated, the cracks propagated through the wall of the housing, ultimately leading to leakage of oil from the housing, and necessitating shutdown of the units. The failure investigation described in this paper was performed to identify both short term and long term measures which could be used by a wind field operator who had recently installed over fifty such turbines. At issue was the efficacy of remedies to the problem proposed by the manufacturer, and whether the operator should accept final turnover of the wind field.

Figure 1. Photograph of Severely Cracked Transmission Housing

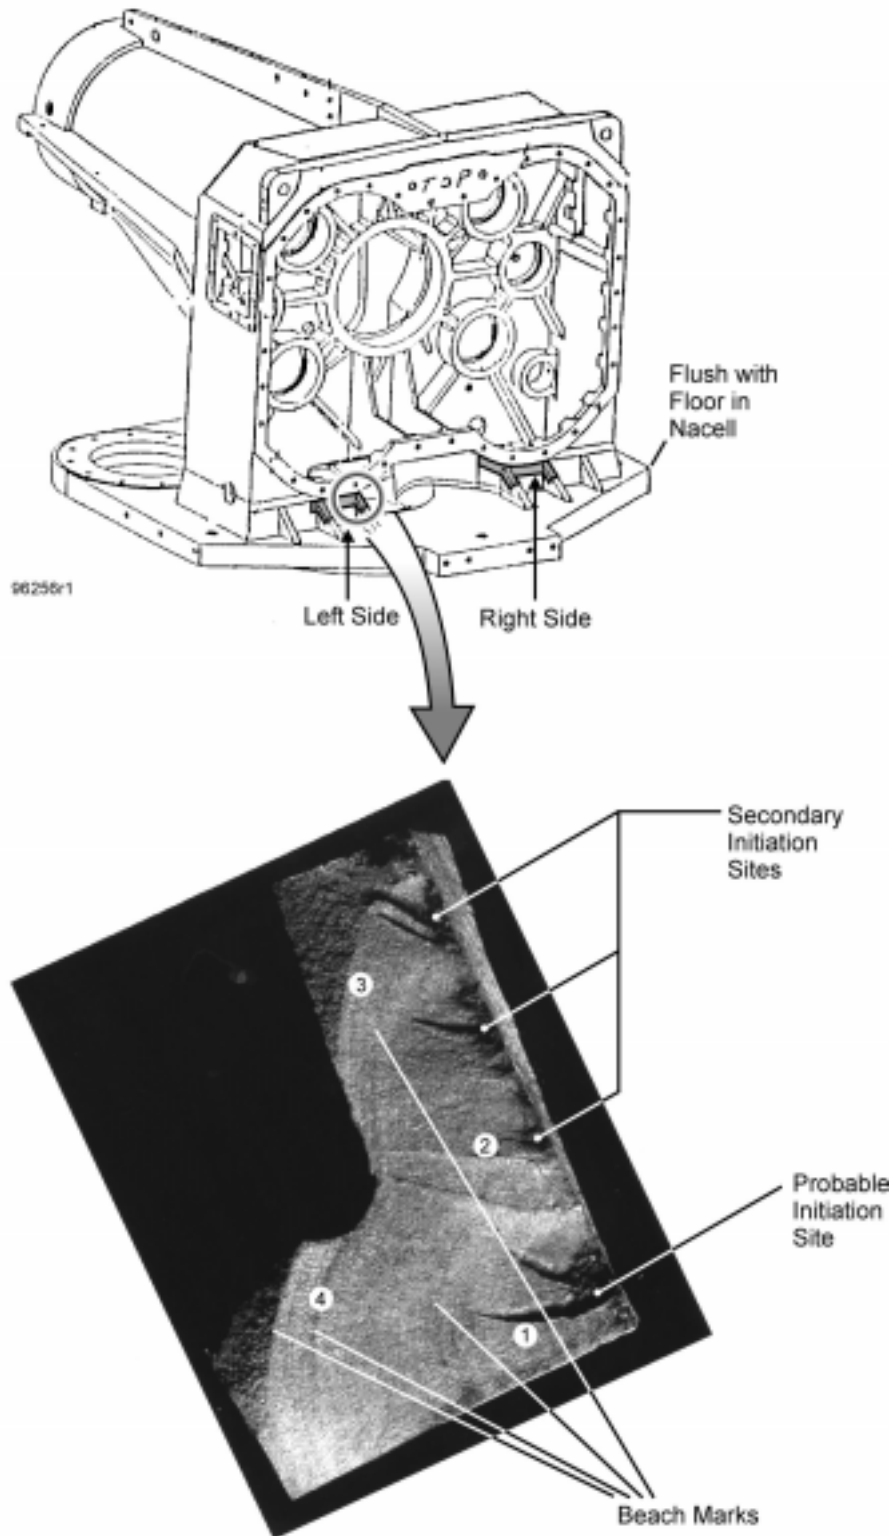
Structural Integrity Associates obtained material from the manufacturer, including specimens containing the more severe cracking, and material from

unfailed locations for mechanical properties testing (Figs. 2 and 3). The manufacturer also provided housing design details, which were used to create analytical models (Fig. 4), but very little information was available on the magnitudes of anticipated loads on the housing under various operating conditions. With this as input, the failure investigation proceeded via the following major steps.

Figure 2. Schematic of Transmission Housing Showing Location and Macrograph of Most Severe Cracking

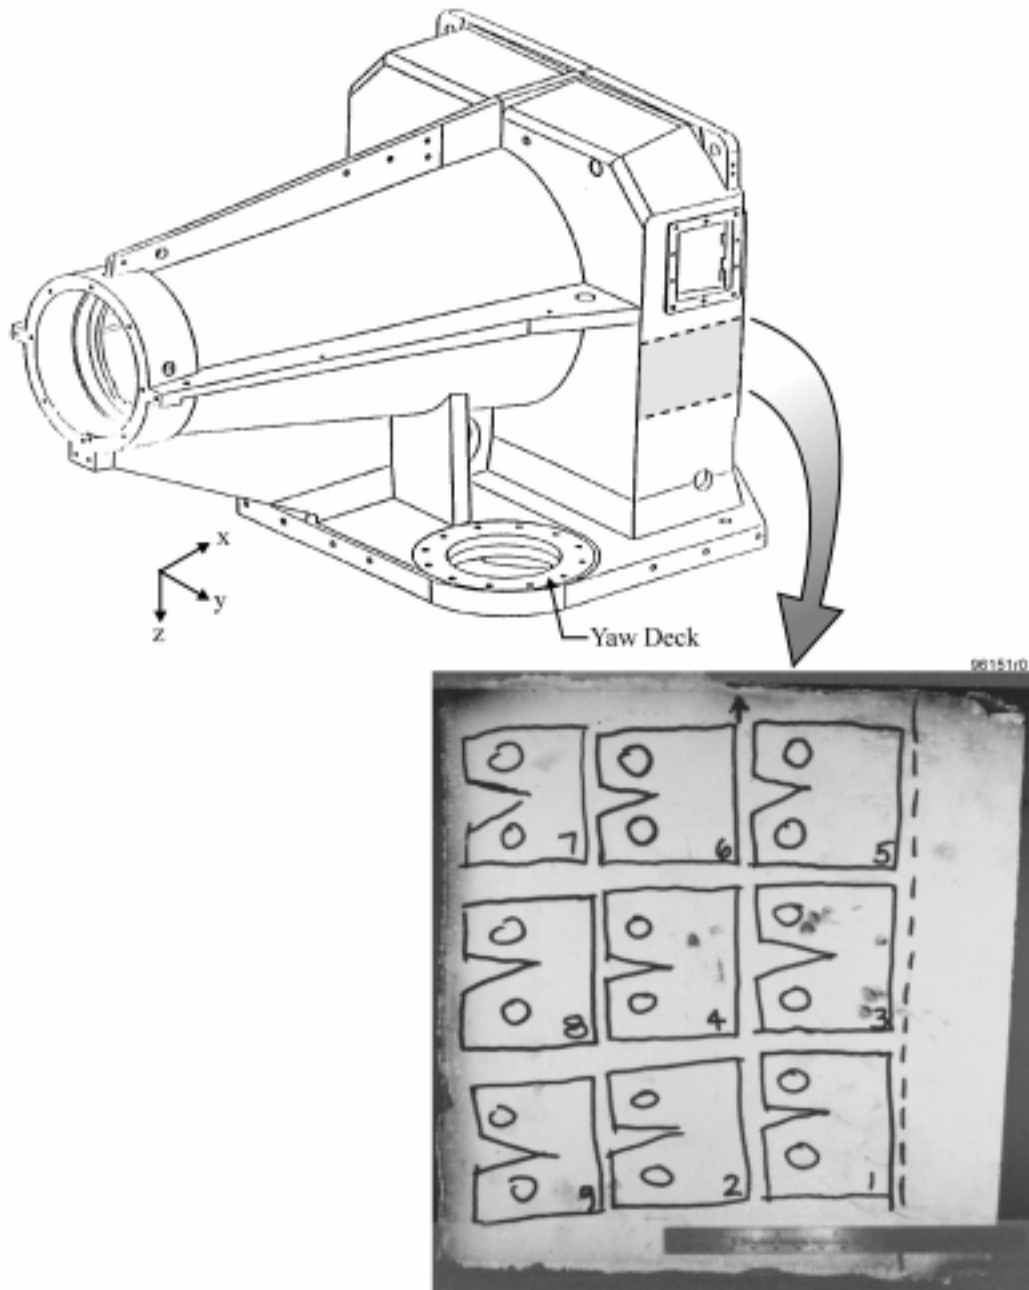
2. Crack Growth Rate Testing – In addition to the field failures, fatigue crack growth specimens were machined (Fig. 3) from the same transmission housing, and tested in the laboratory under controlled loading conditions. The fracture surfaces from these specimens were also examined in the SEM in order to compare the fracture surface characteristics from housing material loaded under unknown conditions (field failures) to those from well-characterized loadings (fatigue crack growth specimens). The objective of this activity was to provide information on the probable time and number of cycles for crack growth and to estimate the stress range that must have existed in the field to produce the observed fatigue failures.

Figure 3. Schematic of Transmission Housing Showing Location from which Fracture Mechanics Crack Growth Specimens were Obtained

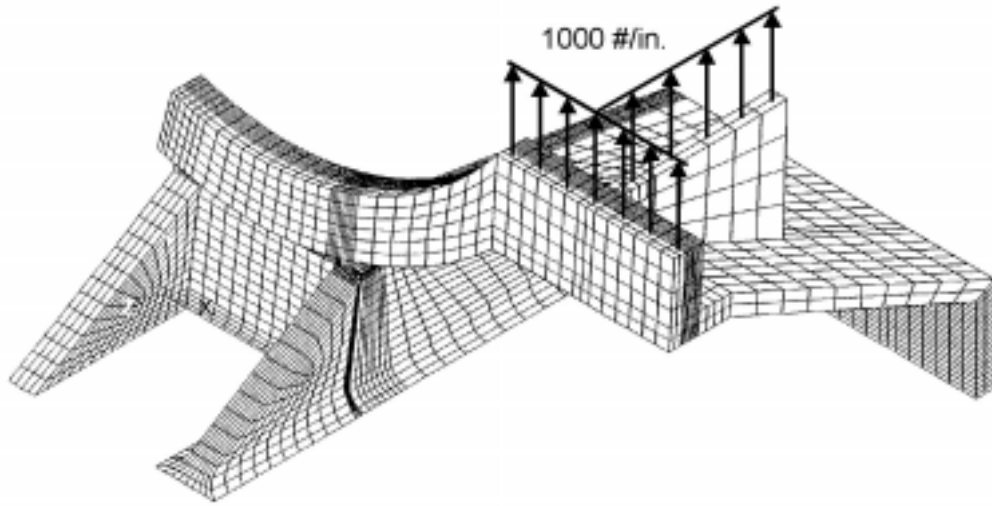
3. Finite Element Stress Analysis –The authors developed a finite element sub-model of the local region of the transmission housing in the vicinity of the gussets (Fig. 4). The sub-model included only those portions of the housing and adjacent components believed to be of significance to the cracking. A painstakingly detailed mesh was used in the vicinity of potential stress raisers, such as the fillet between the gusset and the housing body (i.e. the crack initiation site). The model was loaded using vertical tractions of 1000 lbs./in. along the top surface of the internal gusset and cover flange, as illustrated in Fig. 4. This loaded region is in the direct load path between the rear, main shaft bearing and the cracking region. Applying loads over this region is considered a reasonable approximation of the wind loading on the housing at the crack location. Since the absolute magnitude and direction of the wind loading were unknown at the time of modeling, an arbitrary value of 1000 lbs./in. upward was assumed as a unit load which could later be

Figure 4. Finite Element Model of Transmission Housing Cracking Location

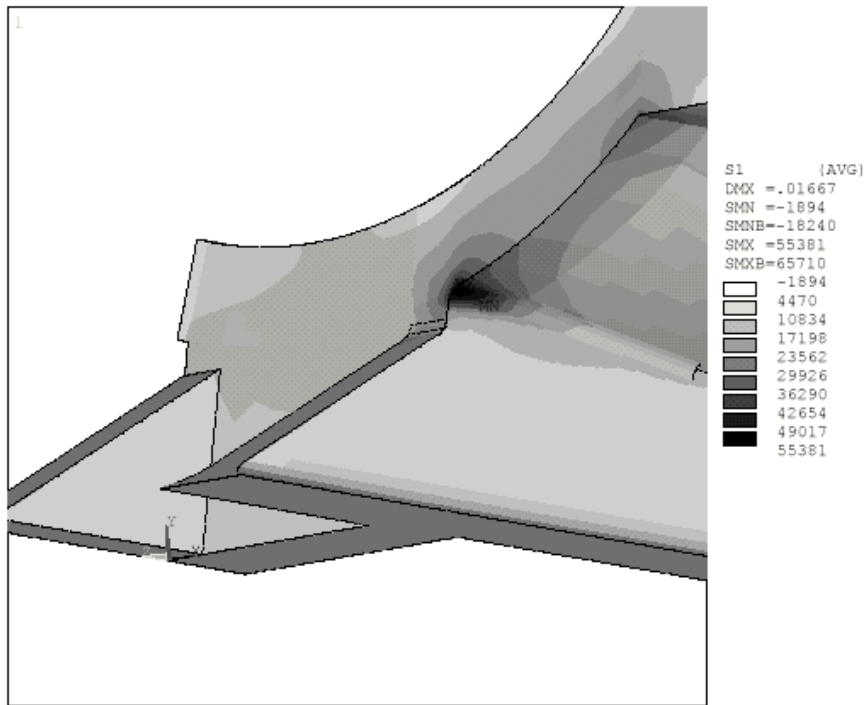
scaled up or down as appropriate. The resulting stress distribution is illustrated in Fig. 5.

Figure 5. Stress Distribution Resulting from Finite Element Analysis

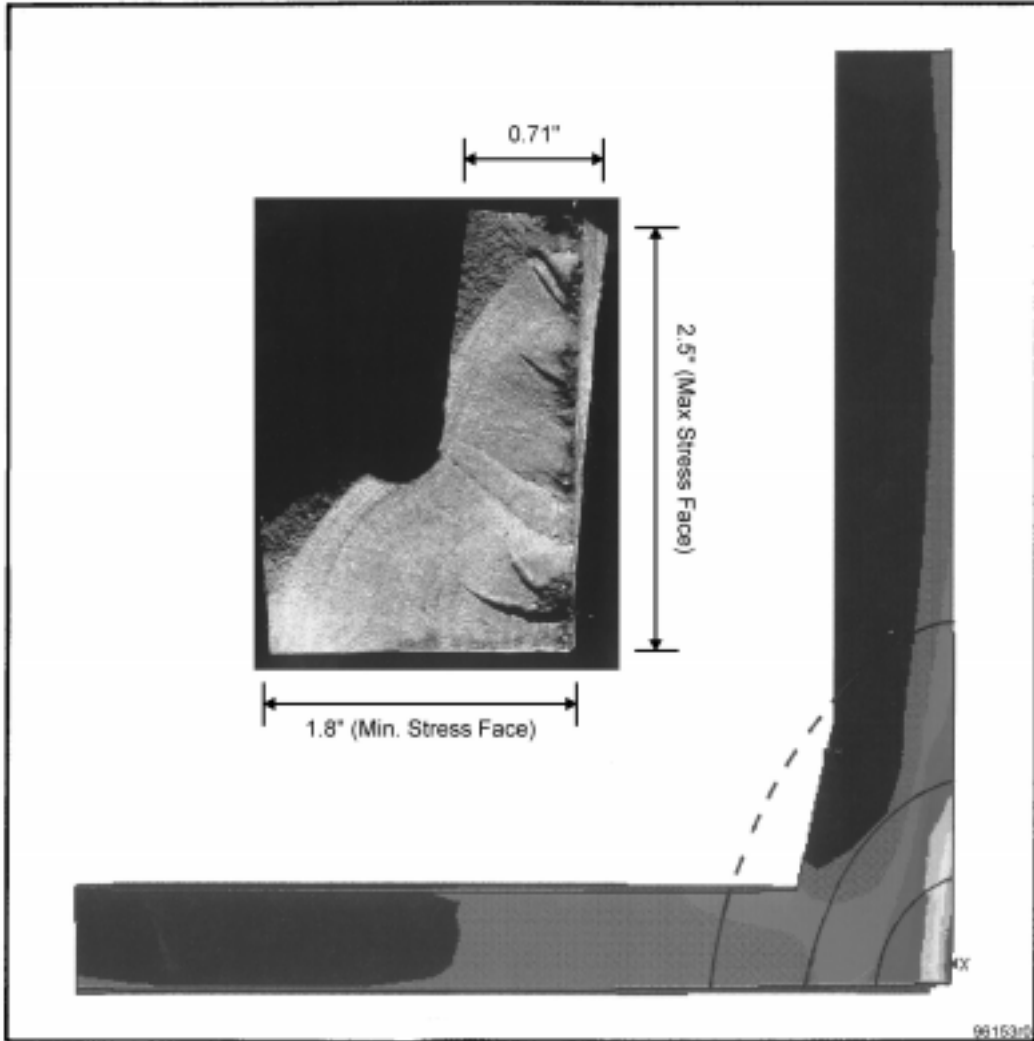
4. Fracture Mechanics Crack Growth and Critical Flaw Size Analysis – As illustrated in Fig.6, a quarter-elliptical crack was modeled at the highest stressed horizontal section in the finite element model in order to predict stress intensity factor versus crack size. The stress intensity range computed in this manner was used as input to a Paris Law crack growth model derived from the fatigue crack growth testing described above, Fig.7. The computed stress intensity factor range was scaled to a value consistent with the observed crack growth rate / striation spacing in the field failures. This yielded a prediction of the actual load amplitude and number of cycles which must have occurred to produce the observed failures.

Figure 6. Horizontal Section of Finite Element Model through Crack Location with Fracture Mechanics Model Superimposed

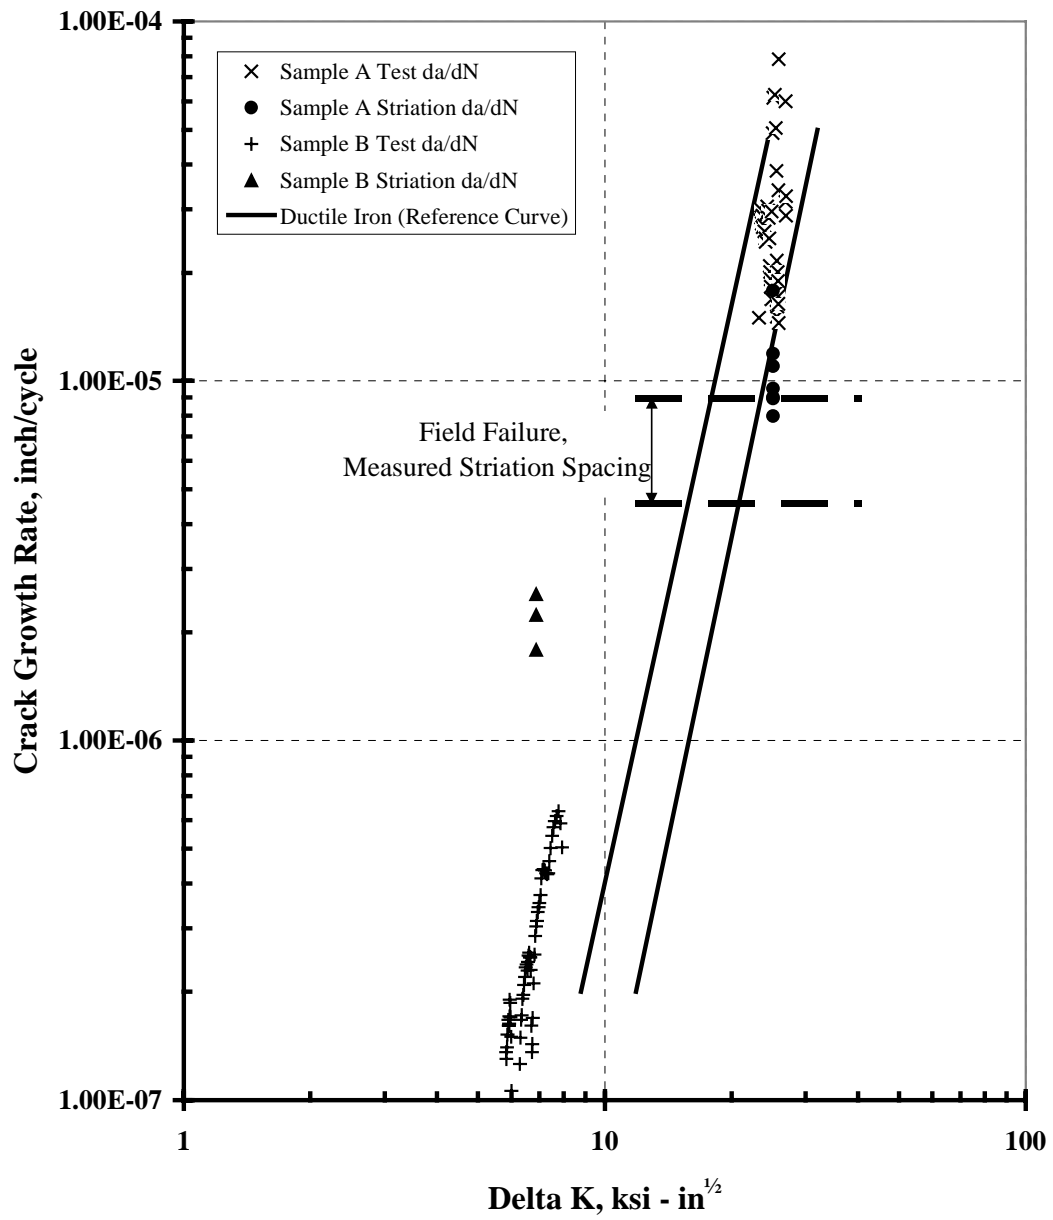
1. Metallurgical Analysis – The metallurgical failure analysis included optical metallography, plus optical and scanning electron fractography. The material was found to be “as-specified”, without excessive surface or internal defects for a casting of this category. Selected locations on the fracture surface from the largest crack, numbered (1) through (4) in Figure 2, were examined in the SEM. The fracture surface showed definite beach marks (visible with the unaided eye and in the SEM) and striations. Using the SEM photographs, striation spacing was estimated for various sections of the fracture surface. The resulting striation count was then used to estimate the crack propagation rate.

Figure 7. Fracture Mechanics Crack Growth Test Results and Correlation with Measured Striation Spacing
