MATERIALS LABORATORY CASE STUDIES CASE STUDY #5 PROCESS UPSETS – CONDITION ANALYSIS

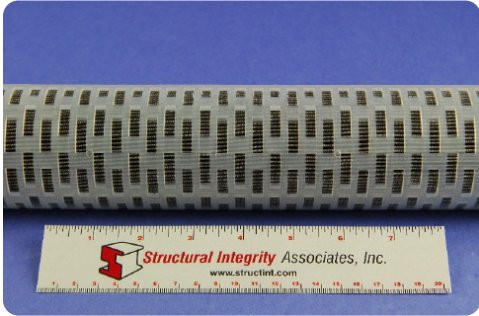
FIGURE 1. The filter shown in the as-received condition.

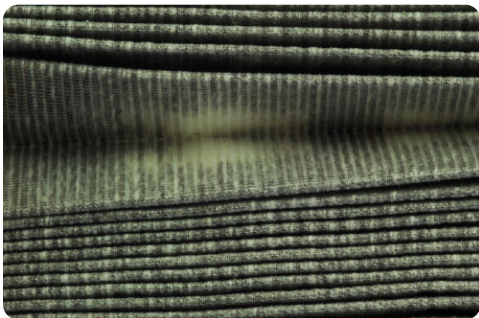
FIGURE 2. The yellow color is the original appearance of the filter.

The filter was visually examined and documented in the as-received condition as shown in Figure 1. The submitted sample had a perforated plastic shell that covered an inner filter. The outer plastic was removed to provide access to the filter underneath. Figure 2 shows close images of the filter, which was yellowish-white with much of its surface covered in gray colored debris/deposit.
