NEWS & VIEWS

Metallurgical Lab Case Study:

Corrosion Fatigue in WaterWall Tubes Increasingly A Safety Concern as Coal Plants Cycle

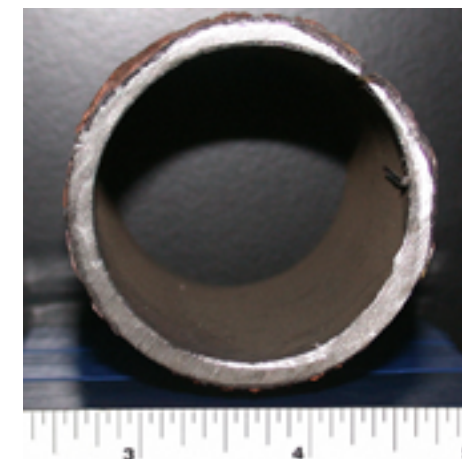
OD wall loss is most severe at the 10:00 and 2:00 positions due to coal ash corrosion.

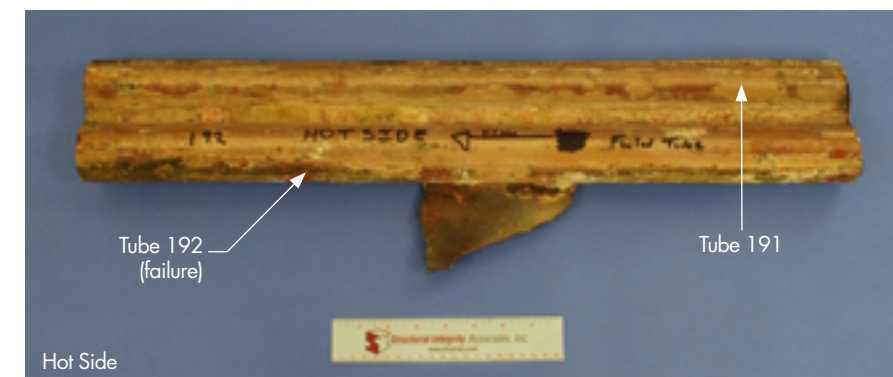
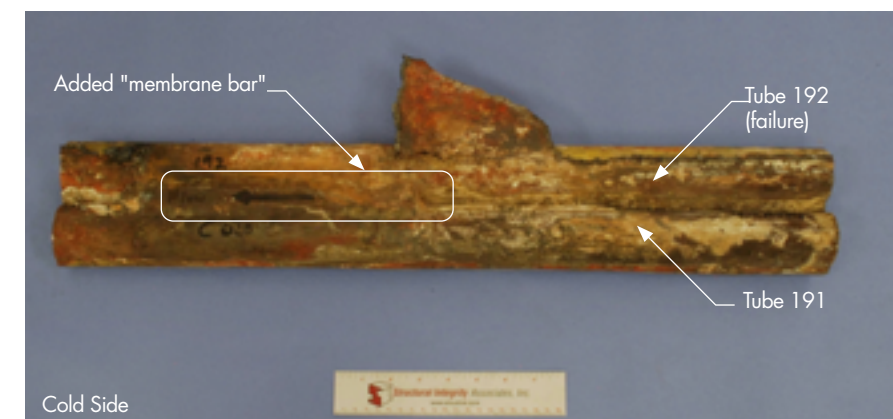
FIGURE 1. As-received photographs of the submitted waterwall tubes (Tube 191 and Tube 192). Tube 192 was marked as "failed". These tubes are adjoined via neutral axis membrane weld. However, on the cold side an added "membrane bar" ~10" in length was noted.

Figure 1 shows the tubes (Tube 191 and Tube 192) in the as-received condition. An annotation by plant personnel notates Tube 192 as the failed tube, although the specific region of failure was not noted. The waterwall tubes are adjoined via membrane weld; however, on the cold side an added “membrane bar” ~10” in length was noted. This “membrane bar” was not fully fused to the tube-to-tube membrane weld, so a gap between the two was present. To facilitate a better examination of the cold side, the tube was grit-blasted to remove the deposits/oxides along the OD surface. Figure 2 shows photographs of the cold side before and after-blasting. A significant number of pad welds, attachment welds, etc. were noted along the cold side OD surface. External or cold side casing attachment points for Tube 192 were confirmed by plant personnel. However, it was unclear if the regions notated for Tube 191 were also attachment points to the casing.

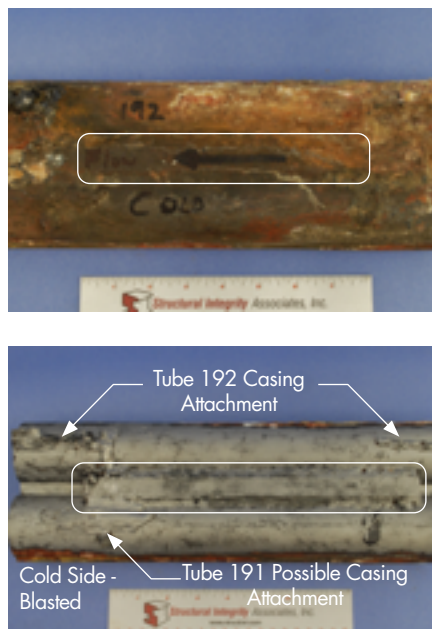
FIGURE 2. Additional photographs of the cold side of the tube after removal of the OD deposits/oxides where a number of pad welds were noted.

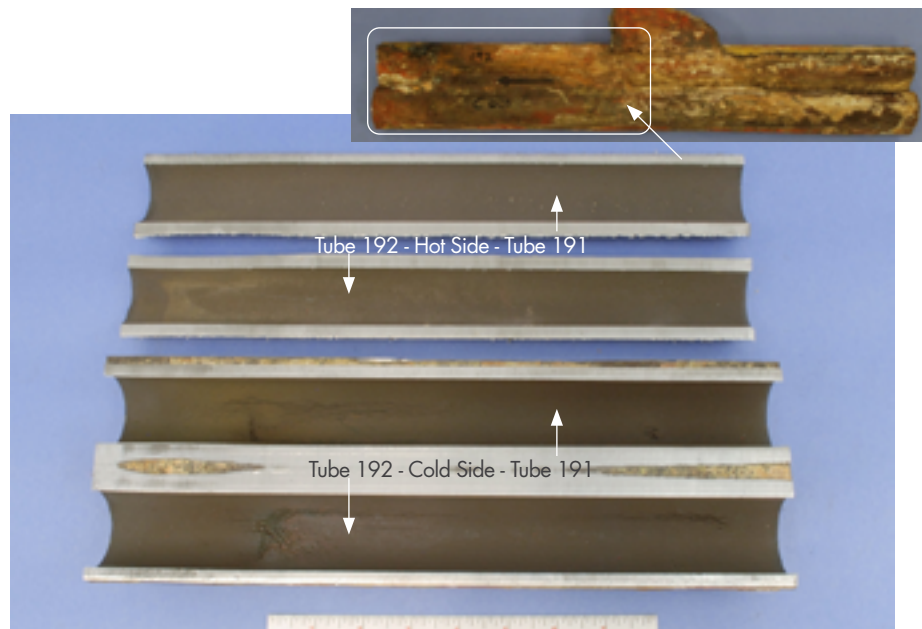
FIGURE 3. A review of the internal surface prior to sectioning identified indications along the ~14” length of tubing noted in the yellow box. After sectioning along the neutral axis (membrane weld) a multi-array of cracking was noted on the cold side only. A number of parallel cracks oriented in both the longitudinal and circumferential directions were observed and appear directly related to the stress field developed as a result of the welds on the cold side OD surface.

A review of the internal surface prior to sectioning identified indications along an ~14” length of tubing (noted in Figure 3). The tubes were sectioned in this region along the neutral axis (original tube-to-tube membrane weld). The ID surface along the cold side for both tubes exhibited a multi-array of cracking with Tube 192 exhibiting more extensive damage. A number of parallel

cracks oriented in both the longitudinal and circumferential directions were observed and appear directly related to the stress field developed as a result of the welds on the cold side OD surface of both tubes. Figure 4 shows photographs correlating the pad/attachment welds on the cold side OD surface of both tubes to the damage on the ID surfaces.

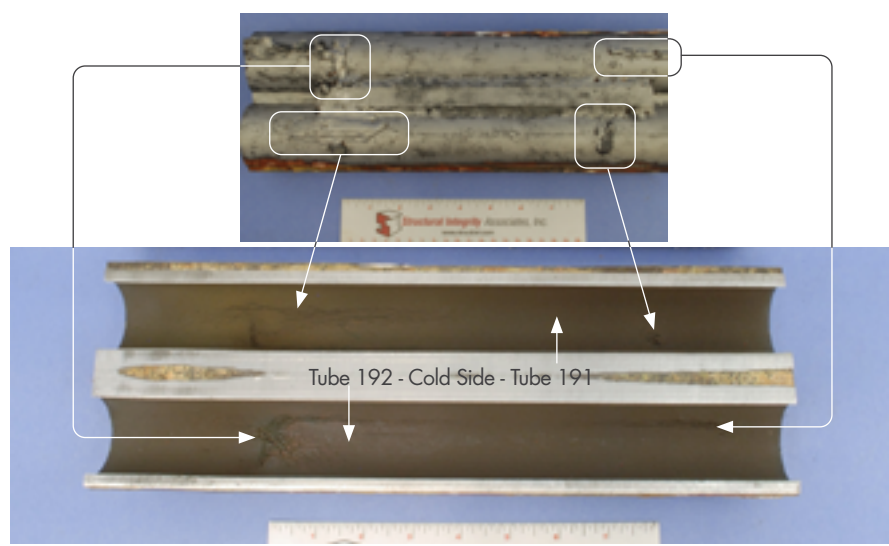
FIGURE 4. Additional photographs providing a visual representation of the OD surface pad welds and the resulting damage on the ID surface.

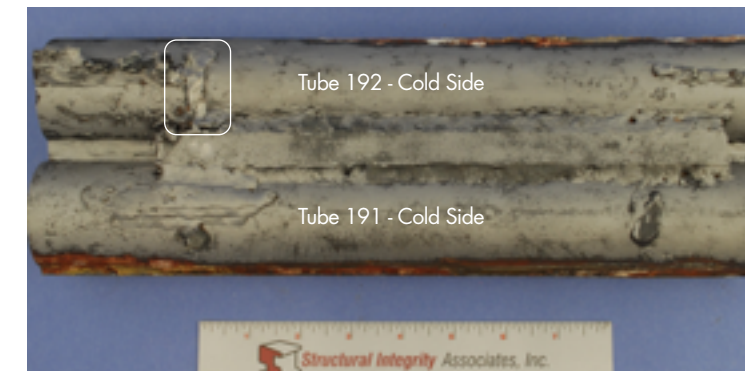
To help identify the actual leak location, a soap solution was applied to the cold side OD surfaces and pressurized air was applied against the cold side ID surfaces. The leak location was identified on Tube 192 at the location shown in Figure 5.

FIGURE 5. To facilitate the actual leak location, which was still not obvious at this point, a soap solution was applied to the cold side OD surface and pressurized air was applied against the ID surface. The leak location was identified at the location within the blue box on Tube B.

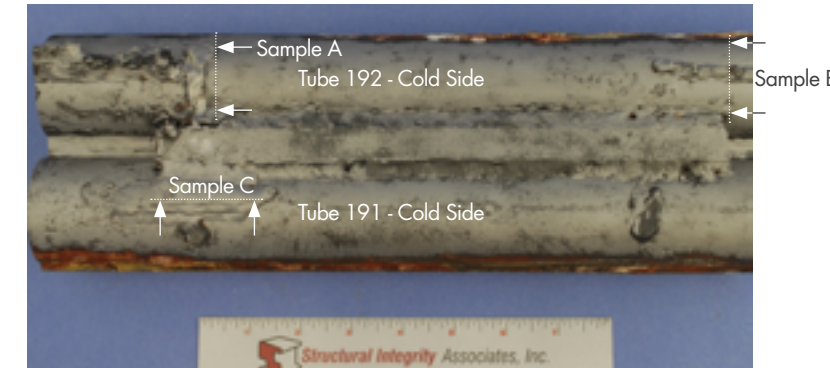
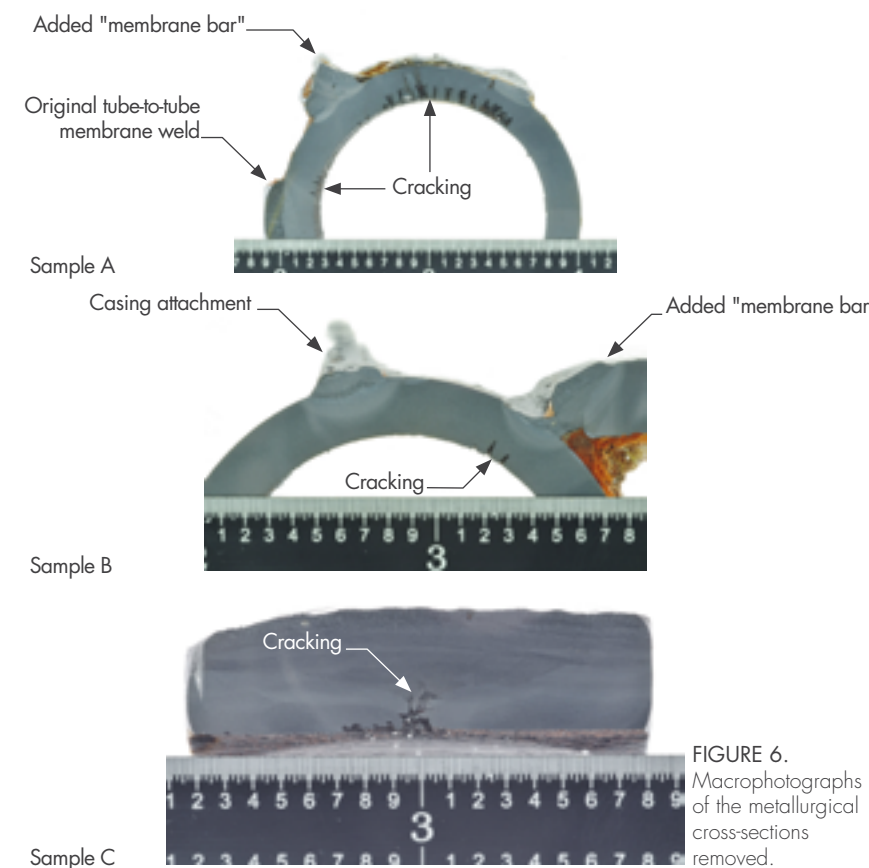
All of the cross-sections revealed cracking emanating from the ID surface. Sample A exhibited extensive and distinct cracks along the cold side crown at approximately the same circumferential zone where the circumferential weld is located on the OD surface/adjacent to the added “membrane bar”. In addition, cracking was noted along the original tube-to-tube membrane weld on the cold side. Sample B exhibited obvious cracking adjacent to the added “membrane bar” on the cold side. No damage was noted in proximity to the casing attachment weld. Sample C exhibited obvious cracking underneath the pad weld.

FIGURE 6. Macro photographs of the metallurgical cross-sections removed.

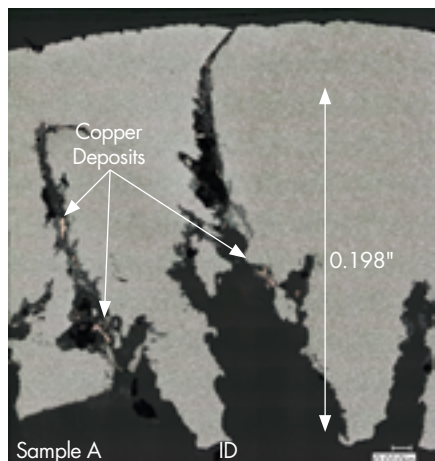
Figure 7 contains an overall stitched photomicrograph of Sample A from Tube 192 documenting the through-wall location. This location exhibited typical crack profiles representative of corrosion fatigue with signs of discontinuous growth via corrosion bulges. Copper deposits were also noted. At the through-wall location it appeared that the damage progressed to ~90% of the local wall thickness before failure resulted.

FIGURE 7. Overall stitched photomicrograph of Sample A at the through-wall location. This location exhibited typical crack profiles representative of corrosion fatigue with signs of discontinuous growth via corrosion bulges. Copper deposits were also noted. At the through-wall location it appeared that the damage progressed to ~90% of the wall thickness before failure resulted.

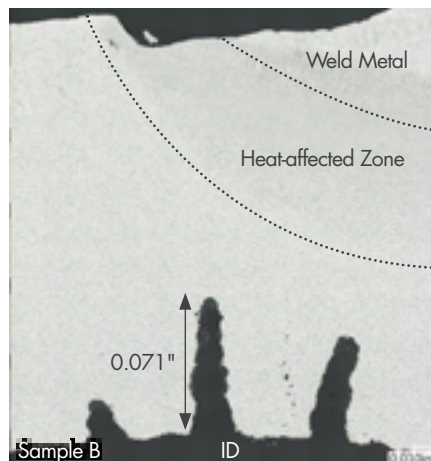
Figure 8 contains an overall stitched photomicrograph of Sample B at the deepest location. This location exhibited typical crack profiles representative of corrosion fatigue with signs of discontinuous growth via corrosion bulges. Minor amounts of copper deposits lined the crack and ID surfaces. At the deepest point, the damage progressed to ~35% of the local wall thickness. These cracks were in line with the added “membrane bar”. A higher magnification photomicrograph of the deepest location from Sample B is shown in Figure 9. The crack is blunt-tipped, contains corrosion bulges, and is lined with deposits/oxides.

FIGURE 8. Overall stitched photomicrograph of Sample B at the deepest location. This location exhibited typical crack profiles representative of corrosion fatigue with signs of discontinuous growth via corrosion bulges. Minor amounts of copper deposits lined the crack and ID surfaces. At the deepest point, the damage progressed to ~35% of the wall thickness.

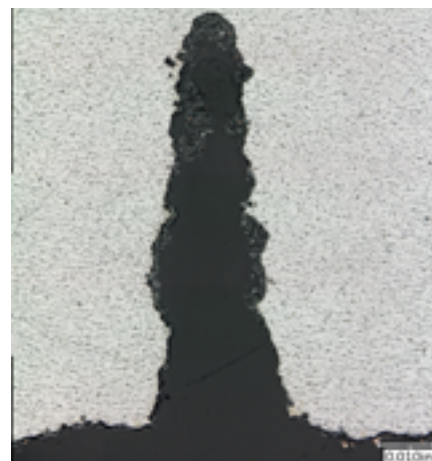
FIGURE 9. Higher magnification of the deepest location from Sample B. The copper is more clearly observed.

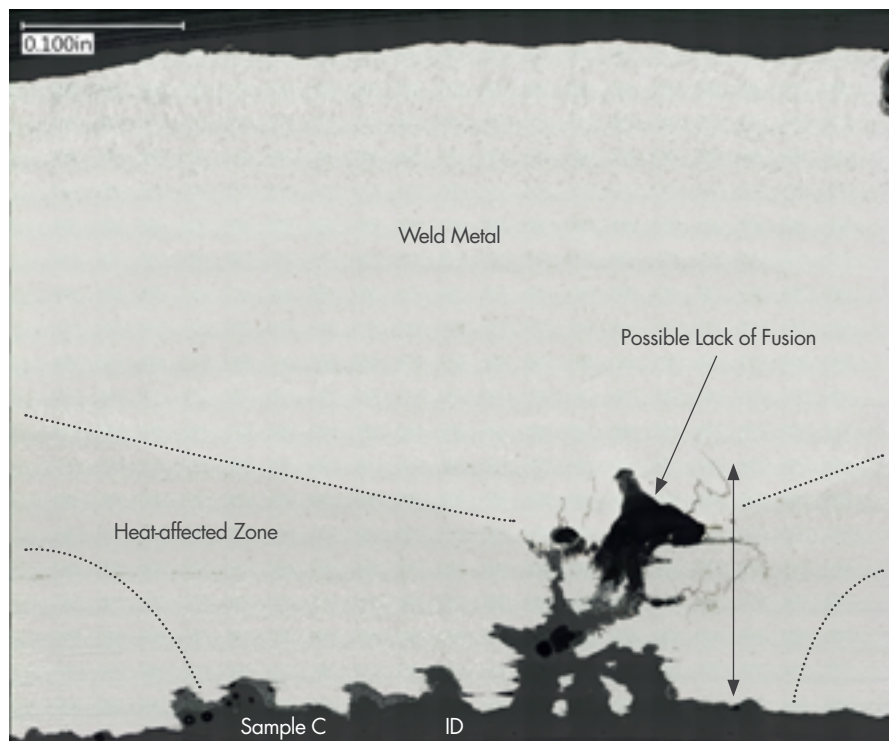
Figure 10 contains an overall stitched photomicrograph of Sample C from Tube 191. This location also exhibited a crack profile representative of corrosion fatigue. At the deepest point, the damage progressed to ~37% of the local wall thickness (note: the pad weld increased the wall thickness to ~0.400”). A significant amount of weld metal is present at this location and could possibly indicate previous repair attempts. The cracking extended through the heat-affected zone (HAZ) until linking with a possible lack

FIGURE 10. Overall stitched photomicrograph of Sample C at the deepest location. This location exhibited typical crack profiles representative of corrosion fatigue with signs of discontinuous growth via corrosion bulges. At the deepest point, the damage progressed to ~37% of the wall thickness. It should be noted that a significant amount of weld build-up was observed in this sample and is most likely a result of a previous repair effort.

of fusion site in the weld metal. In the longitudinal direction, the unaffected base metal exhibited a banded microstructure.

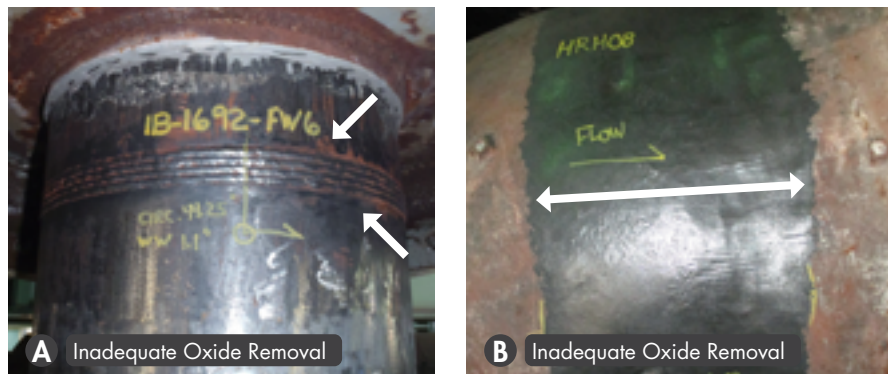
FIGURE 3. Examples of Improper Surface Prep (A) by Light Hand Grinding and (B) Wire Brushing

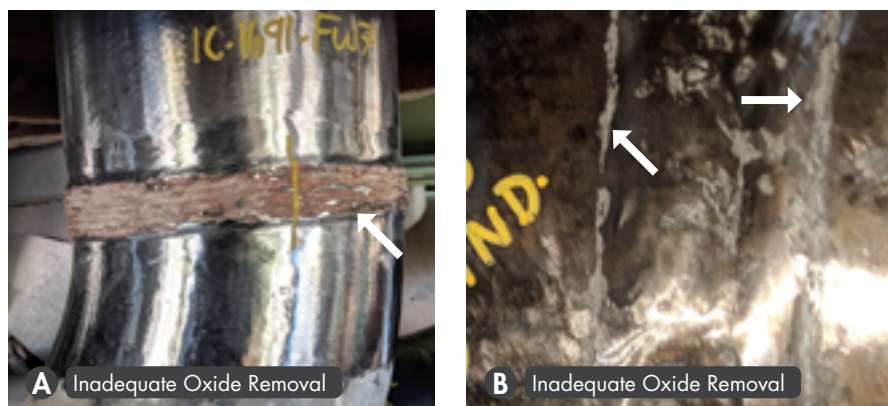
FIGURE 4. Examples of Inadequate Surface Prep at (A) Multiple Weld Passes and (B) Weld Toes

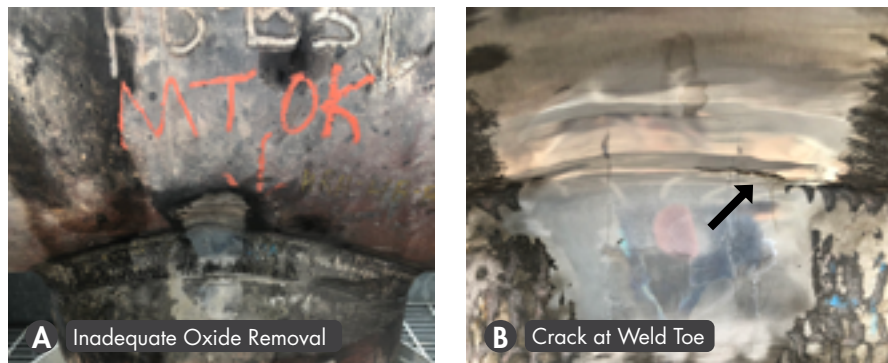
FIGURE 5. Example of Inadequate Surface Prep Leading to an "MT OK" (A) Finding on a Cracked Saddle Weld; the image in (B) is a Close View of the Crack Location (Note that the MT Inspection was Not Performed by Structural Integrity)

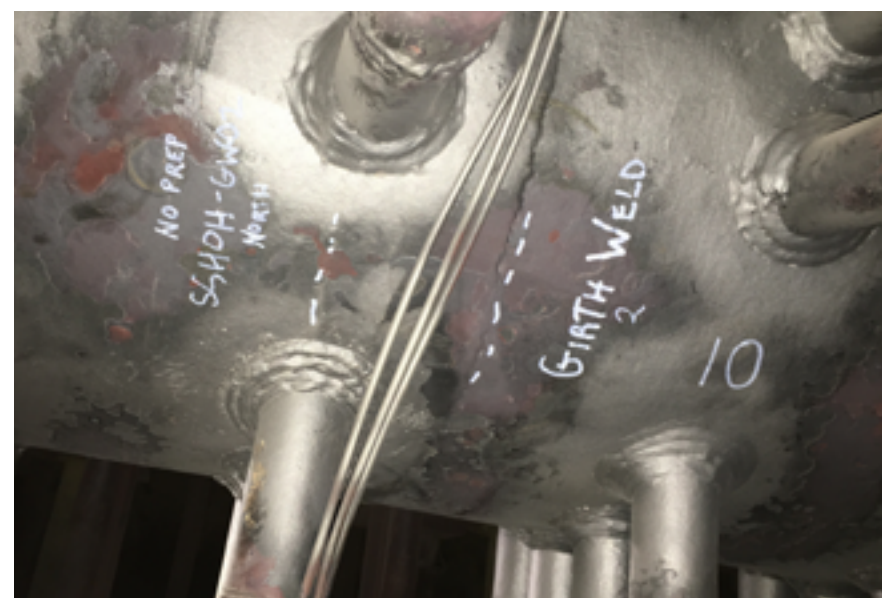
FIGURE 7. ABOVE AND BELOW Examples of Good Surface Prep Obtained by Grit Blasting at Header Stub Tube Welds (Note in the UPPER Image that a Header Girth Weld was Not Prepped for Inspection)

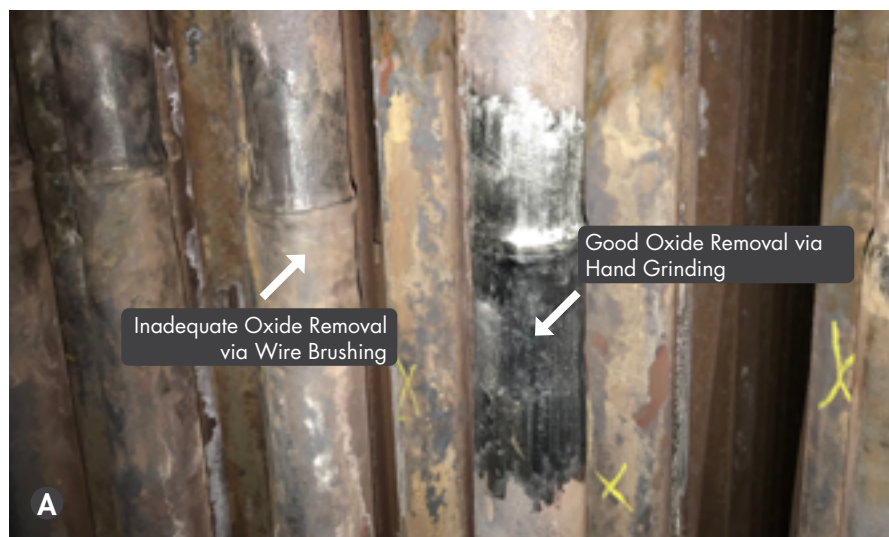
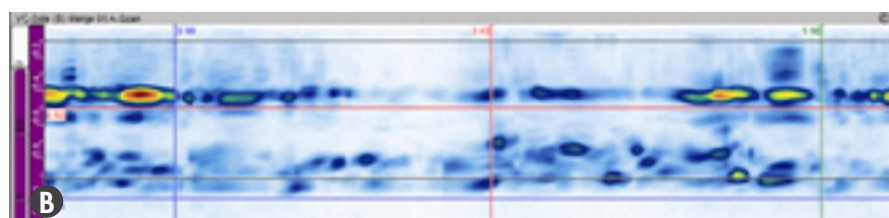
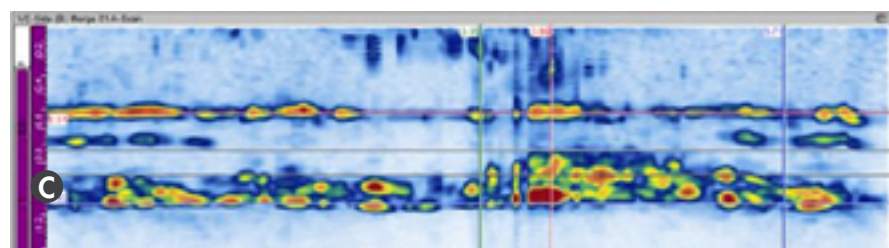
FIGURE 8. (A) Examples of Improper and Good Surface Prep at DMW Welds and (B) the Associated Phased Array Scans Obtained after Wire Brushing and (C) Proper Hand Grinding (Note that the Surface Prep Shown includes Weld Metal and Austenitic (Stainless) Tubing Above the Welds, whereas Only the Ferritic Tubing Requires Prep)
