# NEWS & VIEWS

*Structural Integrity* Associates, Inc.<sup>®</sup>

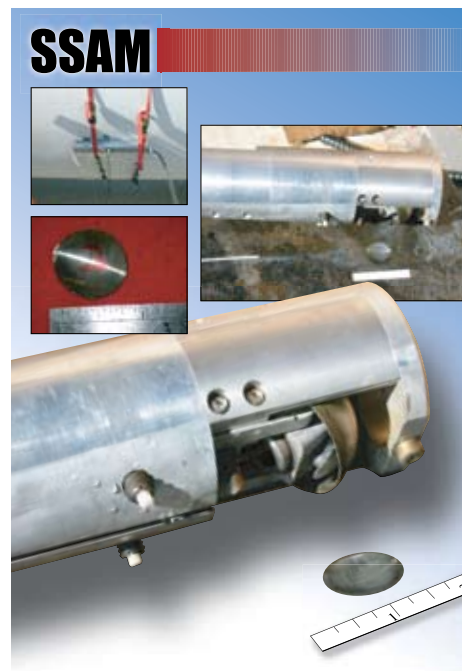
Down-bore miniature sampling tool

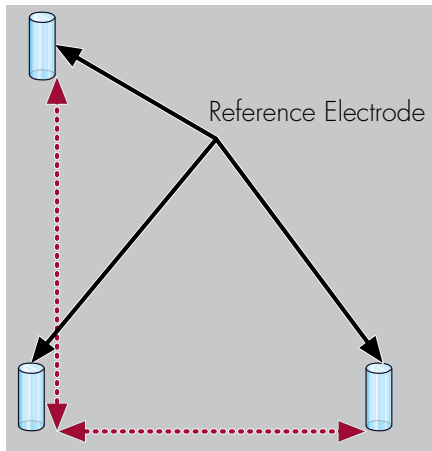
Figure 3: APEC Reference Electrodes and Picture of Example Survey

APEC is a combined CP survey technique that collects area potential measurements based on a modified CIS approach in combination with an evaluation of the earth current movement using an enhanced 3-half cell DCVG methodology (see Figure 3). In a terminal or station environment, it is important to know where any corrosion cell is operating and where CP currents are flowing. When CP system rectifiers are cycled "ON" and "OFF", the migration of CP current around the plant can be understood and used to adjust and balance the overall performance of a CP system.

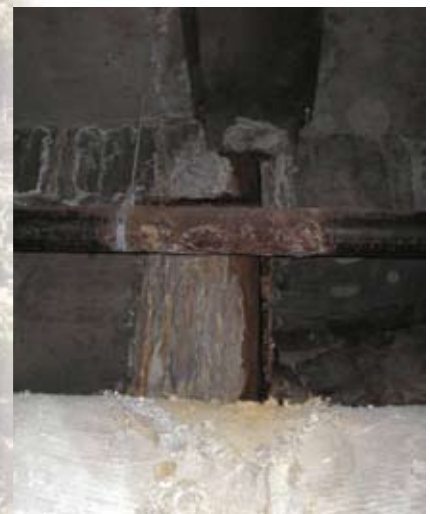
Figure 1: Photo showing area with water dripping from above in tunnel

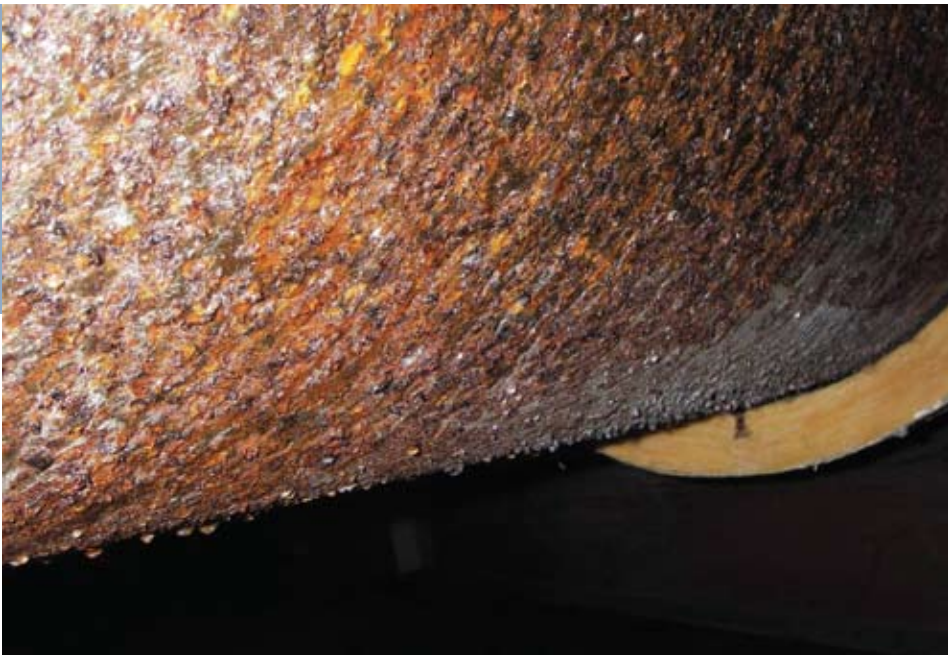
Figure 2: External corrosion on chilled water system

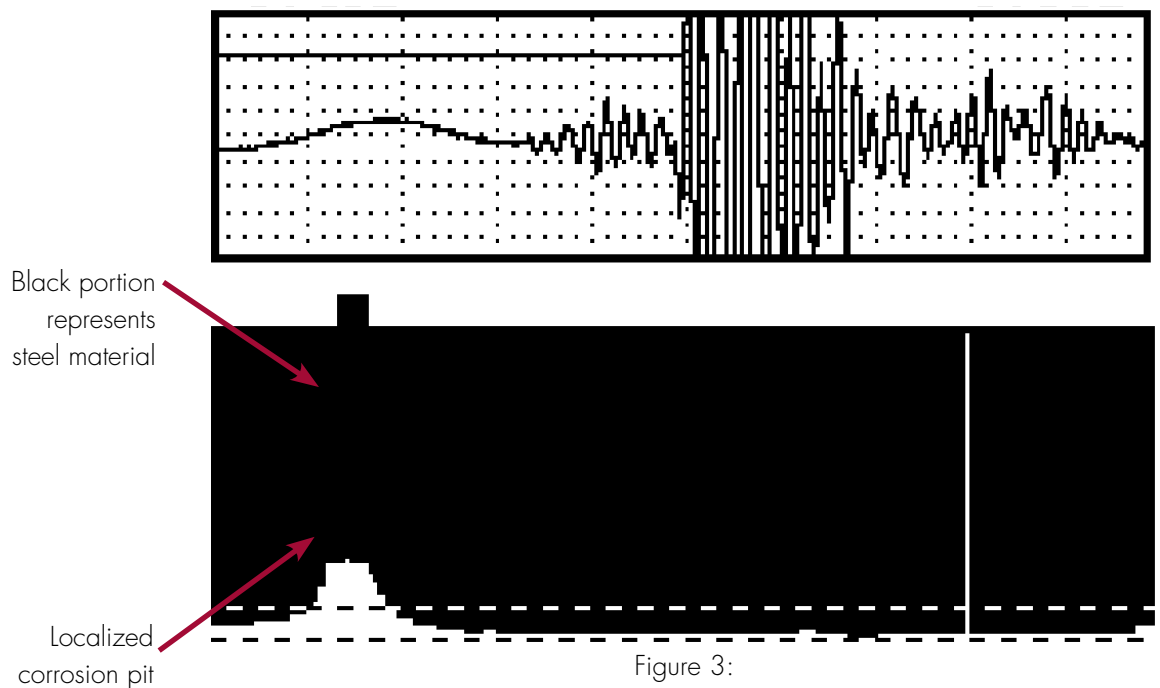
Figure 3: B-Scan screen capture showing internal profile of pipe

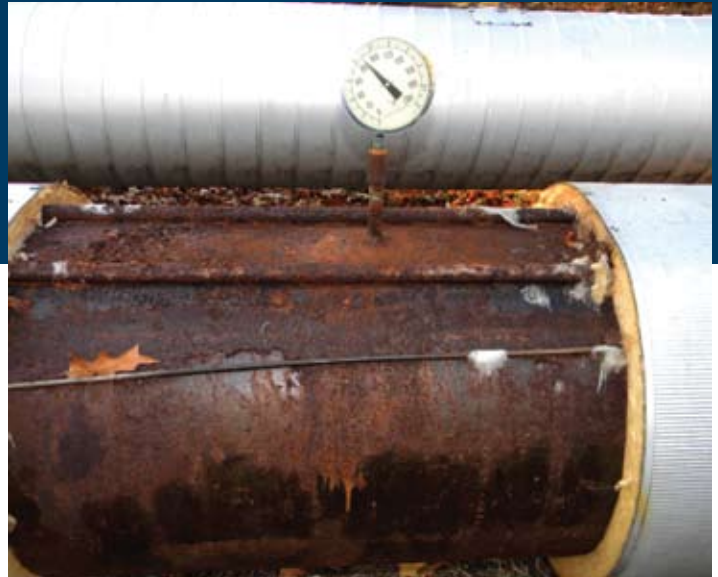
Figure 3. Piping Region Susceptible to Corrosion

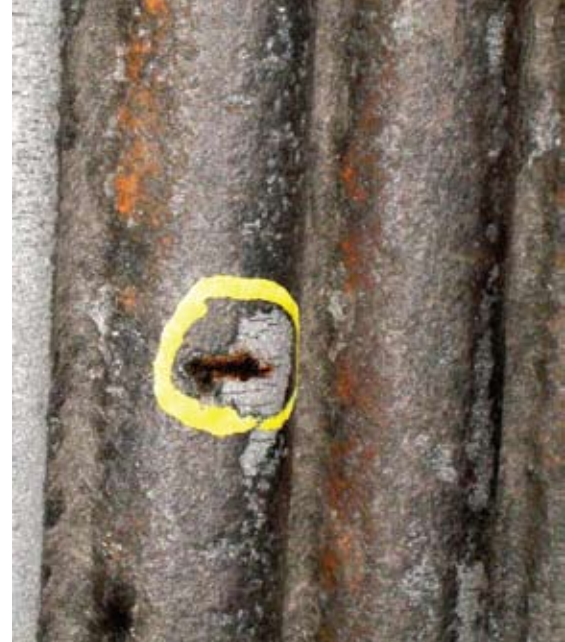
Figure 1 Overall view of the leak of Front Wall tube 124 noted during the field examinations on May 15, 2009.
