Dissimilar Metal Welds in Grade 91 Steel ¹⁵

Strategic Internal Corrosion Monitoring for Gas Pipelines 19

THE IMPACT OF THE ASCE 7-16 STANDARD ON SEISMIC 8

UPDATE ON PROPOSED SAFETY OF GAS TRANSMISSION & GATHERING PIPELINE REGULATION 45

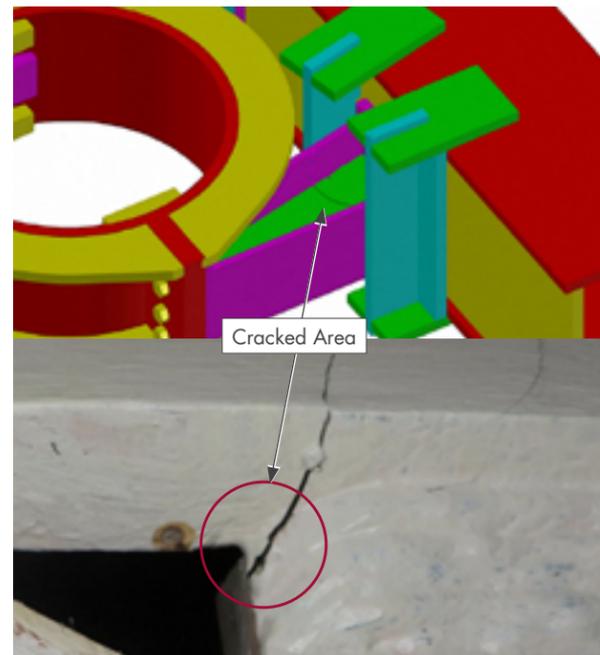
FIGURE 1. Load definition from sensors for Main Steam Support Hanger Fracture Mechanics Evaluation

- Cause determination and remaining life assessment for cracking observed in a main steam pipe support; (Figure 1)
- Modal characterization and subsequent piping redesign/tuning following small-bore socket weld failures (numerous examples);
- Failure analysis, phenomena identification, and redesign support following a main steam condenser failure;
- Source determination and evaluation of mitigation strategies for RHR check valve leakage;
- Root cause and design support in response to failure of an MSR bellows assembly;
- Response characterization for significant events during shipment of nuclear fuel rods on a tractor/trailer bed (Figure 2).

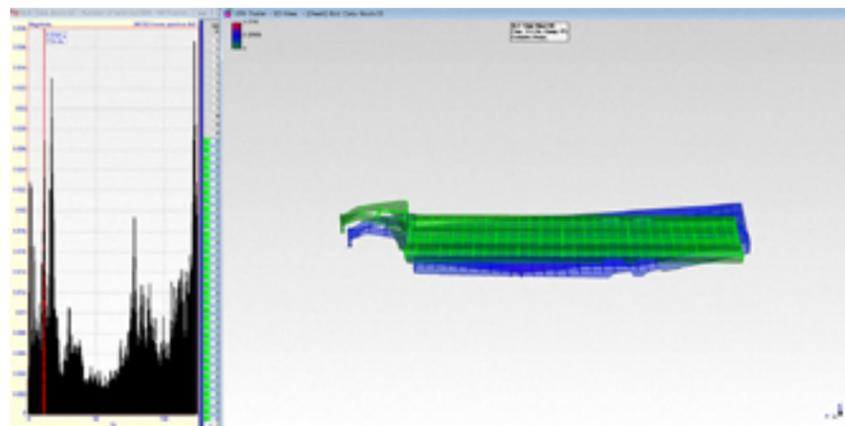
FIGURE 2. Modal Analysis of Tractor/Trailer (Identify source and Transmissibility into shipment contents)

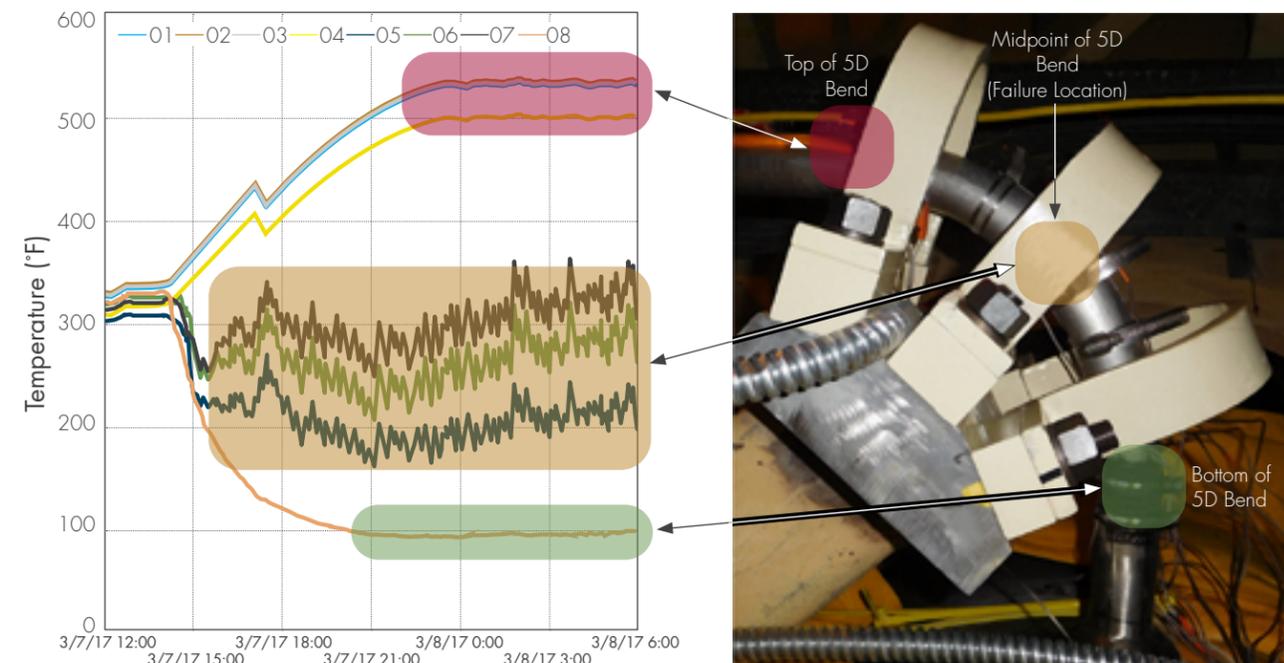
FIGURE 3. Safety Injection Line with Severe Thermal Cycling Sufficient to Initiate and Grow a Crack

The sensors not only characterized unique, localized damage at the failure location (Figure 3) but also offered comparisons between loops and between units and stations. This offered the insight necessary to pinpoint the driving phenomenon (cross-loop leakage), quantify the effectiveness of a mitigatory design change (bleed system), and in some cases provided the confidence to increase inspection intervals. The data from these instrumentation deployments is altering management strategies from time-based to condition-based. The financial impact of this shift is significant, not only in time and dose savings from deferred inspections, but also in terms of avoided cost (emergent repair/replace activities are estimated to cost at least \$250k per line and up to \$10M for a forced outage).

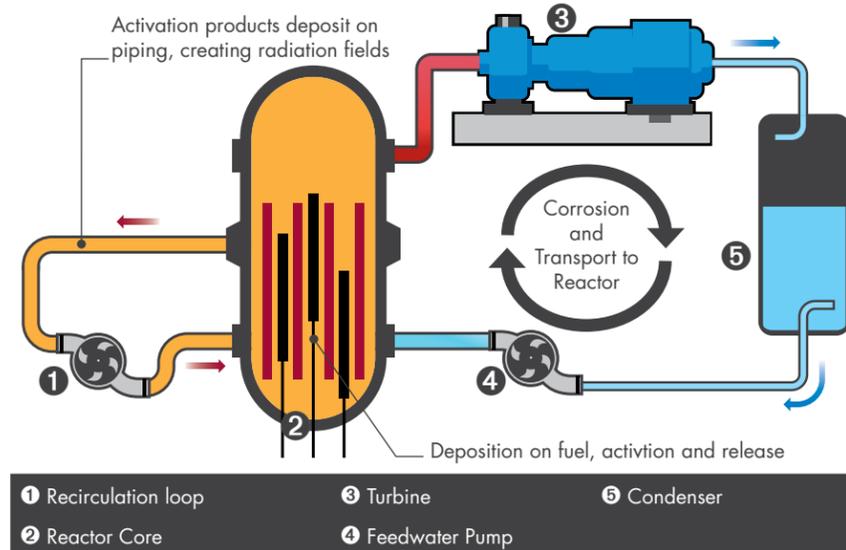
FIGURE 1. BWR Primary System

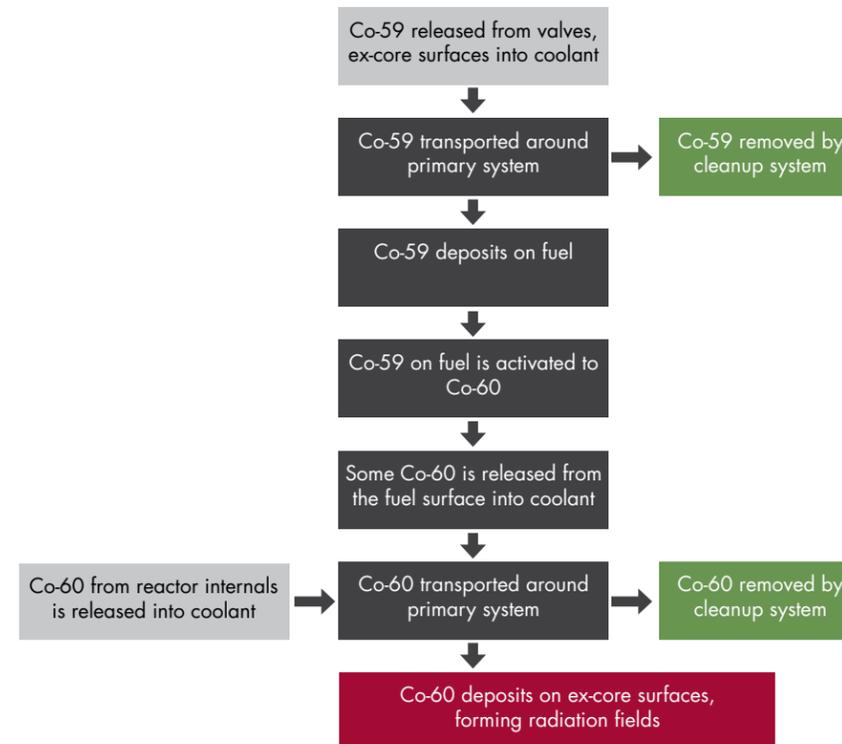
FIGURE 2. Schematic of Co-60 activation and transport

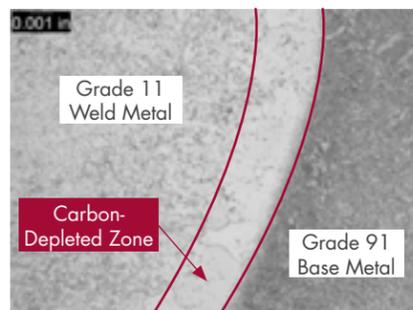
FIGURE 1. A carbon-depleted zone which has developed in a Grade 91 base metal to Grade 11 weld metal interface after approximately 90,000 hours of operation at 1040°F. Cracking and creep damage (cavitation) were found in other areas of this weld.

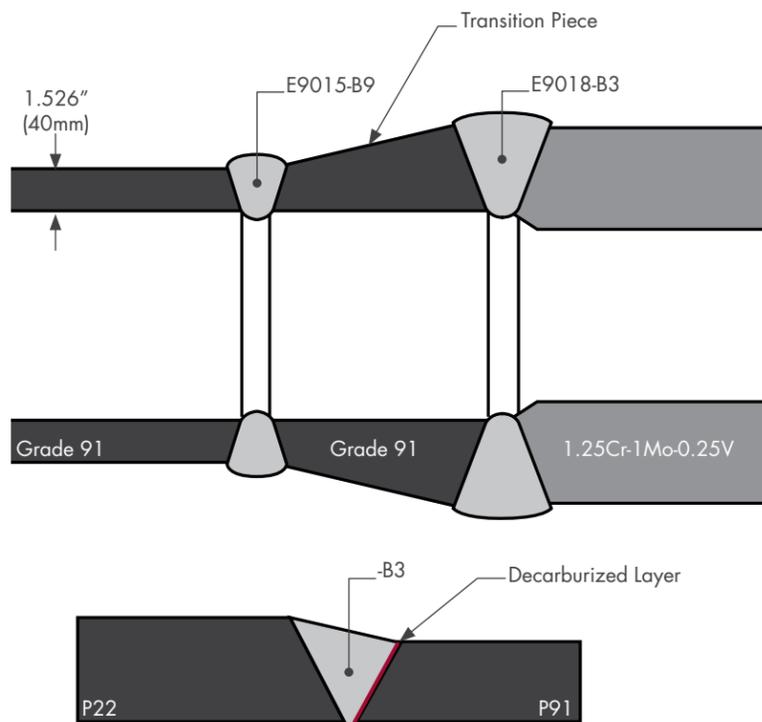
TOP Good design: a Grade 91 piece is used to transition between the thicknesses of the Grade 91 pipe and a CrMoV valve body. The filler metal used in the thicker weld could be either matching to Grade 22 (B3 type) or Grade 91 (B9 or B91 type).

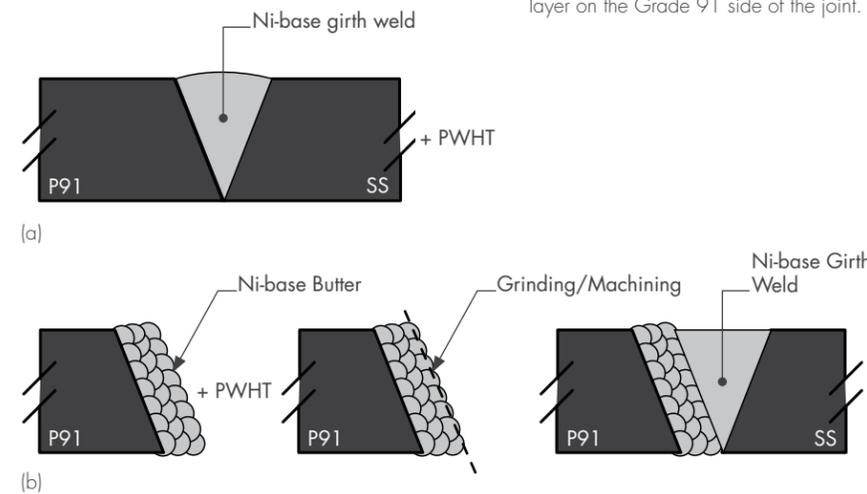
FIGURE 3. Two common fabrication routes used in manufacturing Grade 91 to stainless steel DMWs: (a) weld with Ni-base filler and PWHT of entire weld; (b) use of a nickel-base butter layer on the Grade 91 side of the joint.

To date, DMWs joining Grade 91 to stainless steel have been made using nickel-base alloy weld consumables such as ERNiCr-3/ENiCrFe-3 (nickel alloy 82/182) using welding parameters (preheat, interpass, and PWHT temperatures) suitable for Grade 91. In thin-section welds, the two materials are typically joined directly and the completed weld given a PWHT at Grade 91 conditions (Figure 3a). In thicker-section welds the Grade 91 side of the joint is sometimes first “buttered” with several layers of nickel-base filler, subjected to a PWHT, and then a final closure weld is made to the stainless side of the joint (again with a nickel-base filler). No PWHT is performed after the closure weld (Figure 3b). Note

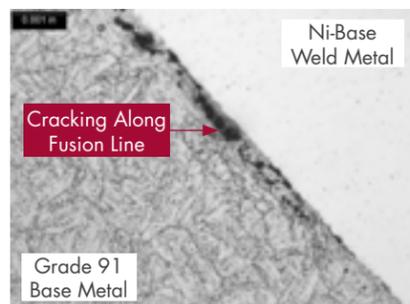
FIGURE 4. Micrograph showing typical cracking along the Grade 91 to nickel-base weld metal fusion line in a thick-section DMW.

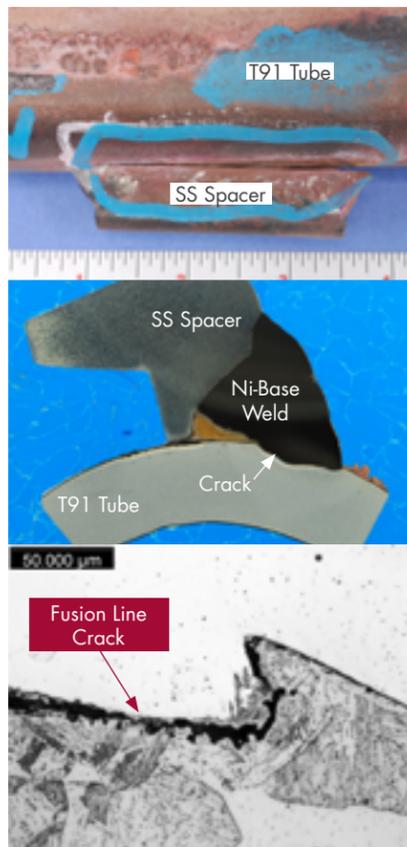
FIGURE 5. Disbonding of stainless steel slide spacer welded onto a Grade 91 tube. The weld was made using a nickel-base filler metal, and cracking occurred along the fusion line between the weld metal and the Grade 91 tube.

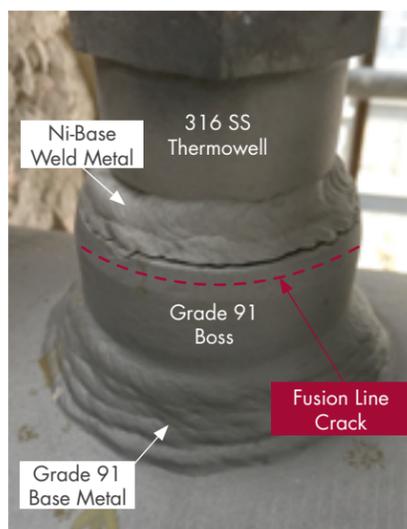
FIGURE 6. Stainless steel thermowell in a Grade 91 piping system found cracked along the fusion line between the Grade 91 boss and the nickel-base weld metal. If the weld had completely cracked, the thermowell would have been ejected from the pipe.

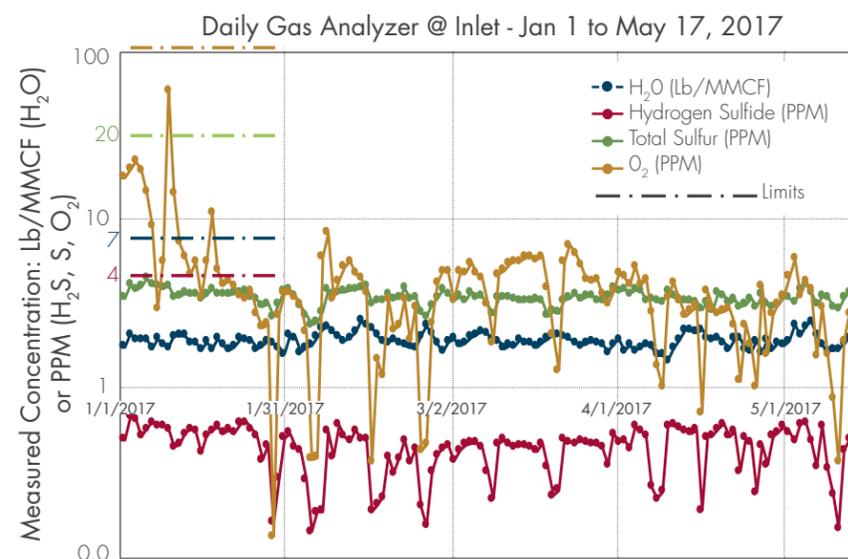
FIGURE 1. Gas Composition Analysis Chart

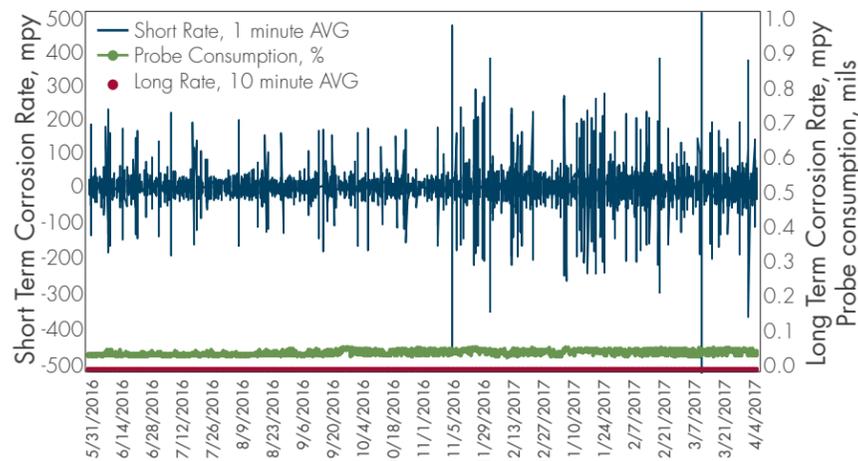
FIGURE 3. Corrosion Rate Analysis Chart for ER Probe

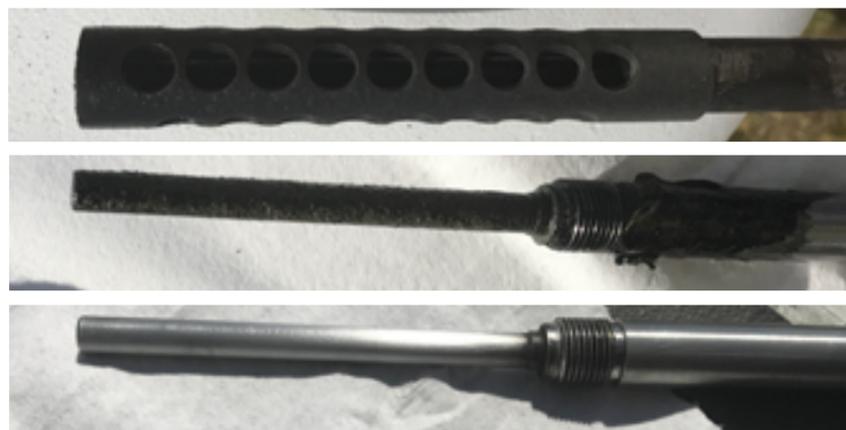
FIGURE 4. TOP ER Probe as removed MIDDLE ER Probe with Velocity shield removed BOTTOM ER Probe after samples collected & cleaning

Based on the fluctuations seen in the STCR as noted above, the ER probe was removed and inspected. Once the probe was removed for inspection, a sample of the surface deposit was collected for elemental analysis using scanning electron microscopy / electron dispersive microscopy (SEM/EDS) to provide information on the elemental characteristics. A light layer of a black deposit covered all exposed surfaces, some of which was easily removed manually with a cloth. Solvent cleaning had little effect, suggesting the deposit was not predominantly hydrocarbon based (i.e., grease, lubricant, oil). The probes were successfully cleaned with a light abrasive pad prior to returning to service.

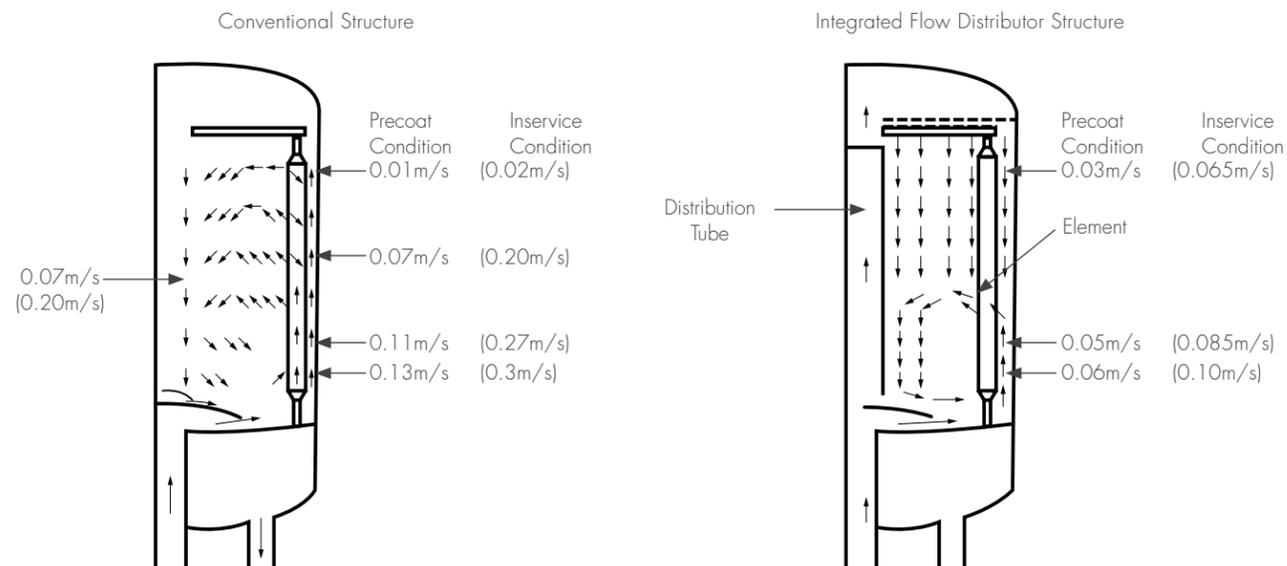
FIGURE 1. Bottom Tubesheet Filter/Demineralization Flow Distribution Improvement with IFD

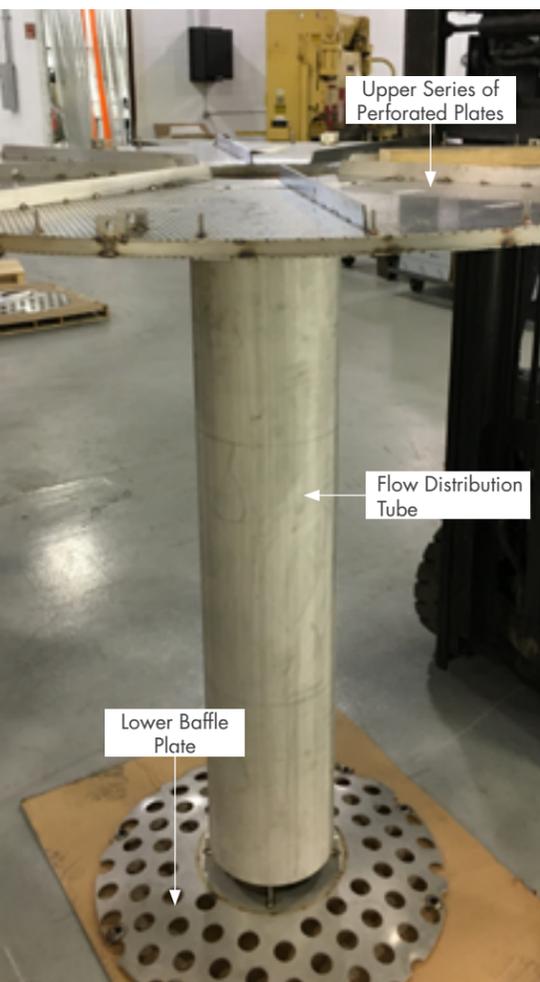
FIGURE 2. Browns Ferry IFD

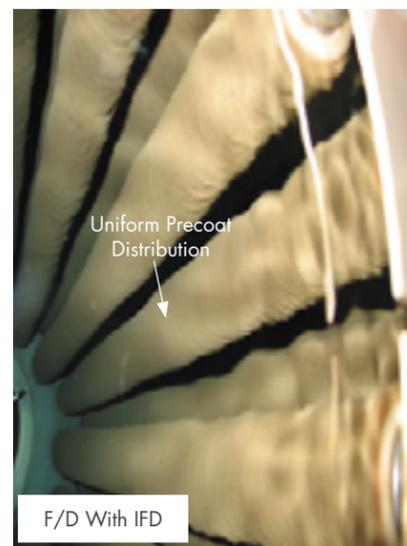
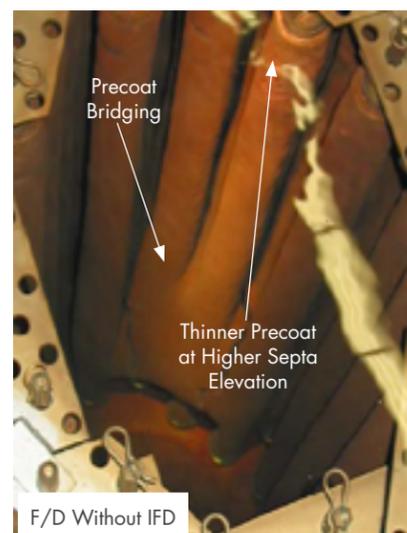
FIGURE 3: CF/C Precoat Uniformity Before and After IFD Installation

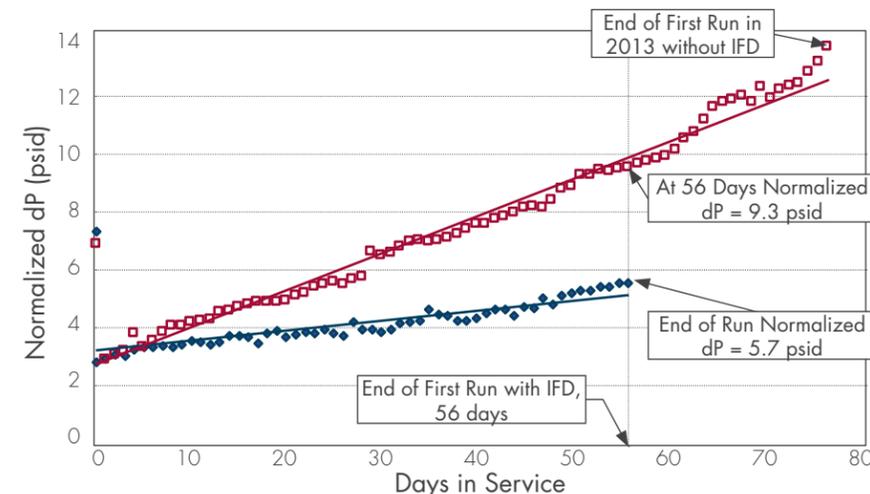
FIGURE 4. Browns Ferry CF/D 1B Differential Pressure after New Septa Installation

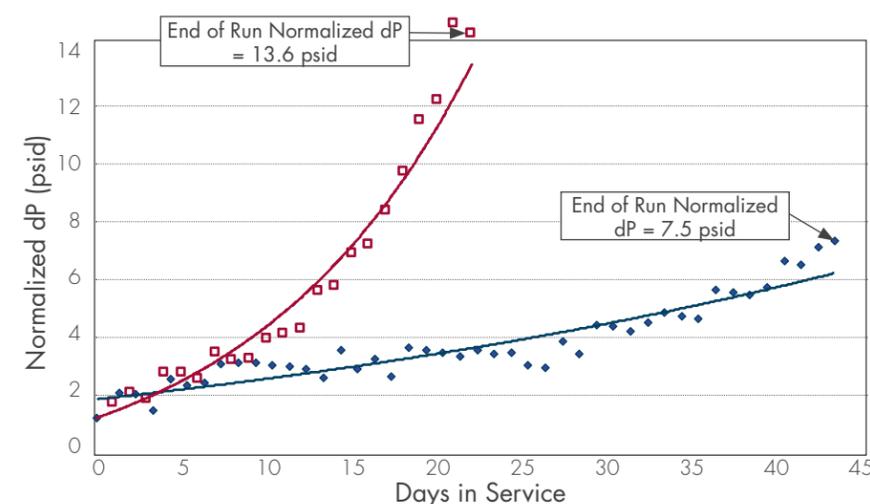
FIGURE 5. Browns Ferry CF/D 3A Differential Pressure after New Septa Installation

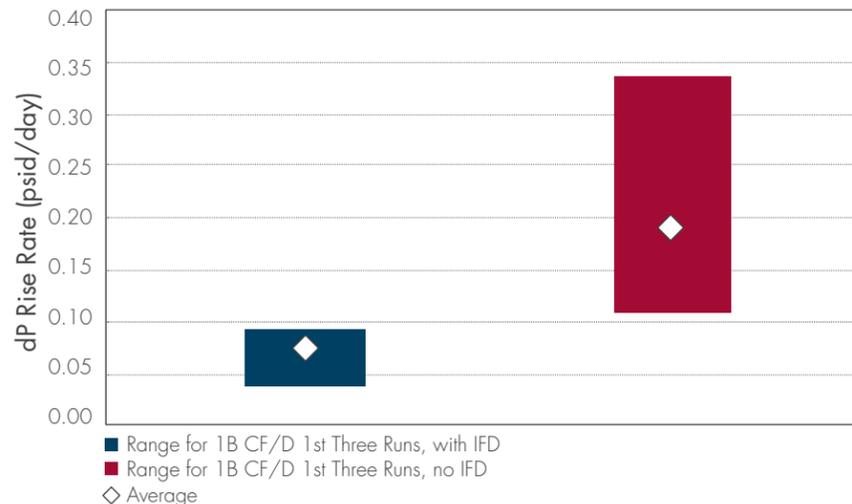
FIGURE 6. Browns Ferry CF/D 1B dP Rise Rate during the 1st Three Runs After Septa Replacement

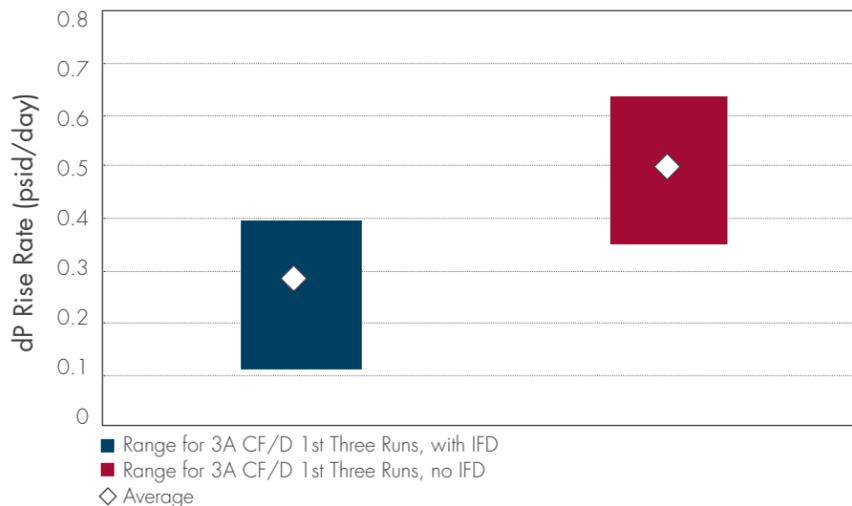
FIGURE 7. Browns Ferry CF/D 3A dP Rise Rate during the 1st Three Runs After Septa Replacement

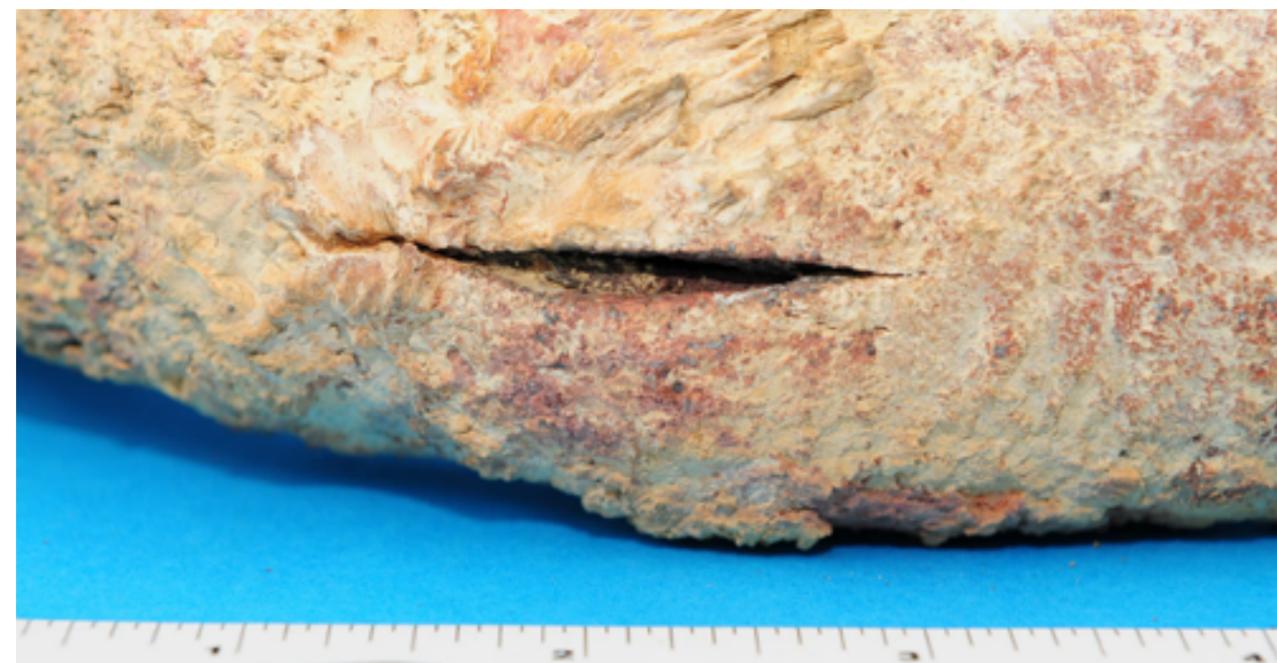
Thick-edged longitudinal rupture in tube section

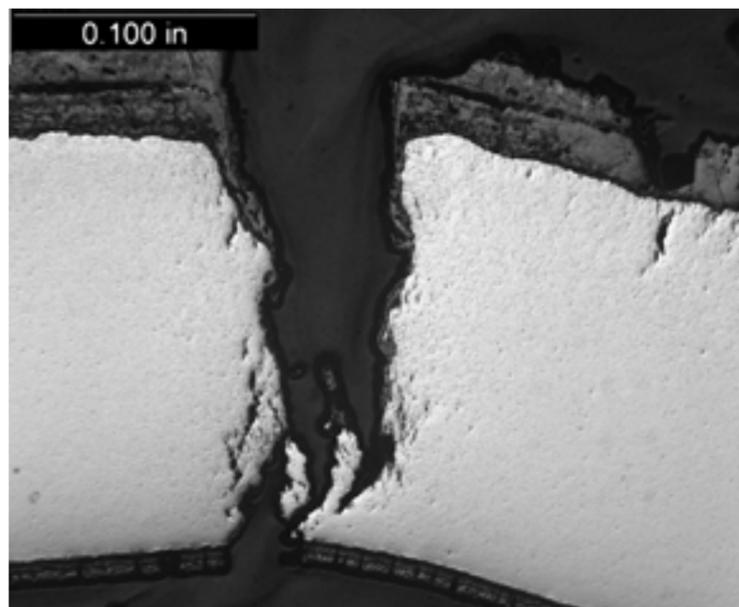
TOP Ring-section through rupture showing some swelling and thick outer diameter and inner diameter oxide

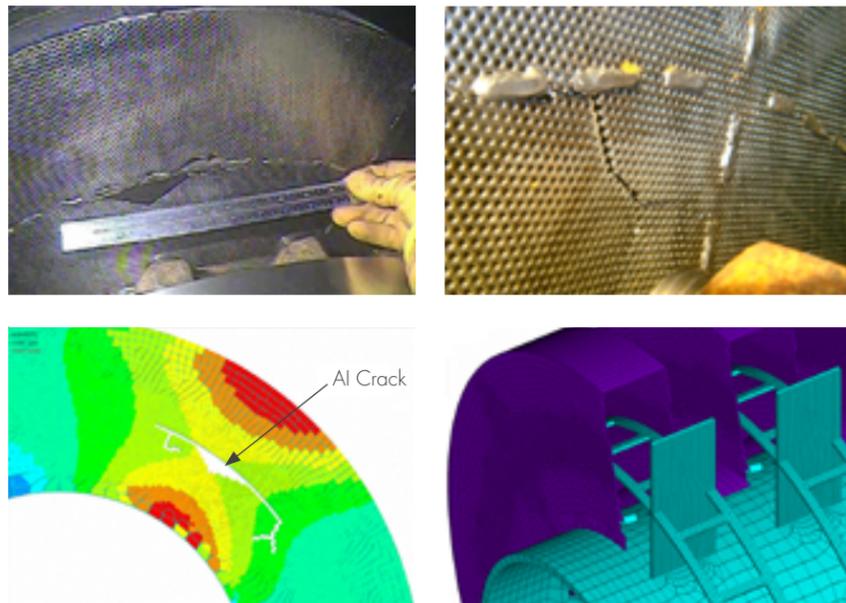
FIGURE 2. ECCS Strainer Damage Finite Element Models

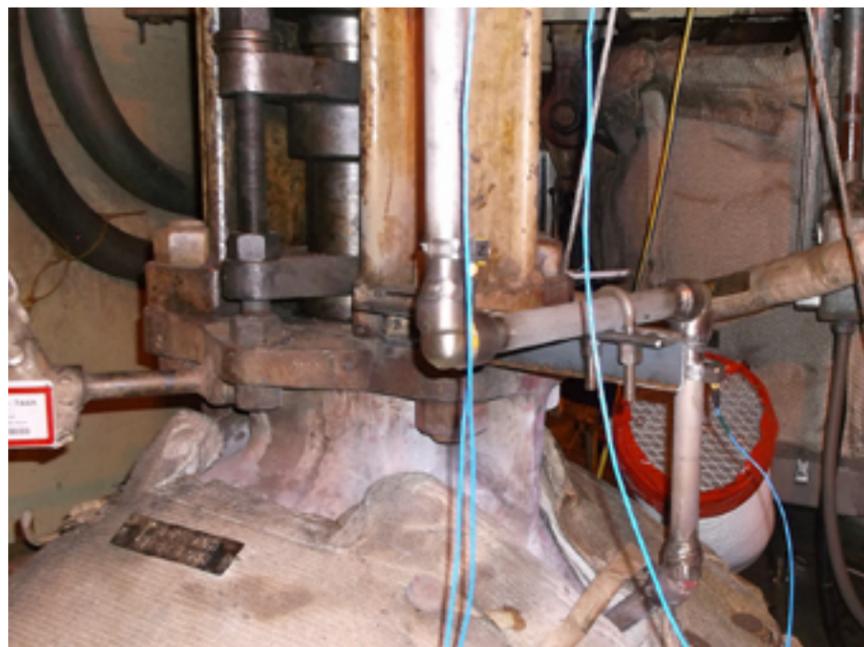
FIGURE 3. Smallbore Line Post-Repair Monitoring

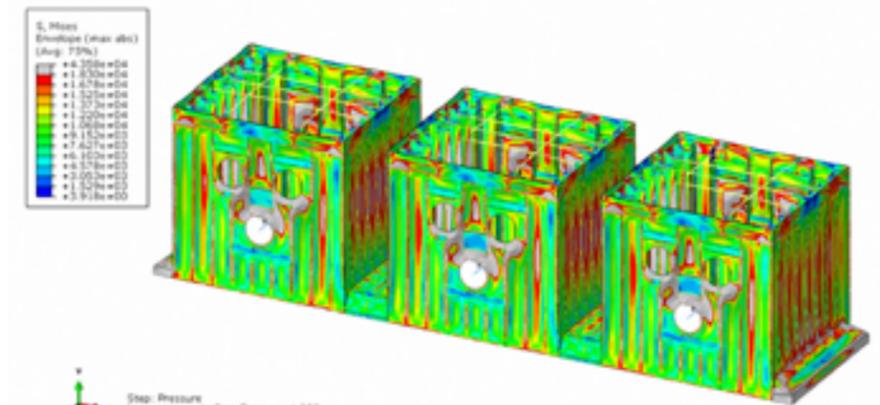
FIGURE 4. Condenser Stress Profile

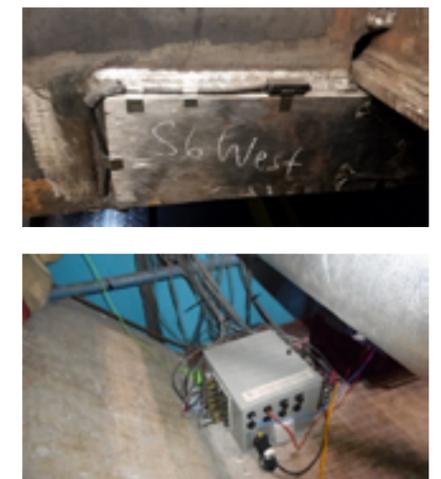
FIGURE 5. Monitoring Structural Response

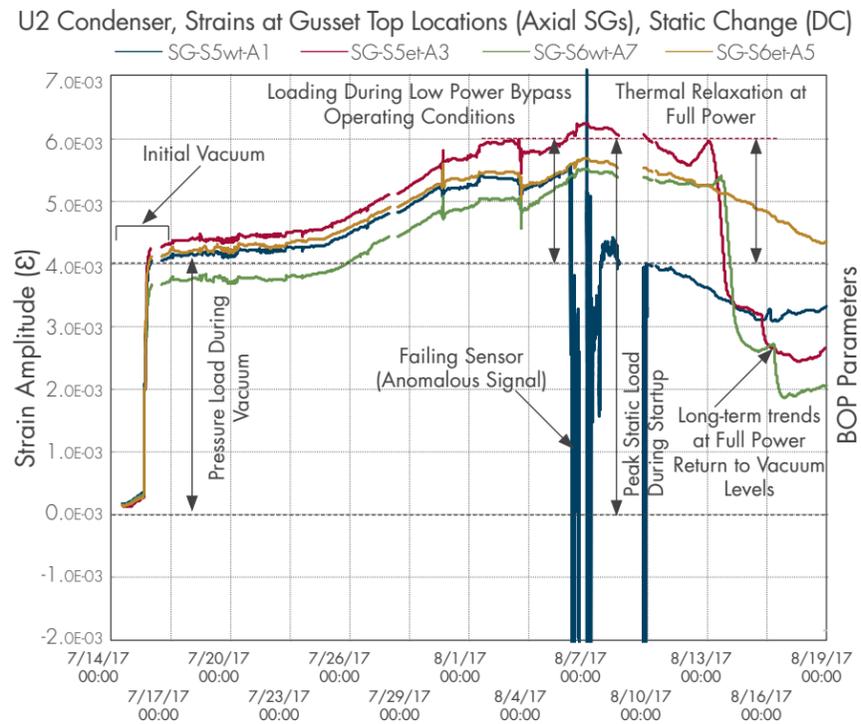
FIGURE 6. Loading Conditions from Installed Instruments

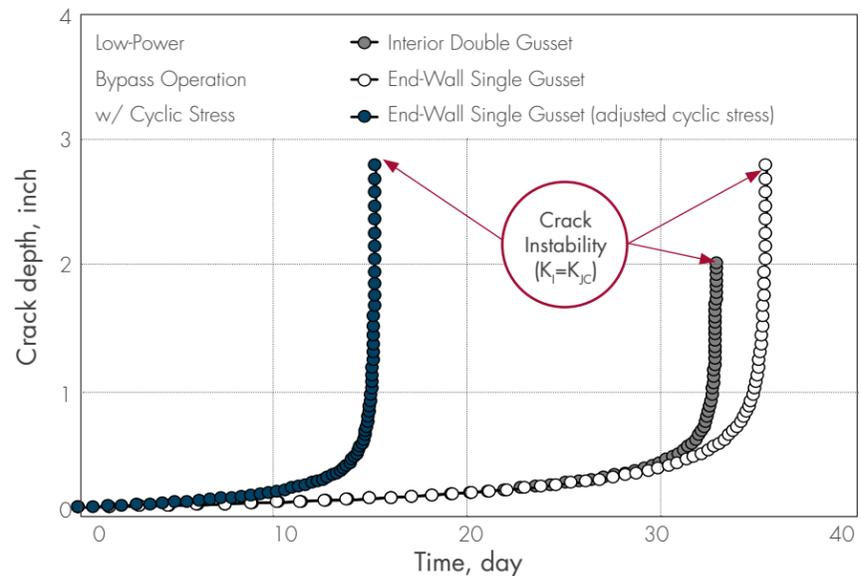
FIGURE 7. Serviceability Evaluation Based on Crack Growth Over Time

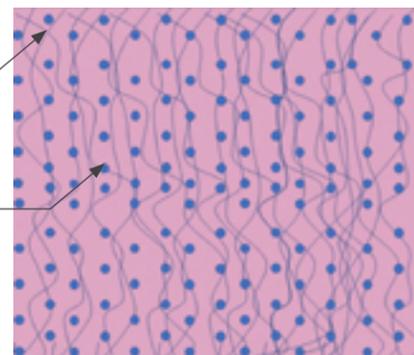
FIGURE 1. A general depiction of soft biological tissue.

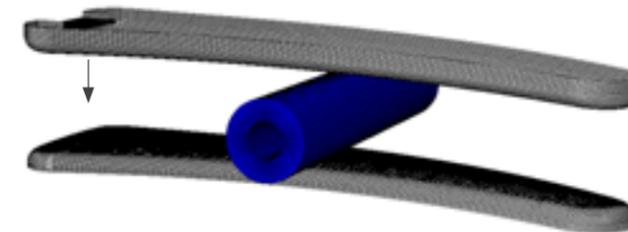
FIGURE 2. Abaqus simulation of a full surgery

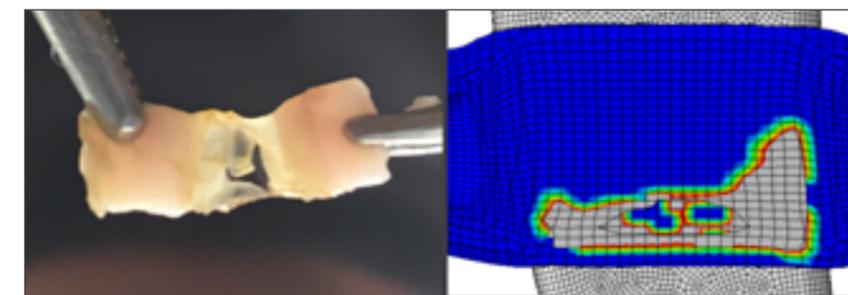
FIGURE 3. LEFT A result of an experimental artery cutting test. RIGHT The simulated result of the same test in Abaqus, the gray represents completely damaged tissue⁽¹⁾.

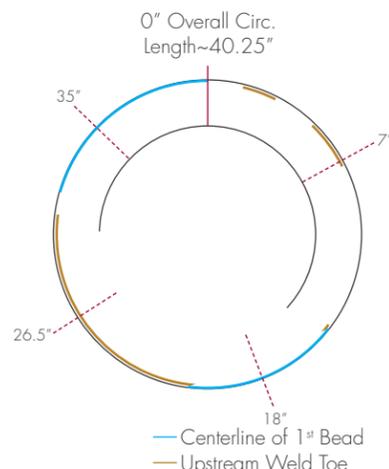
FIGURE 1. Schematic of upstream weld ring section illustrating the extent of crack-like surface indications found in laboratory visual and magnetic particle inspections. The circumferential locations of four metallographic sections removed from the ring are also noted.

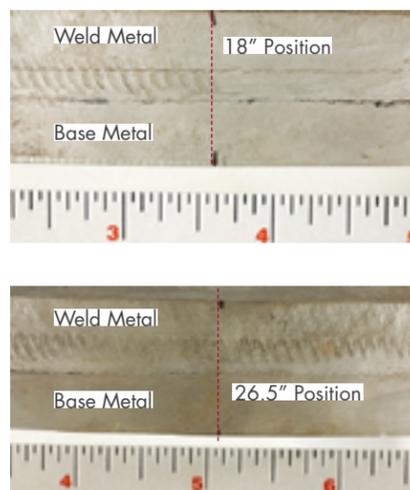
FIGURE 2. Close views of crack-like visual indications on the weld surface at two circumferential locations. Cracks were found at both weld toe and at the centerline of the first weld bead.

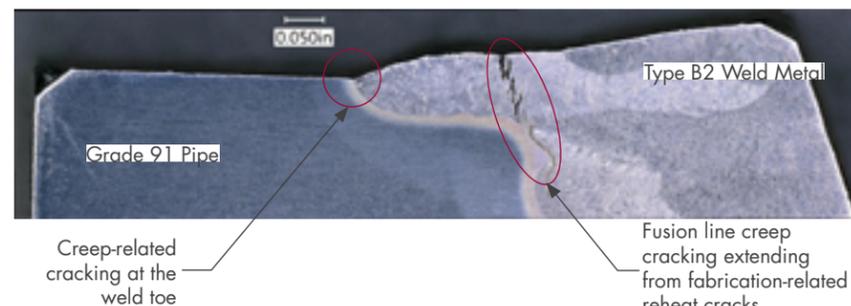
FIGURE 3. Overview of the metallographic section prepared at the 18" circumferential location, with creep-related cracking present at the weld toe, in the first weld bead, and along the fusion line. Creep cracking in the first weld bead likely developed from fabrication-related reheat cracks.

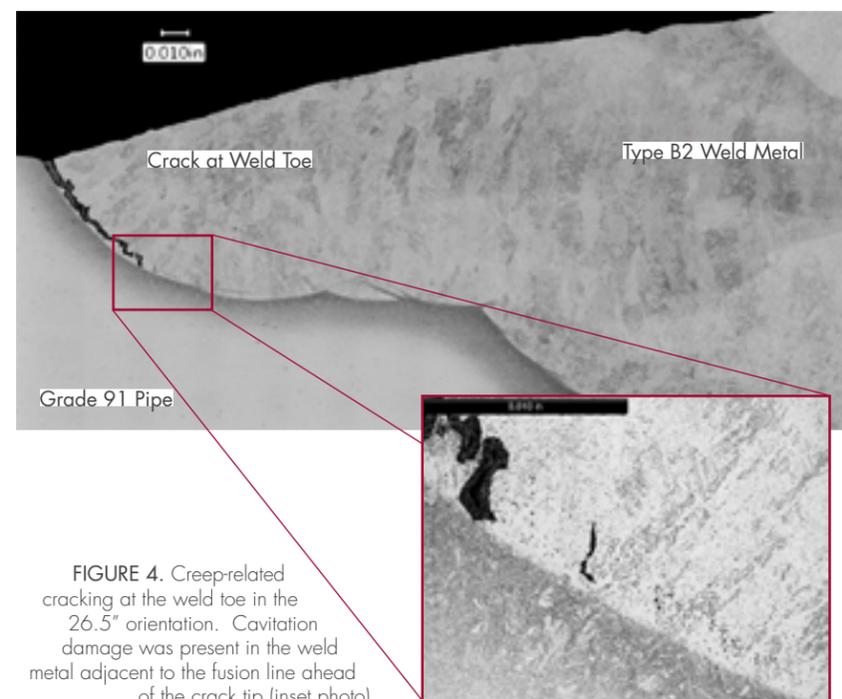
FIGURE 4. Creep-related cracking at the weld toe in the 26.5° orientation. Cavitation damage was present in the weld metal adjacent to the fusion line ahead of the crack tip (inset photo).

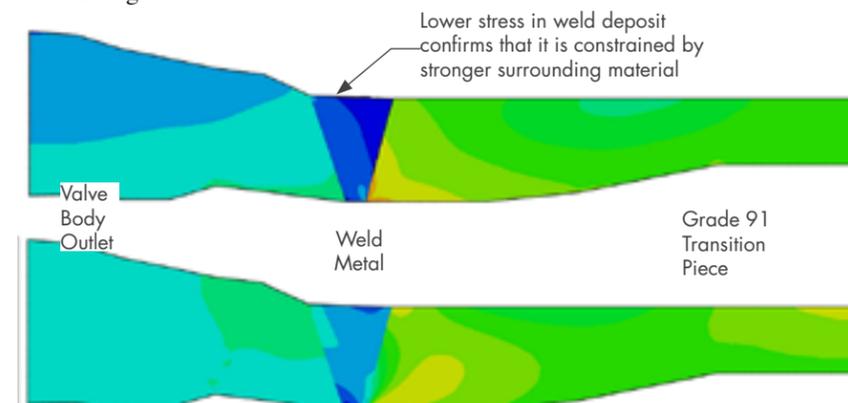
FIGURE 5. FEA output showing spatial distributions of creep-redistributed von Mises equivalent stress TOP and maximum principal stress BOTTOM in the modeled weldment.

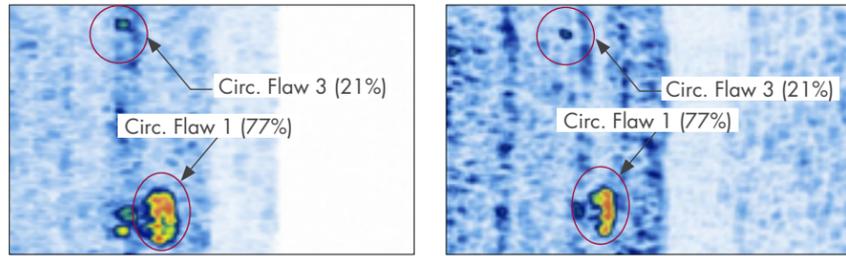
FIGURE 2. Circumferential Flaw 1 & 3 Data
 LATITUDE™ Data 13 LINES
 Scan Increment = 0.080"
 Index Increment = 0.400"
 AUT Data 34 LINES
 Scan Increment = 0.040"
 Index Increment = 0.150"

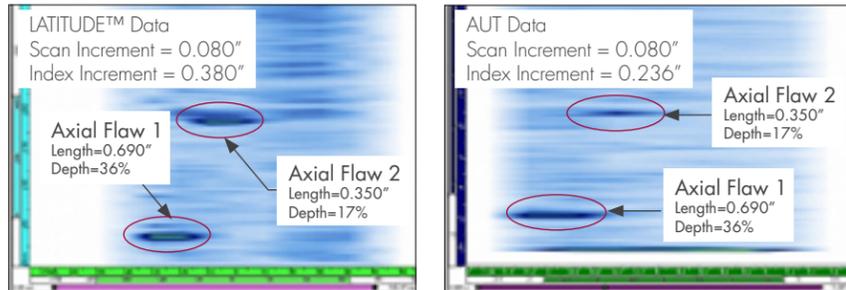
FIGURE 3. Axial Flaws 1 & 2
 Among the most difficult of flaws to detect in PDI samples LATITUDE data acquired with a larger index increment Less data, less scan time Better Signal to Noise Ratio (SNR) with LATITUDE approach

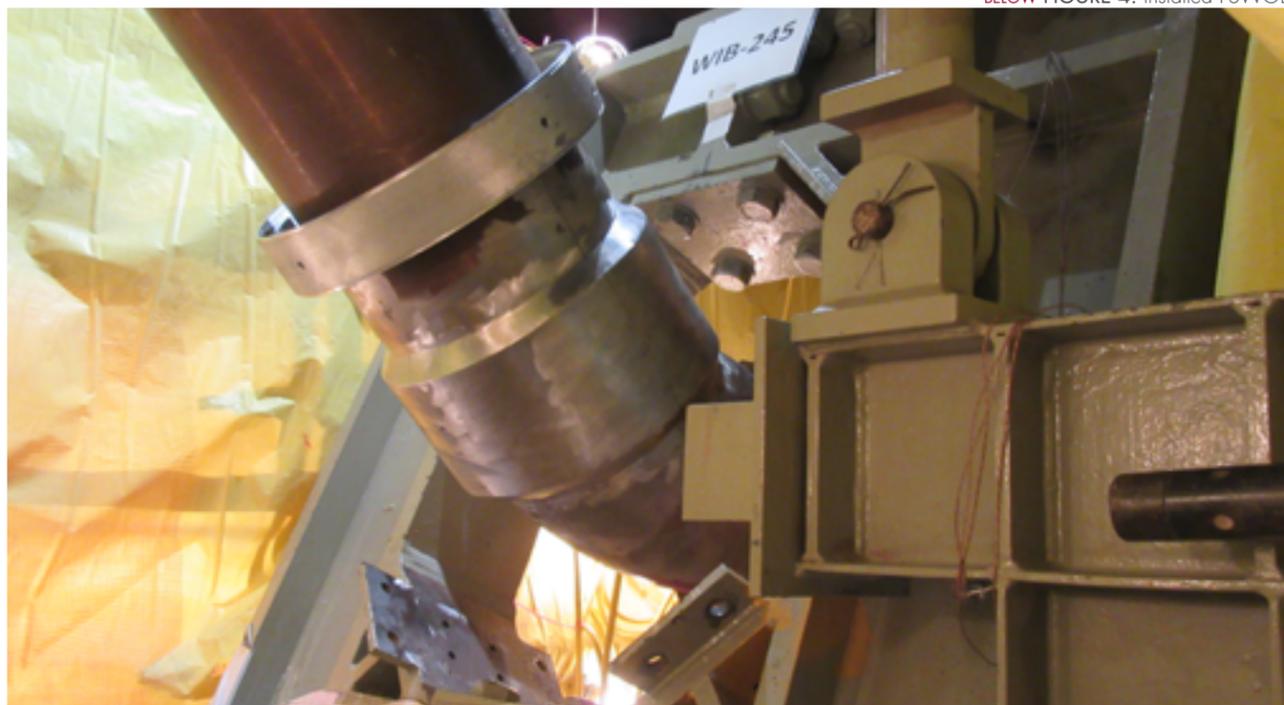
BELOW FIGURE 4. Installed FSWOL

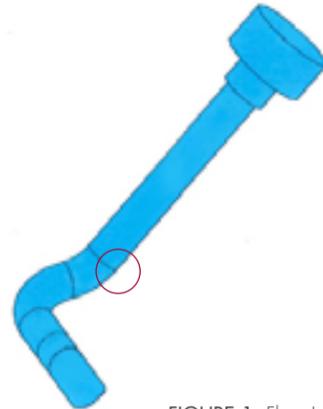
FIGURE 1. Flaw Location

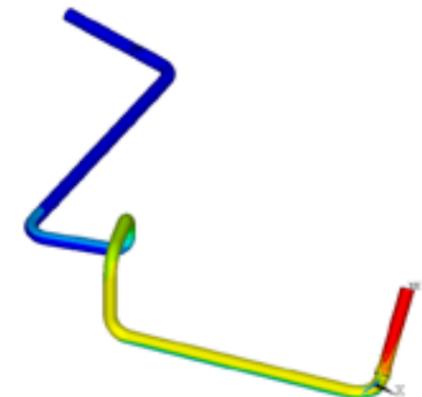
FIGURE 2. RHR Suction Line Thermal Stratification

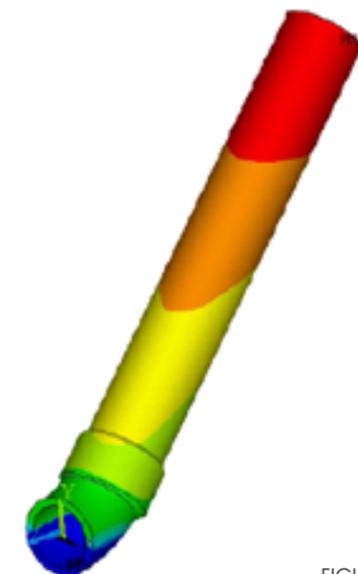
FIGURE 3. Thermal stratification at FSWOL Location (FSWOL Shown)

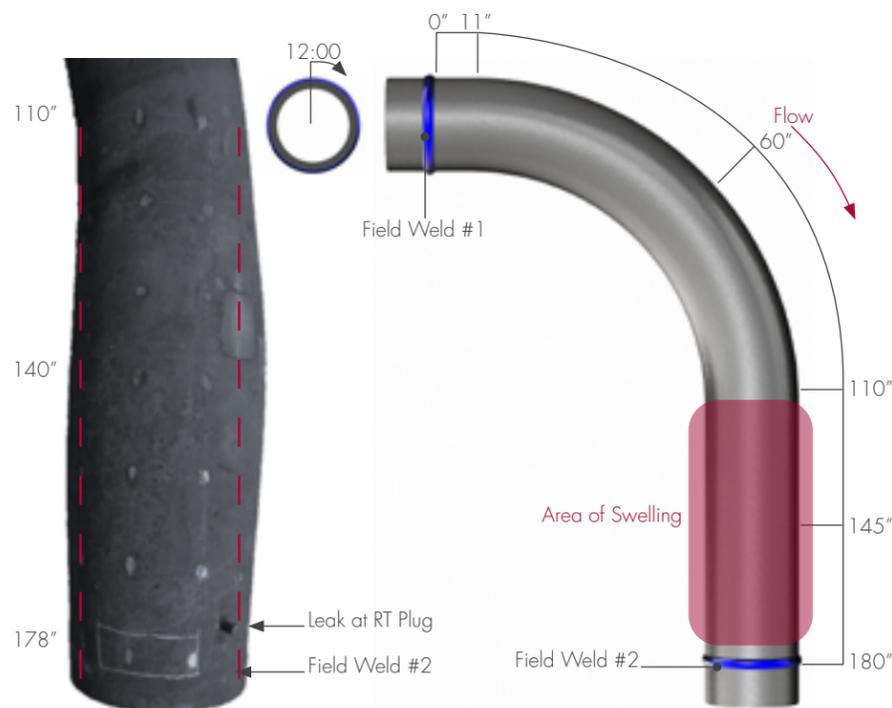
FIGURE 1. Swelled P91 Main Steam Piping

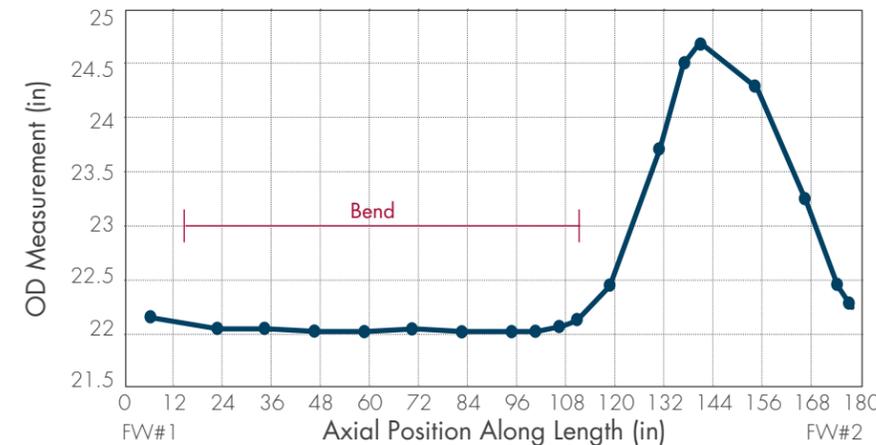
FIGURE 2. Summary of OD Measurements Along the Spool Length

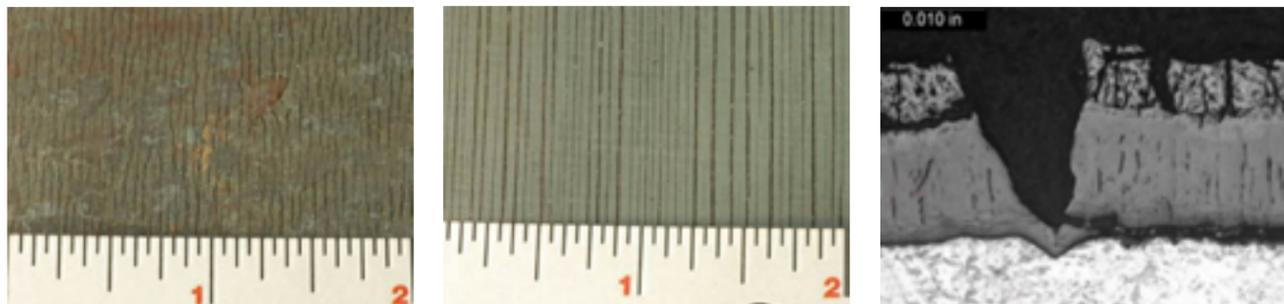
FIGURE 3. Typical appearances of the external **LEFT** and internal **CENTER** surfaces in the swelled region exhibiting axially-oriented cracks in the oxide layer. On the **RIGHT** is a cross sectional view of one oxide crack on the external surface. (Scale shown in inches.)

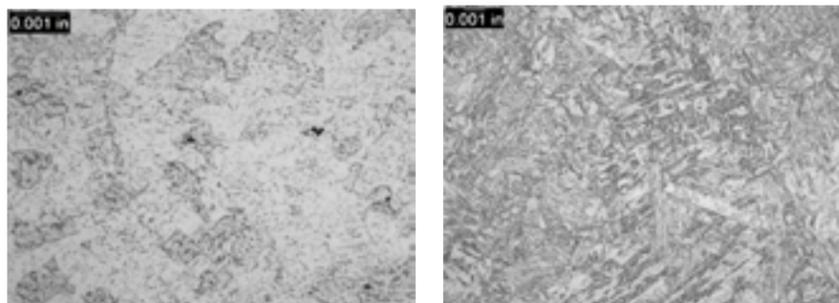
FIGURE 4. Typical microstructures observed in the swelled region **LEFT** consisting of patches of alloy carbides in a ferrite matrix and remote from the swelling **RIGHT** consisting of the desired tempered martensite. (Etchant: Vilellas)

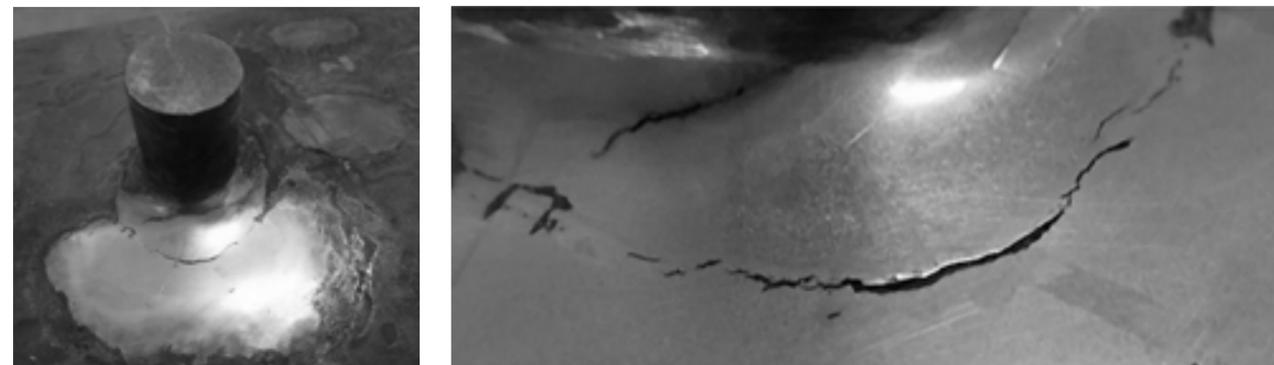
FIGURE 5. The crack along the toe of the RT plug which had leaked in service, initiating the investigation. The crack was readily visible after the surface was ground and polished.

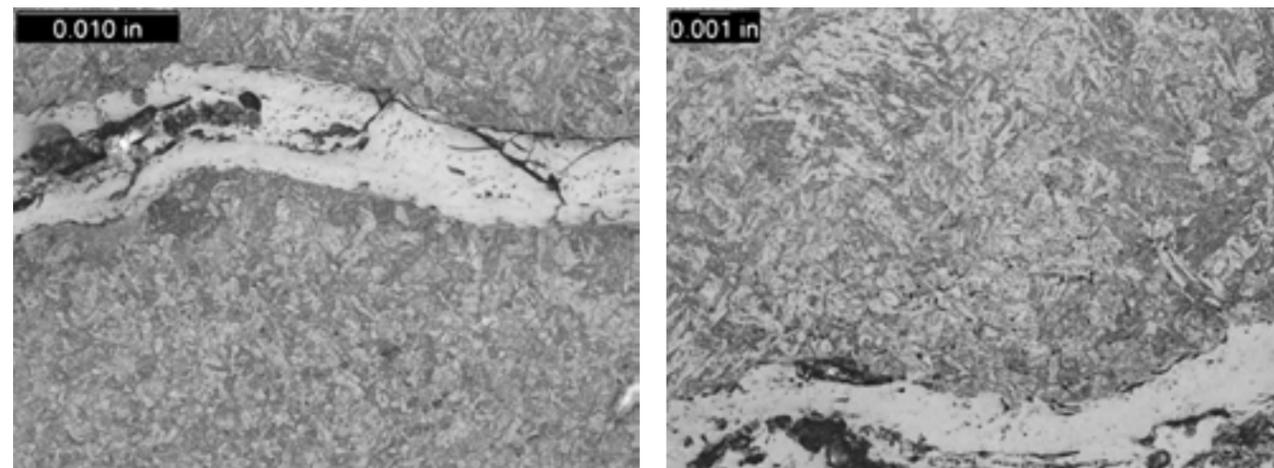
FIGURE 6. Views of the crack observed along the pipe-side toe of the RT plug. The crack was oxide-filled, and creep voids were observed alongside the primary crack (Etchant: Vilellas).
