**PlantTrack™**
Engineering Insight Through Data

President's Corner

In this Issue

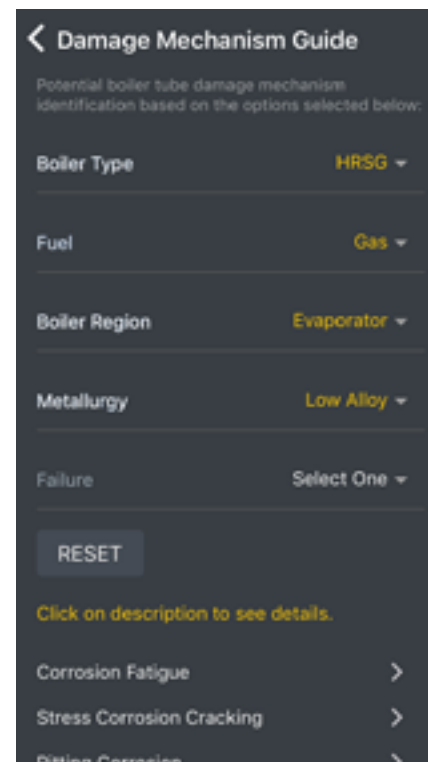
FIGURE 2. Damage Mechanism Guide

The Tube Damage Mechanism Guide shown in figure 2 helps users identify what damage mechanisms are relevant for various components and materials and aids in identifying which damage mechanism may have caused a failure. Several early users of the application have commented this is a useful training tool for engineers and technicians to learn where and why various damage mechanisms occur, and what can be done to mitigate them. In this area of the app, the user is prompted to enter boiler type (e.g. HRSG or Conventional Boiler), fuel being burned, region of boiler/HRSG, metallurgy, and failure feature (e.g.

pin hole, fishmouth, etc.). Based on the input, the app narrows the list of damage mechanisms to only display those that are relevant. The user can then select any of the remaining mechanisms to learn more about what it is caused by, where and when it is most likely to occur, and what corrective actions can be taken. Sample images are provided as well.

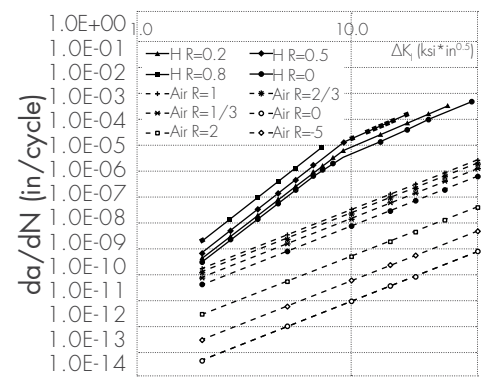
FIGURE 1. Crack Growth Rate Curves

The testing in high pressure hydrogen is very expensive and there are only a limited number of labs around the world that can perform this type of testing. ASME was able to leverage testing done to date to develop Code Case 2938 for hydrogen crack growth for common materials. Figure 1 shows a comparison of the rate of crack growth in hydrogen versus the traditional air curves. It shows that the rate of crack growth in hydrogen is greatly accelerated compared to that in air. Additionally, the “R” ratio, shows the effect of the “mean” or average stress within a cyclic range. In other words, the rate of crack growth increases significantly as the mean stress increases.

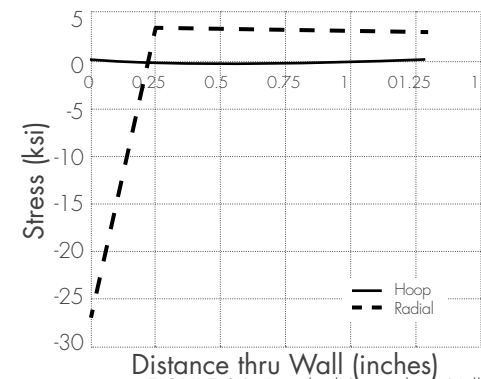
FIGURE 2A. Residual Stress thru Wall

cylinders based on these effects for many of our clients. The one effect that is leveraged is to lower the mean stress using techniques such as autofrettage. Autofrettage is a technique that induces favorable residual stresses into a component to extend the life of the component. In pressure vessels, this is commonly achieved using pressurization to extreme pressures to cause plasticity in the bore of cylinders. Figure 2A shows the resultant residual stresses in a cylinder after such a procedure. The “hoop” stress at the bore is left in a compressive residual stress state after yielding. The operational pressure stress in the wall (Figure 2B), when added to the residual “hoop” stress will result in the same “range” of pressure ($\Delta\sigma$) but with a lower mean stress. In doing so, the life will be increased because part of the crack growth life calculated will have the crack in compression.

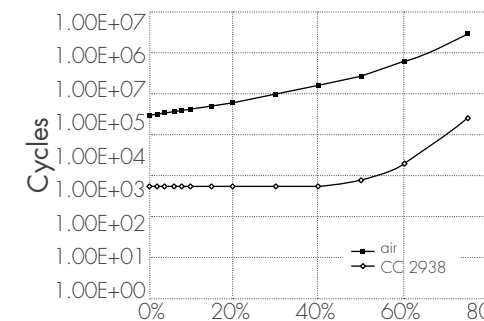
FIGURE 3. Cycles per Design Pressure Range in Air and Hydrogen

The lives of these vessels, as discussed previously are very dependent on the pressure range that the vessels cycle between, and the level of autofrettage in the vessel. Figure 3 shows a comparison of a typical autofrettaged vessel when cycled between a “full” condition and a lower pressure (shown as a % of the design pressure). It is typically expected that the larger the range, the lower the cycle life, even in autofrettaged cylinders. This is not entirely the case when calculating the life in a hydrogen environment. The test data, which was for tests performed in hydrogen, did not include any data where the flaws are in compression. Due to that fact, if a vessel can be designed for hydrogen with as much of the range as possible

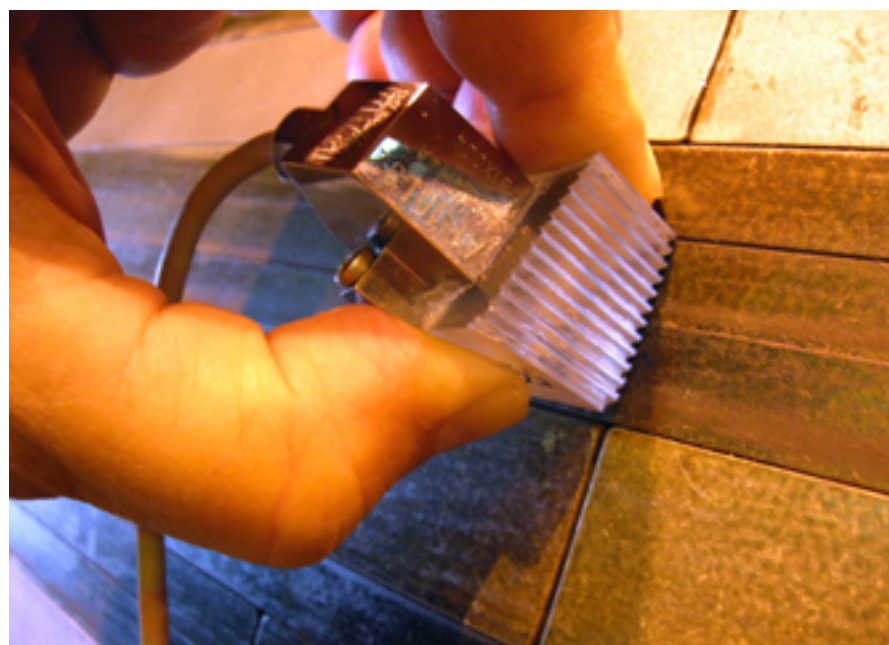
FIGURE 7. Manual LPA inspection of crush surface at the wedge butt joints with wedges installed.

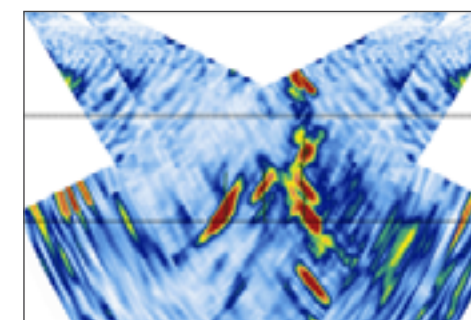
FIGURE 2. Example FEA modeling results showing a merged sectorial scan from a simulated dual-sided PAUT examination of a crack cluster

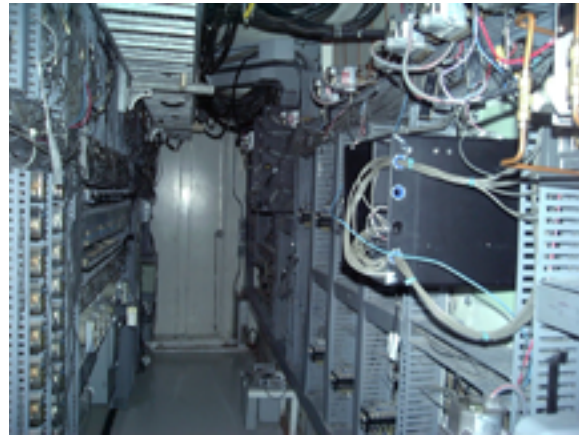
FIGURE 2. Condensate Demineralizer Panel at a BVVR (Inside View)

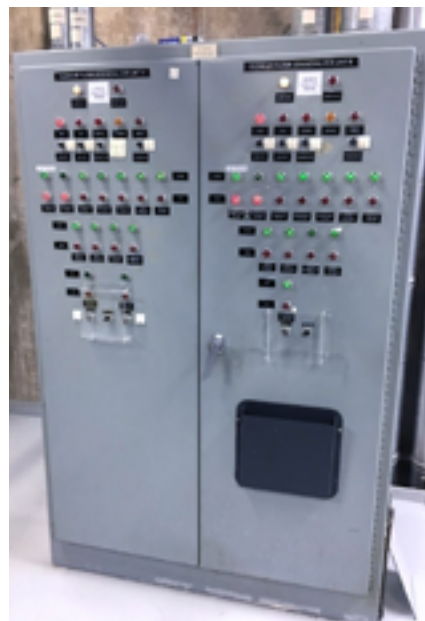
FIGURE 3. Original RWCU F/D Control Panel at James A. FitzPatrick NPP

In the mid to late 1990s, JAF installed an Alternative Decay Heat Removal (ADHR) system adjacent to the first RWCU F/D control panel which resulted in high personnel radiation exposure for plant operators while manipulating the RWCU F/D control

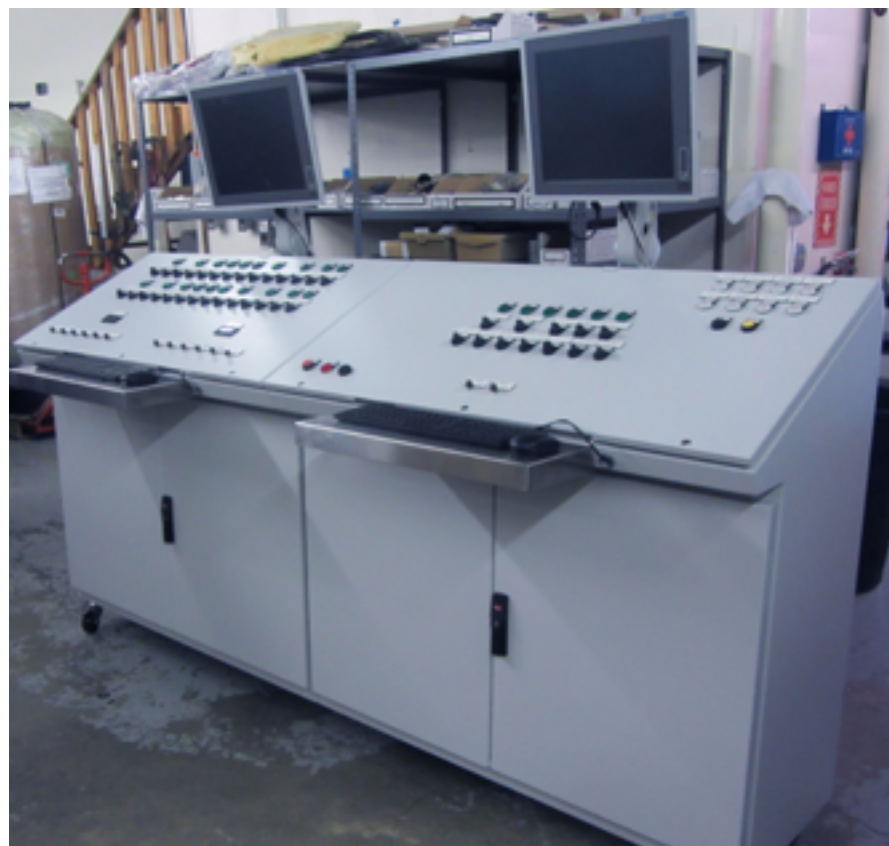
FIGURE 10. JAF RWCU F/D Control System Simulator

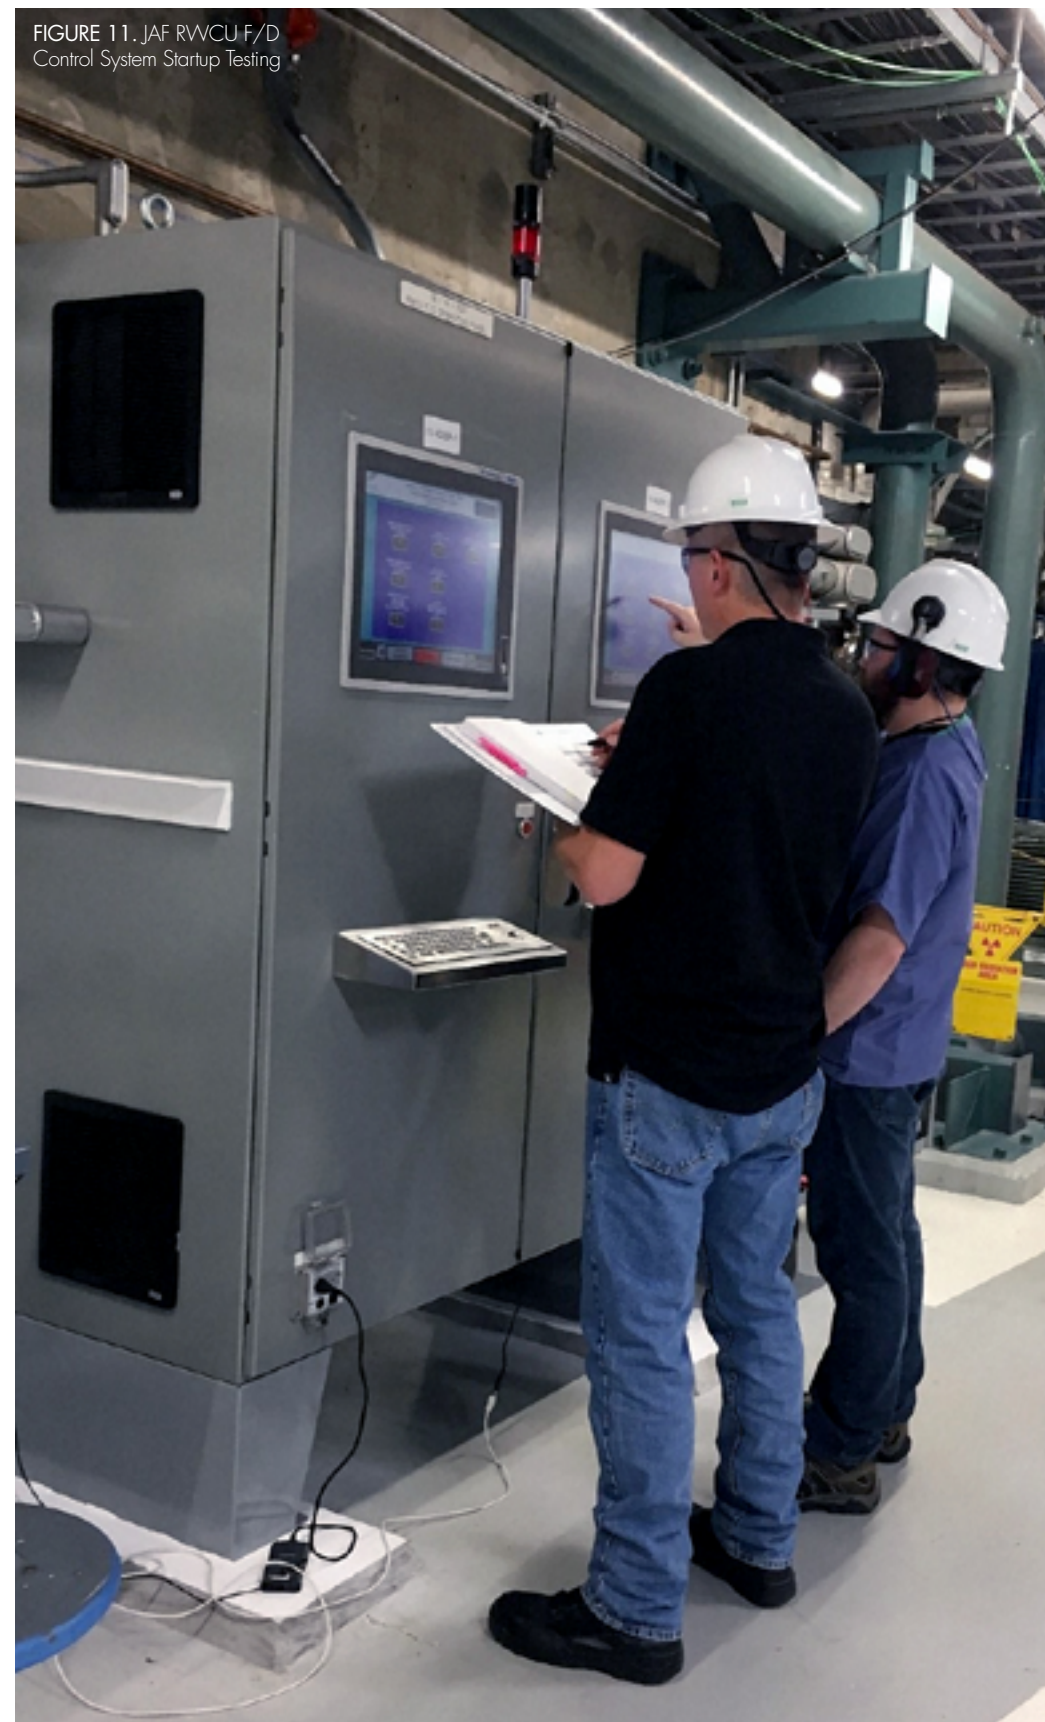
FIGURE 11. JAF RWCU F/D Control System Startup Testing

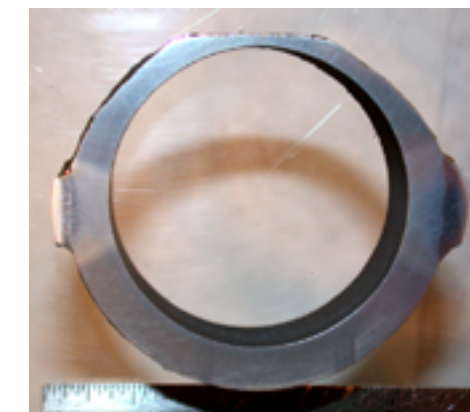
Ring section through area adjacent to rupture showing external wastage around hot side of tube with most severe wastage at crown of tube

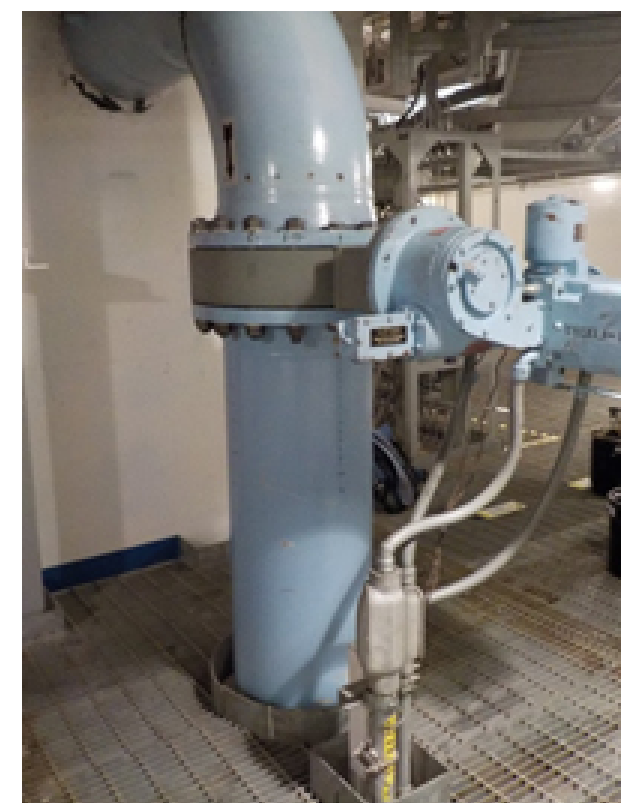
(a) Extent of Condition Exam Location

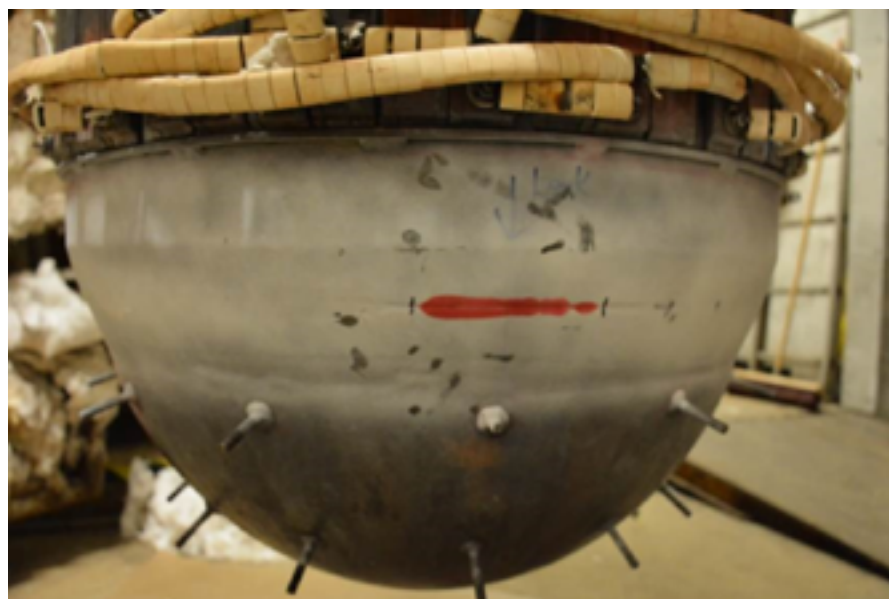
FIGURE 1. PT indication in head

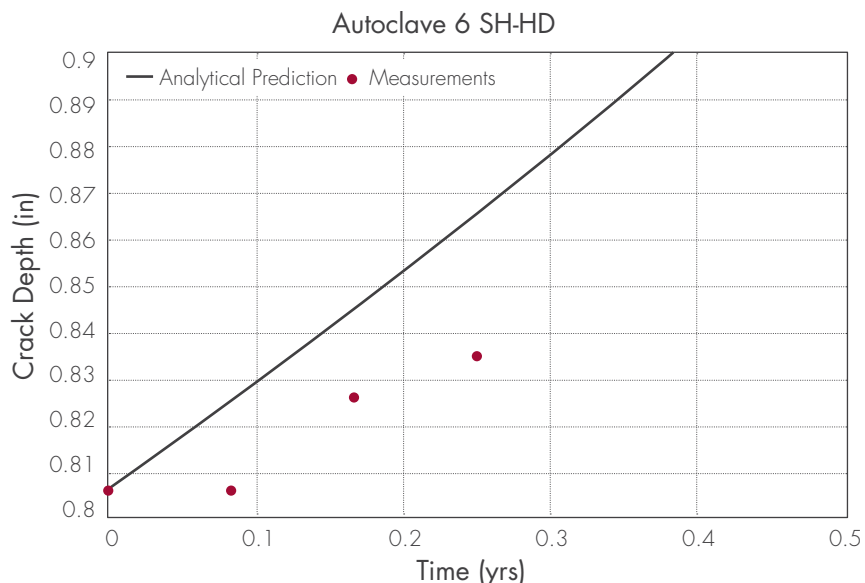
FIGURE 8. Flaw growth prediction

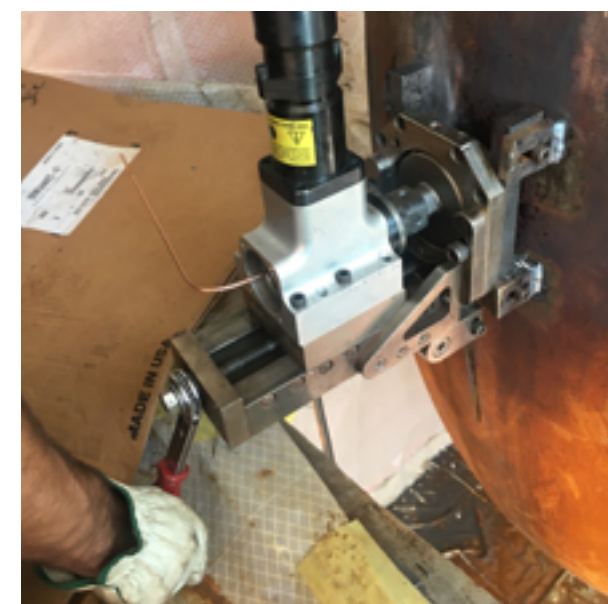
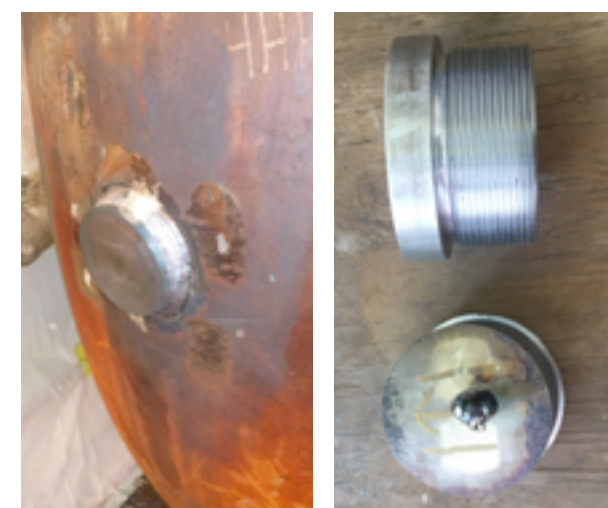
FIGURE 2. Core removal and pipe plugging process. Core Drilling TOP Pipe Spool with Plug Installed BOTTOM LEFT BOTTOM RIGHT Extracted Core LOWER and Replacement Plug UPPER

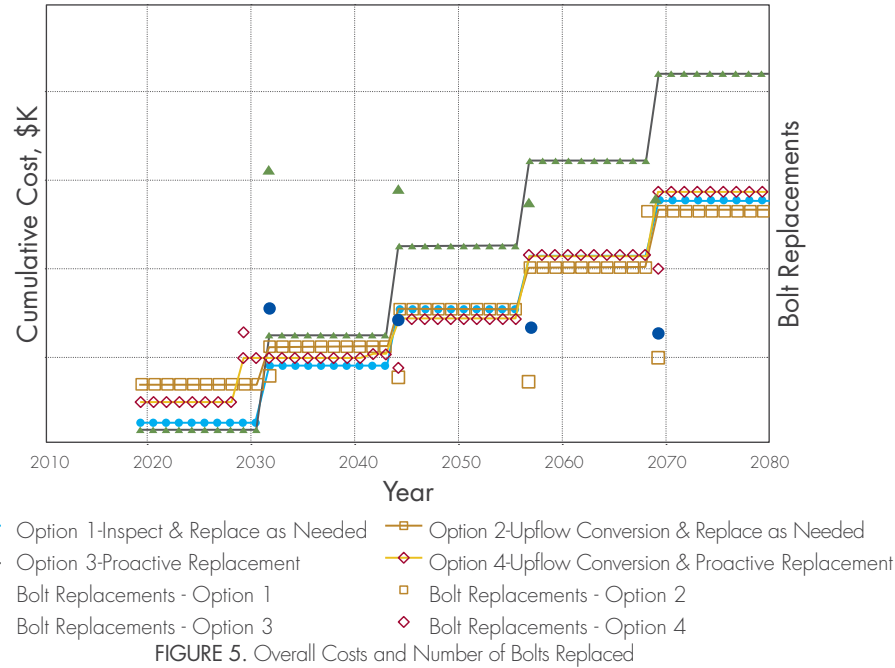
FIGURE 5. Overall Costs and Number of Bolts Replaced
