METALLURGY LABORATORY SERVICES & FAILURE ANALYSES

SERVICES FAILURE ANALYSIS

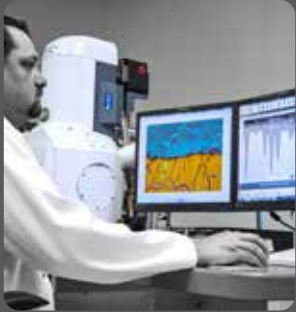
FRACTOGRAPHY

Examination of fracture surfaces can help establish the cause of a fracture by providing information about the crack origin, the mode of propagation and age. Fractography is performed by visual examination, optical examination (stereomicroscope) and high magnifications using digital or scanning electron microscopes.
