MATERIALS LABORATORY CASE STUDIES CASE STUDY #4 INFRASTRUCTURE UPGRADES – MATERIALS ANALYSIS

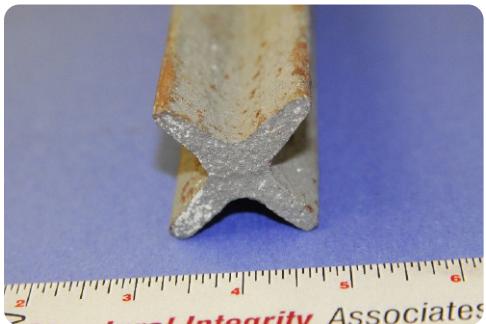
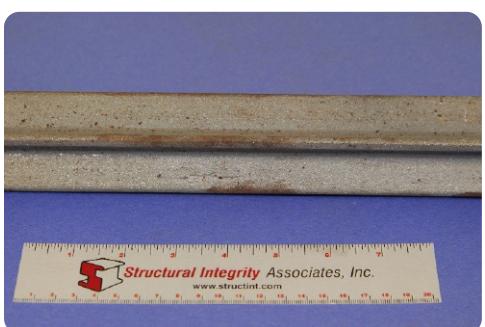
FIGURE 1. The star member shown in the as-received condition.

Structural Integrity received a section of an original star member from one of Austin's Moonlight Towers (Figure 1). The material was suspected to be a ductile or malleable cast iron and the company refurbishing the towers needed to determine a suitable replacement material. SI was asked to perform materials testing on the sample to determine its chemical composition, measure its tensile strength, and evaluate the microstructure to determine the material type.
