NEWS & VIEWS

Forecasting the Life of a Mass Concrete Structure pg.15

A CASE STUDY FROM THE FERMILAB LONG BASELINE NEUTRINO FACILITY

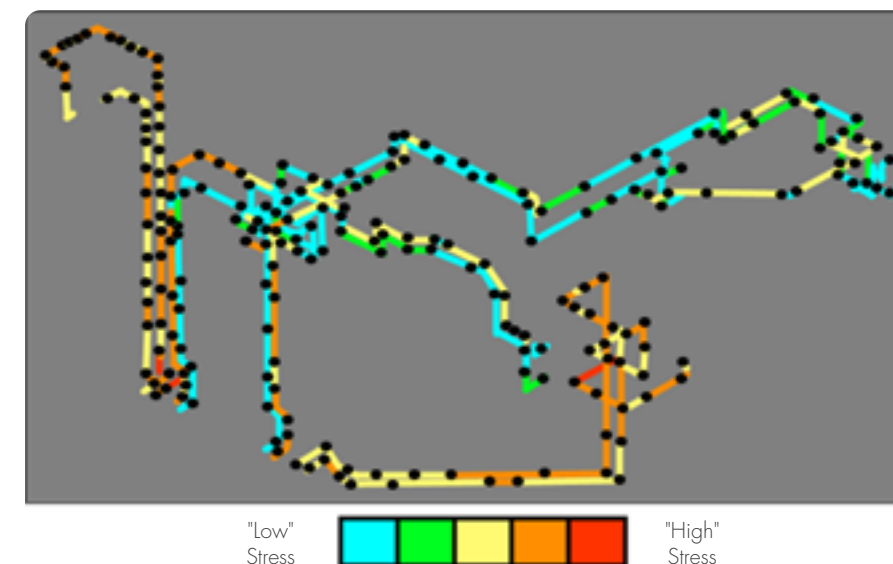
FIGURE 1. Risk and Stress Value Layers

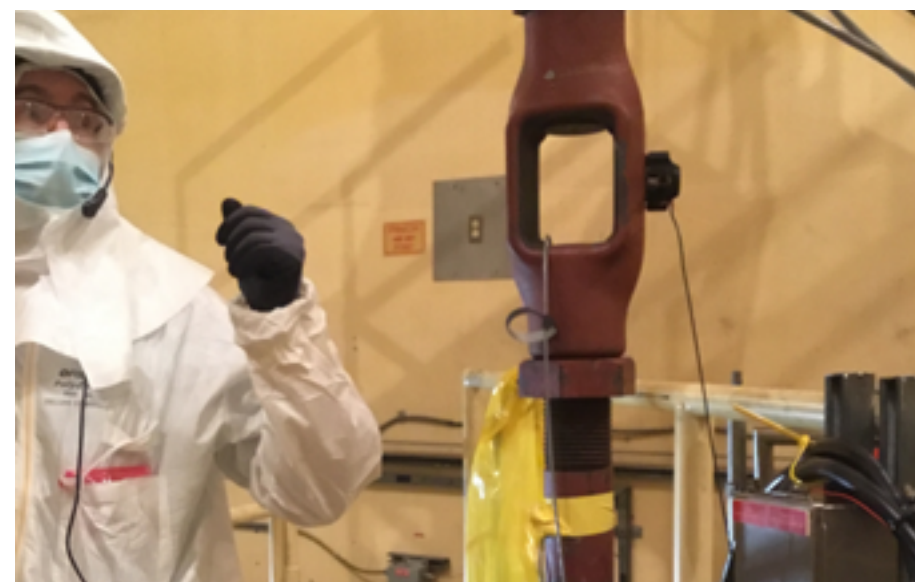
FIGURE 2. Lift rig turnbuckle outfitted with AE sensor.

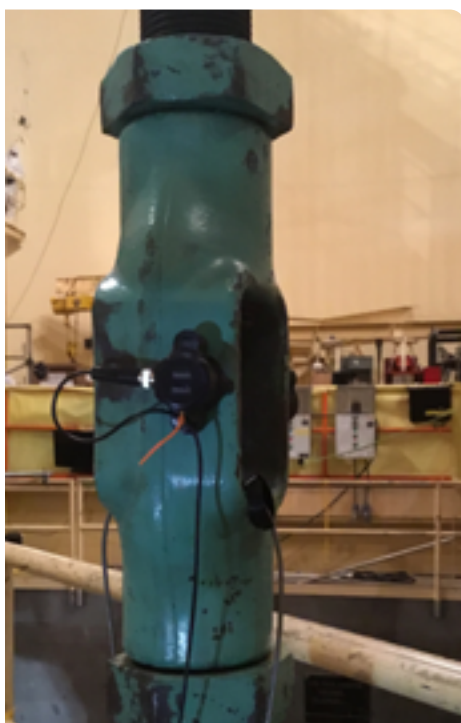
FIGURE 3. Close-up of AE sensor.

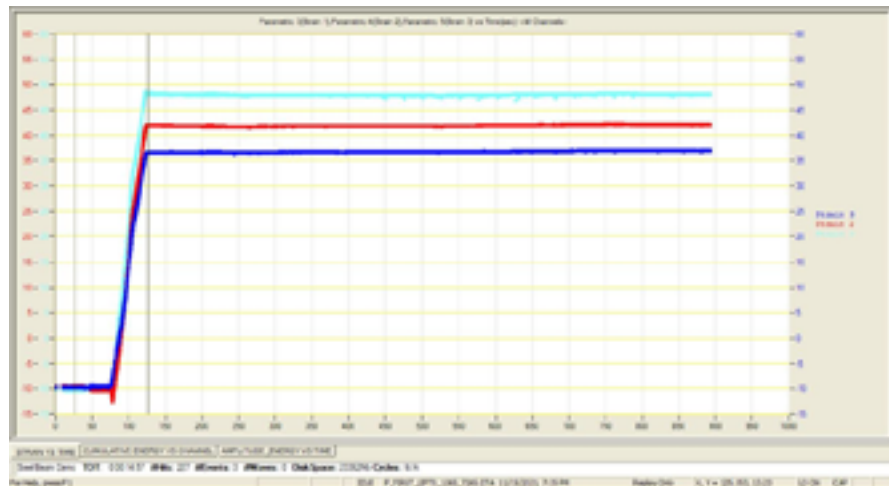
FIGURE 3. Strain gauge output showing precise timing of peak load on lift rig.

peak load is reached. The historical method for synchronizing peak-load with the start of the hold period relied on the use of a stop-watch and video feed of the readout from the containment polar crane load cell. When the load cell appears to max out, the time is noted and marked as the commencement of the test. This approach can be non-conservative from a post-test analysis perspective as the data before the noted start time is typically not considered in the analysis. As the strain gauge correlation provides a much more precise point of maximum load that is directly synchronized with the data acquisition instrument, it is more likely that early acoustic emissions, which are often the most intense and most relevant, are correctly considered in the analysis.

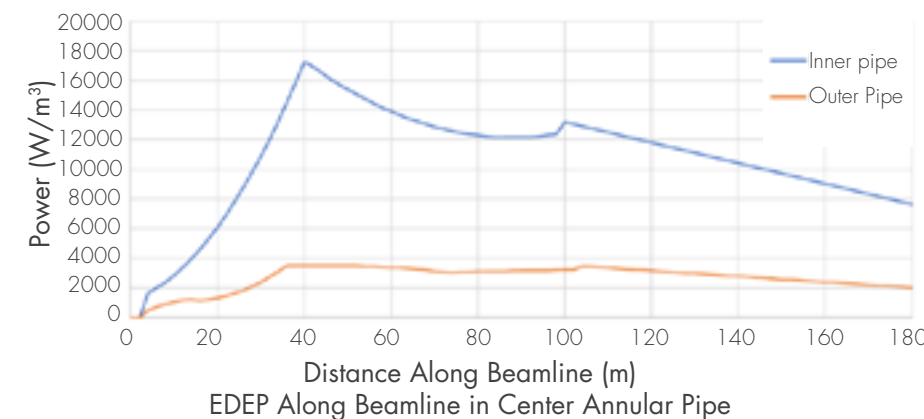
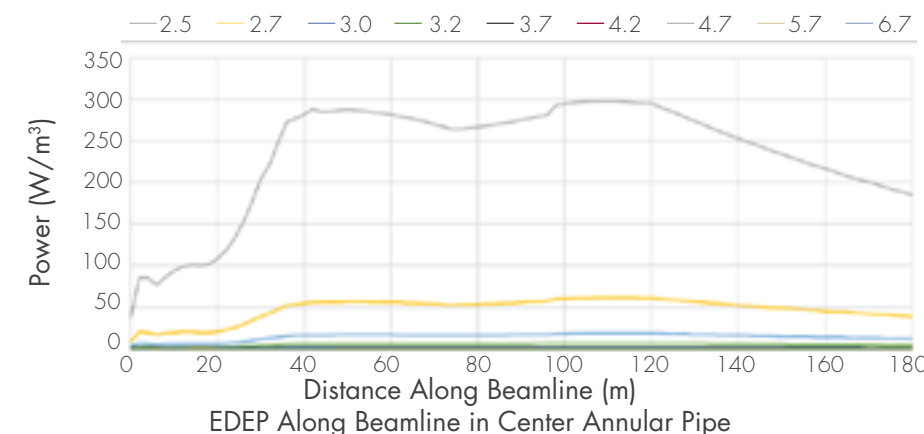
FIGURE 4. EDEP Axial and Radial Distribution along the Beamline

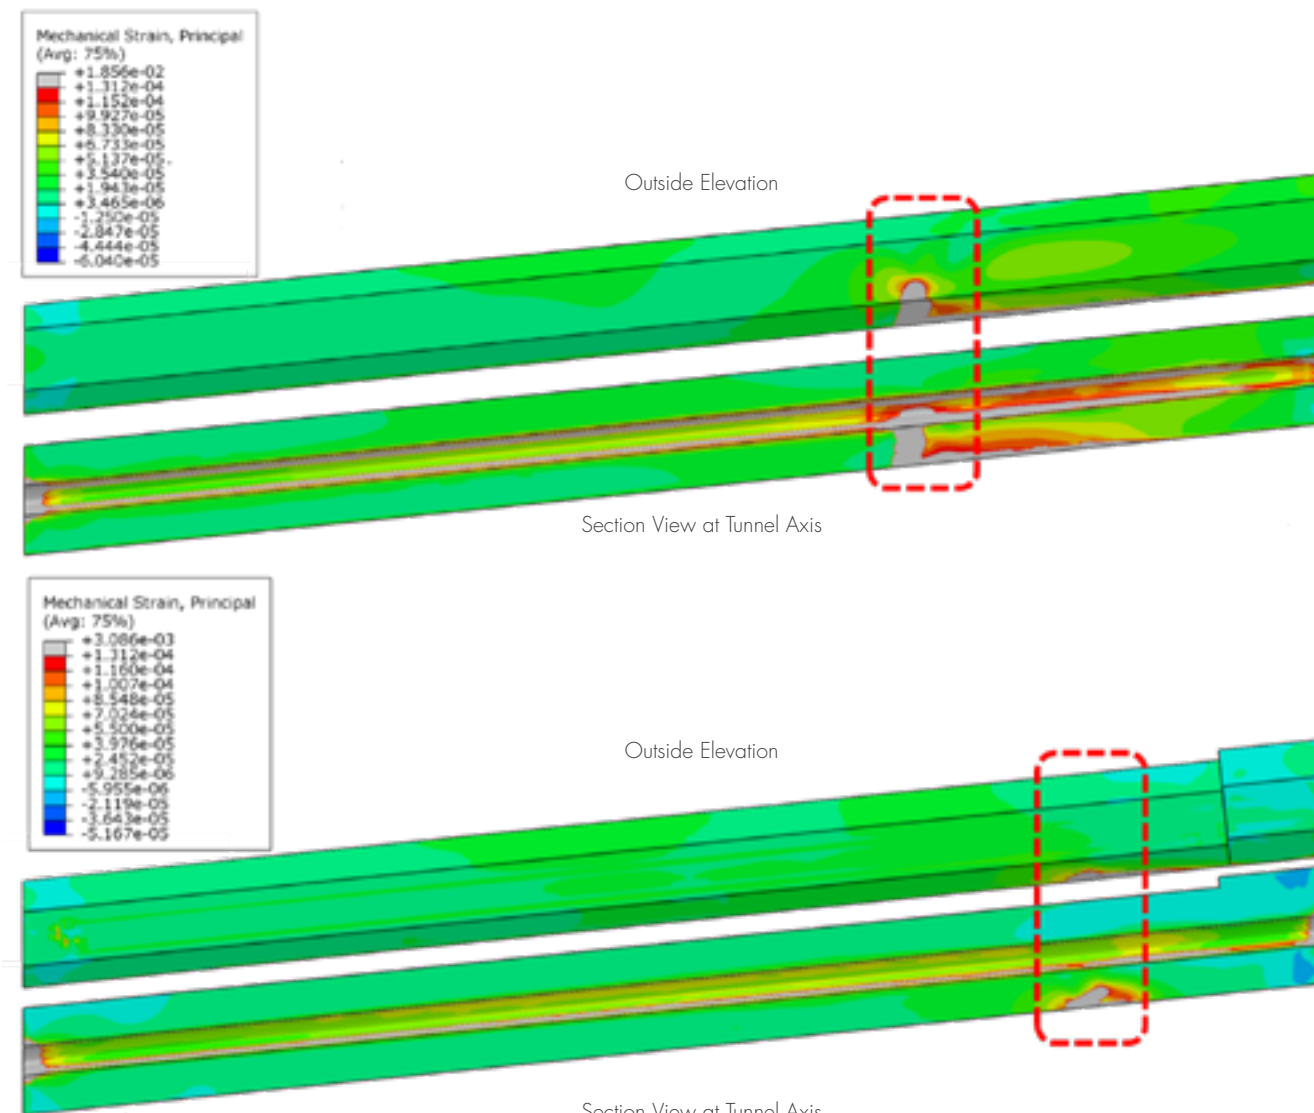
FIGURE 8. Effect of Fixed Rail Boundary Condition Position on Strain.

gravity of the structure along the slope. SI provided valuable design influence with where the fixed rails were to be positioned as the thermal loading created immense stress at the location between the fixed boundary and sliding boundary. In the original position, SI's calculations identified a concentrated area of cracking. To minimize the amount of cracking and additional reinforcement needed, SI proposed moving the position of restraint towards the cool / upstream end of the tunnel.

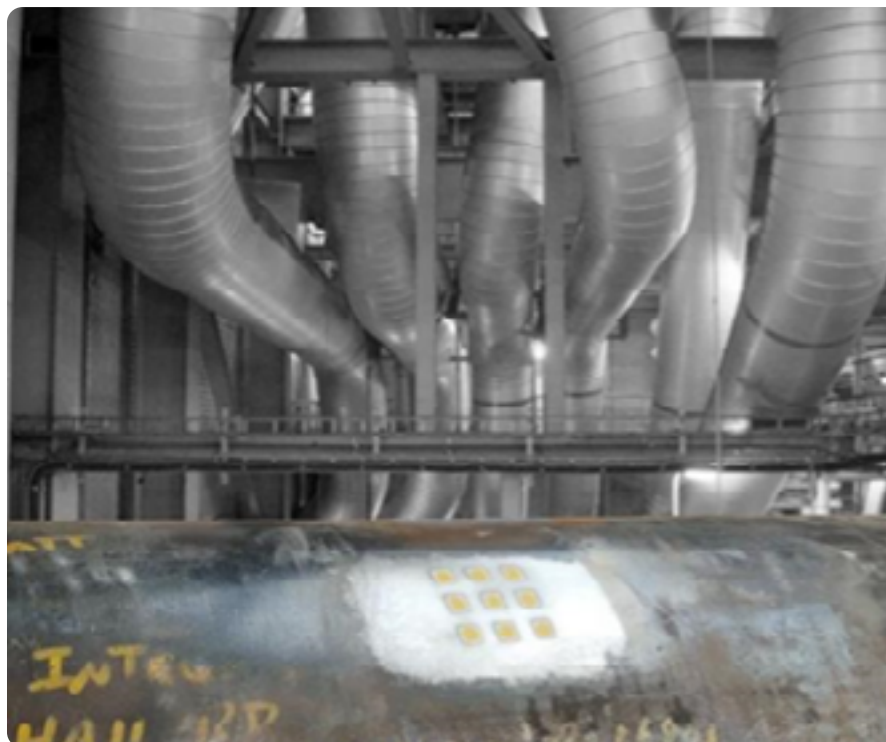
FIGURE 1. Photograph of an ultrasonic thick-film array for monitoring wall-thickness over a critical area of a component.

Over the last several years, Structural Integrity has been working on the development of a real-time thickness monitoring technology that utilizes robust, unobtrusive, ultrasonic thick-film sensor technology that is enabling continuous operation at temperatures up to 800°F. Figure 1 shows a

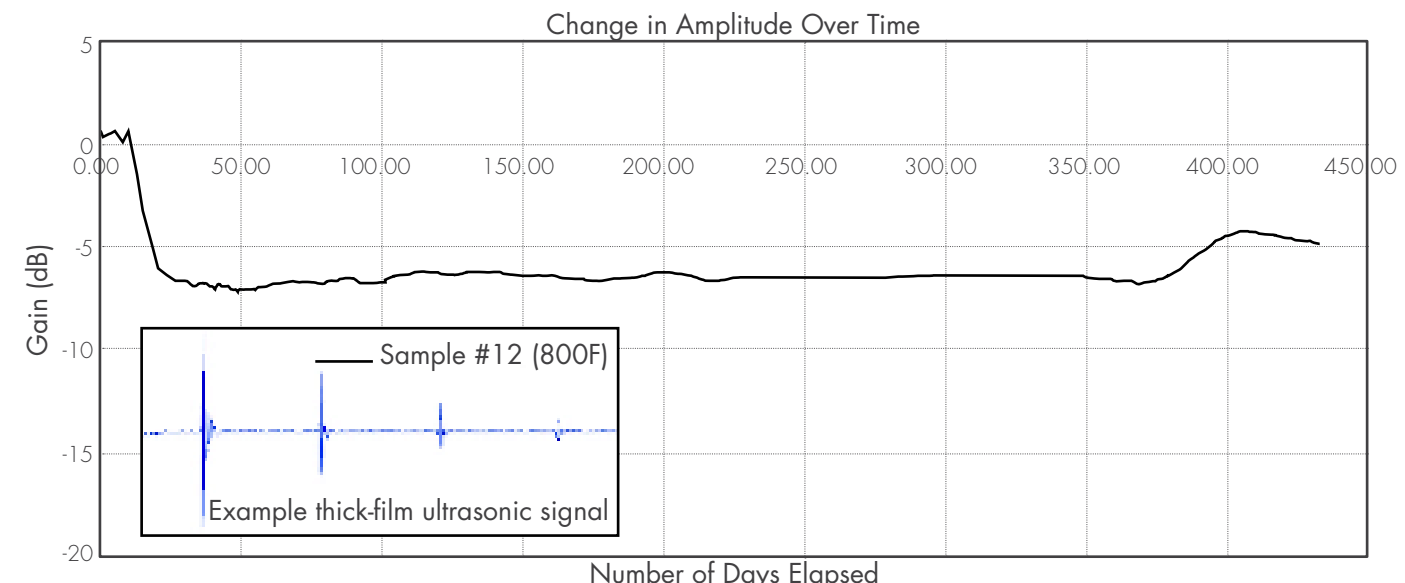
FIGURE 2. A plot of ultrasonic signal amplitude over time for a sensor operating continuously at an atmospheric and component temperature of 800°F.

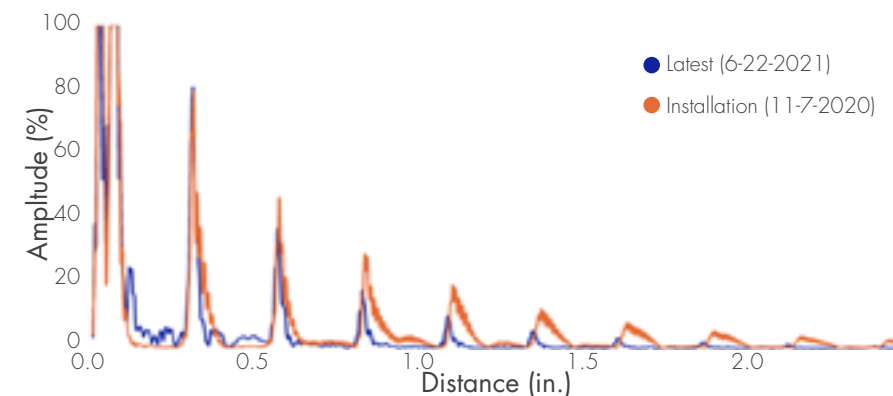
FIGURE 3. Ultrasonic waveforms acquired approximately 8 months apart showing 0.005 inches of wall loss at the sensor location over this period.

Figure 3 shows two sets of ultrasonic data that were acquired approximately eight months apart at an operating power plant. The first data set was acquired at the time of sensor installation and the second data set was acquired after approximately eight months of typical cycling, with temperatures reaching up to ~500°F. Based on the observed change in the time-of-flight between the multiple backwall echoes observed in the signals, it is possible to determine that there has been approximately 0.005

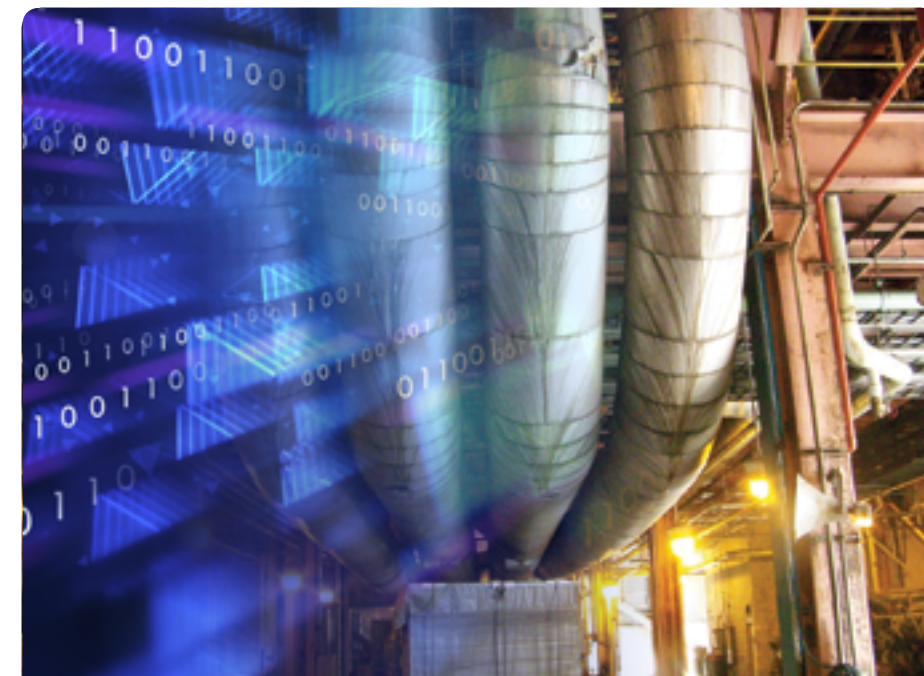
FIGURE 4. Photograph showing Structural Integrity's thick-film ultrasonic sensor technology installed on two high-temperature piping elbows that are susceptible to thinning from erosion.

In addition to significant laboratory testing, the installation, performance, and longevity of Structural Integrity's thick-film ultrasonic sensor technology has been demonstrated in actual operating power plant conditions, as seen in the photograph in Figure 4, where the sensors have been installed on multiple high-temperature piping components that are susceptible to

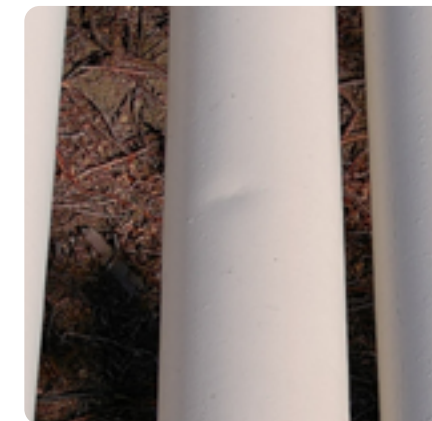
FIGURE 1. Drone image of a dent on an elevated section of pipeline

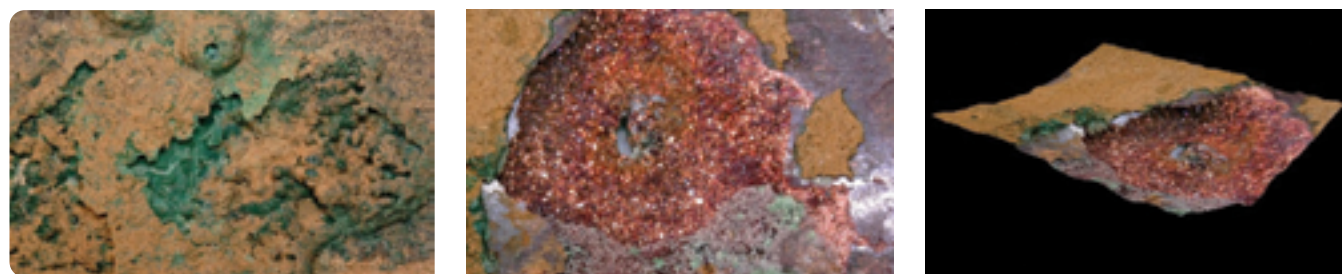
FIGURE 3. Two- and three-dimensional images of a copper heat exchanger tube that has been damaged from under-deposit corrosion (UDC). The image at left shows the typical appearance of the ID deposits. The center image shows a region of damage surrounding a pinhole leak. The 3D image provides an idea of the depth of internal corrosion in the tube.

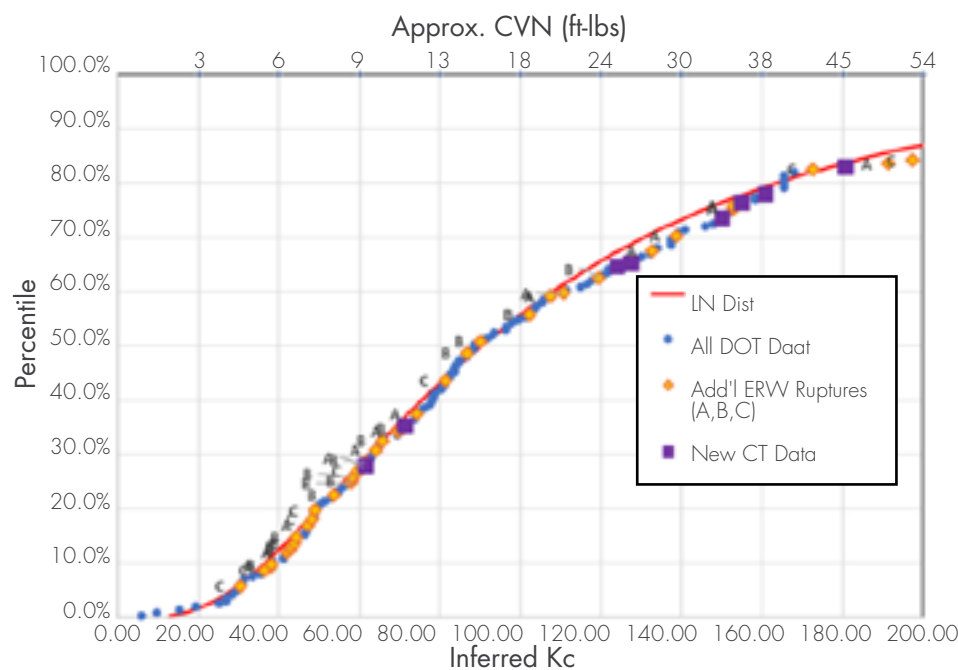
FIGURE 1. Cumulative Distribution of Fracture Toughness from Historical Failures of ERW/FW Seam Welds with New Fracture Toughness Measurements Added (Purple Squares)

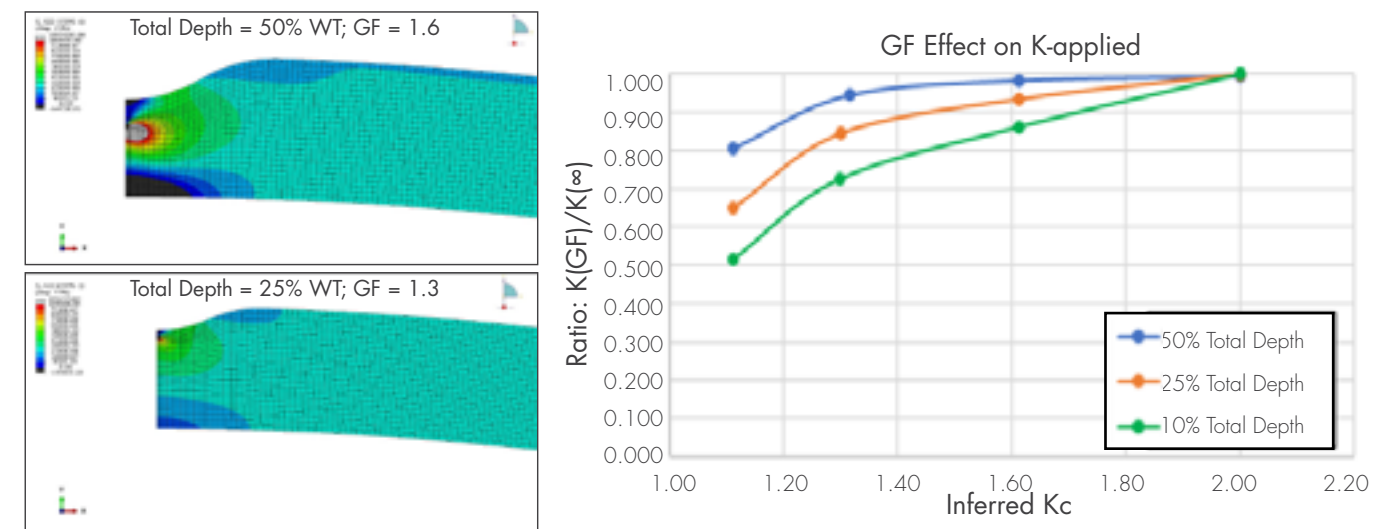
FIGURE 3. Finite Element Model and Results of a Study to Evaluate the Effect of SSWC Grooving Factor on Applied Stress Intensity Factor
