Failure can be defined as any change in a component that prevents satisfactory performance of its intended function. Understanding why a component failed is important for several reasons. First, a determination of the failure mode is an essential component of any root cause analysis. Second, understanding a component failure provides essential information for preventing additional or similar failures. Perhaps most importantly, an erroneous or incomplete analysis can be worse than no analysis at all, since this can prompt inappropriate responses that do not address the basic cause of failure or increase the potential for additional failures.

The degrees to which a failure analysis can be applied range from simply determining the failure mode to performing a full root cause analysis of the failure event. For each situation that occurs, the approach required should be evaluated to determine the level of metallurgical evaluation or engineering effort that should be expended. Identifying the mode of a failure can range from relying on a thorough visual examination by a competent failure analyst to a full laboratory analysis consisting of some or all of the following tasks:

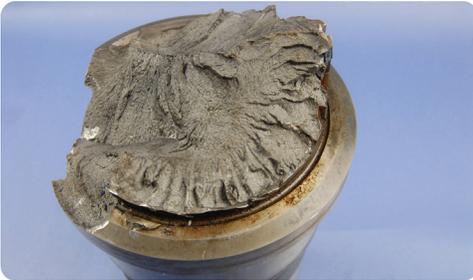
Fractured shaft

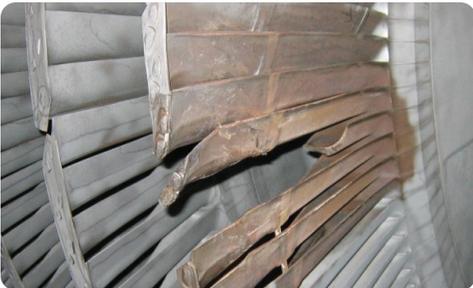
Failed turbine blades

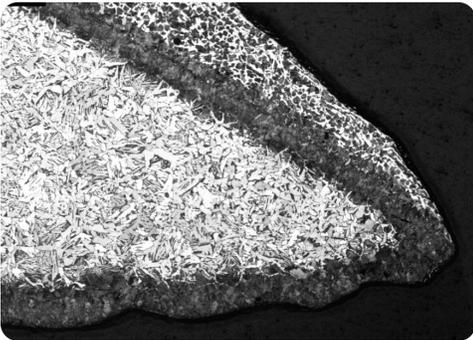
Fracture Tip Section

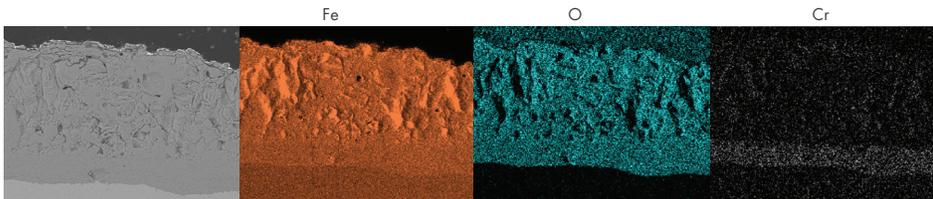
Elemental maps of an oxide from a supercritical boiler waterwall tube showing an inner chromium rich spinel layer and an outer iron oxide layer.

Often surface oxides, deposits, or corrosion products play a significant role in the damage mechanism either by directly causing wall loss or attack of the metal, or by acting as a secondary contributor to a failure (e.g. internal oxide scale "insulating" a steam touched tube and causing an increase in the tube metal temperature). Characterization of these oxides or deposits includes identifying the elements or compounds present, mapping the elemental constituents to show how they are dispersed throughout the layers, and examining the morphology at low and high magnifications.

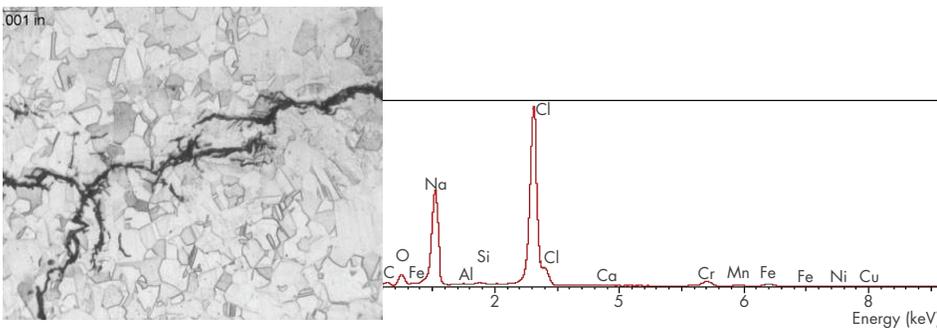
Chloride stress corrosion cracking in an austenitic stainless steel and EDS analysis results from crack deposits showing a very high chlorine peak

Elemental analysis of crack deposits or corrosion products can help identify the damage mechanism. In the case where contaminants cause or contribute to failure, identification of such contaminants can bolster findings and support recommendations for avoiding future failures.

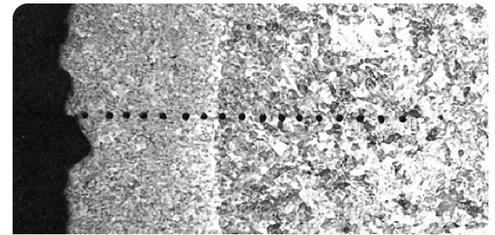
A ring section showing external wall loss as well as swelling  
Microhardness traverse through fractured weld

Dimensional measurements include the major dimensions such as outer and inner diameters and component thickness. They can be used to identify the location and magnitude of material wastage or wall loss. For tubular components, dimensional measurements can also be used to identify the degree of service-induced swelling, which is a measure of accumulated creep damage.

Hardness tests can easily be performed on metallurgical sections and provide an indication of the metallurgical condition of the material. Hardness values can also be used to estimate tensile strength. Other mechanical property testing, including elevated temperature properties (creep strength) and fracture toughness, can be performed as part of more detailed investigations.

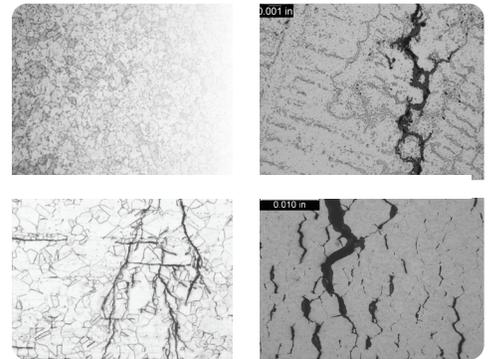
TOP LEFT Degraded T91 microstructure  
TOP RIGHT Cracking in a cast ethylene furnace tube  
BOTTOM LEFT Transgranular SCC  
BOTTOM RIGHT Creep damage in a stainless steel component

Metallographic evaluation allows for assessment of component microstructure and microstructural degradation (spheroidization, graphitization or transformation). It also provides information on damage type, extent, and morphology (cracking/fracture path, rupture features, corrosion, pitting, and cavitation). The appearance and thickness of oxides/scales/deposits can also be assessed.
