Structural Integrity
Associates, Inc.®

NEWS & VIEWS

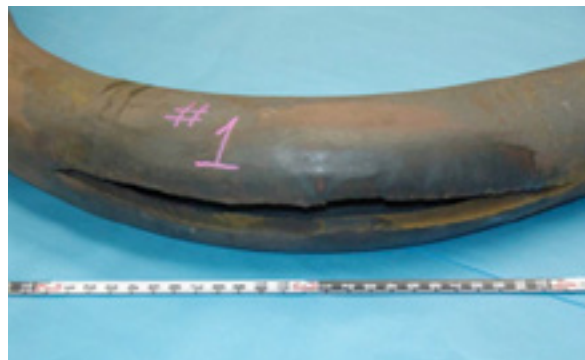
Figure 1. View of the Thick-Lipped Extrados Rupture

2011 could be confirmed as graphitization-related (after the damage mechanism was identified in 2011). The most recent failure occurred along the extrados of a 90° bend with a 24-inch bend radius (Figure 1). The longitudinal fracture was about two feet in

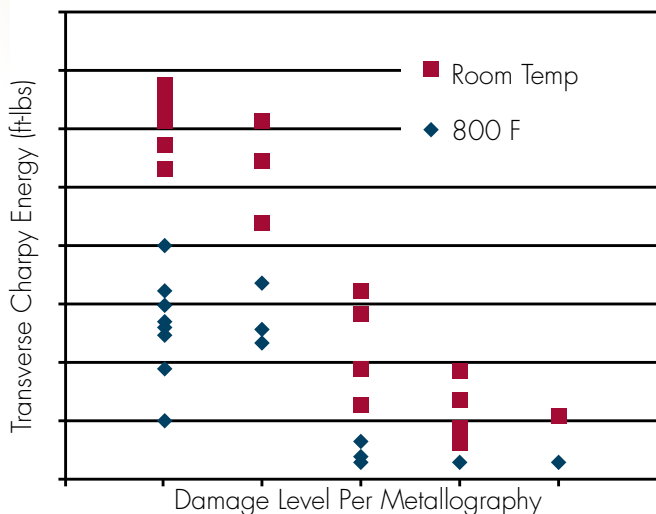
Figure 5. Transverse (Hoop Direction) Charpy Impact Energy as a Function of Volumetric Grain Boundary Graphitization in SA-335 Grade P1 Steel

temperature and at 800°F. Due to the orientation of the damage, we considered the transverse Charpy data as the best indication of loss of toughness in the hoop stress direction. The results from this testing, when plotted versus the observed damage level (from the metallographic samples), shows a strong correlation between the degree of damage and a loss of toughness within the P1 material (Figure 5). In addition to the Charpy testing, we performed hardness testing on multiple locations on seven pipe sections. The average bend region hardness was 184 Vickers, while the average straight region hardness was 162 Vickers, with the difference being attributed to the bends having been formed “cold” with no subsequent post-forming heat treatment, a common practice at the time these bends were fabricated.

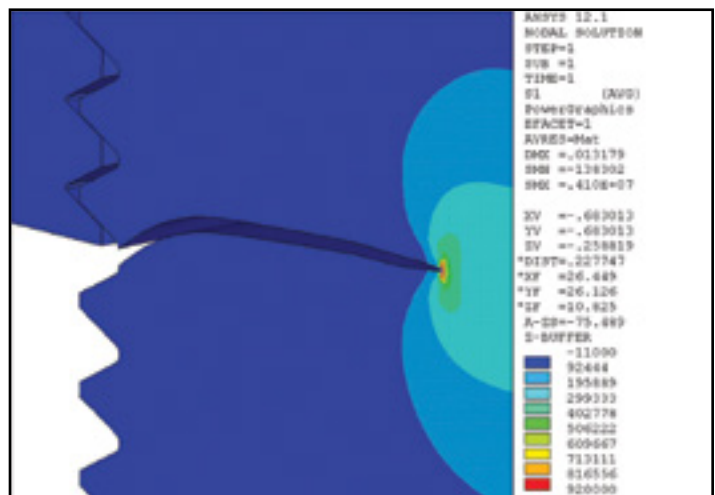
Circumferential Crack Model

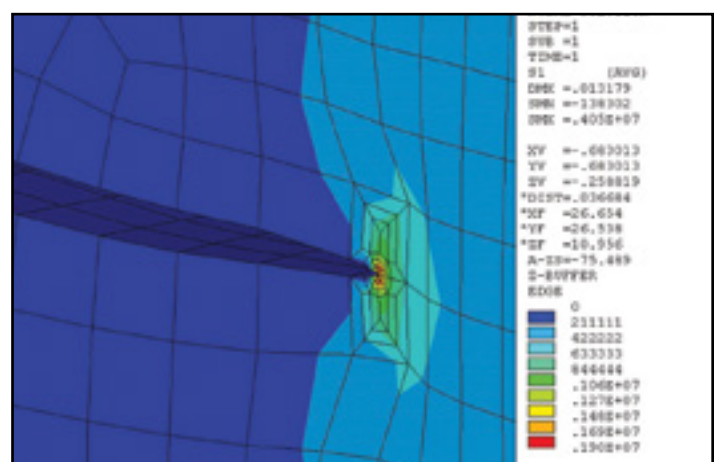
Principal Stress at Crack Tip

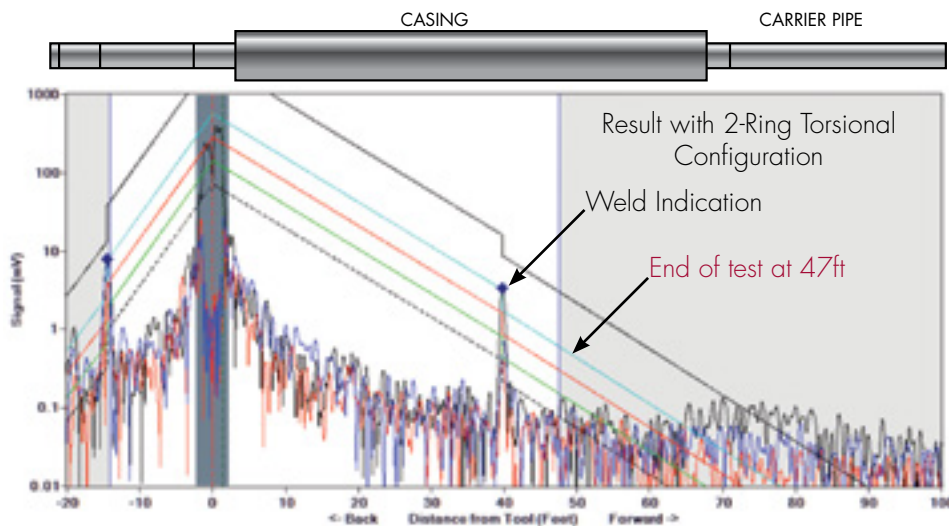
Figure 1 A-Scan result obtained using a standard two-ring torsional GWT collar configuration. Approximately 47ft of diagnostic length was achieved using PHMSA's guidelines.

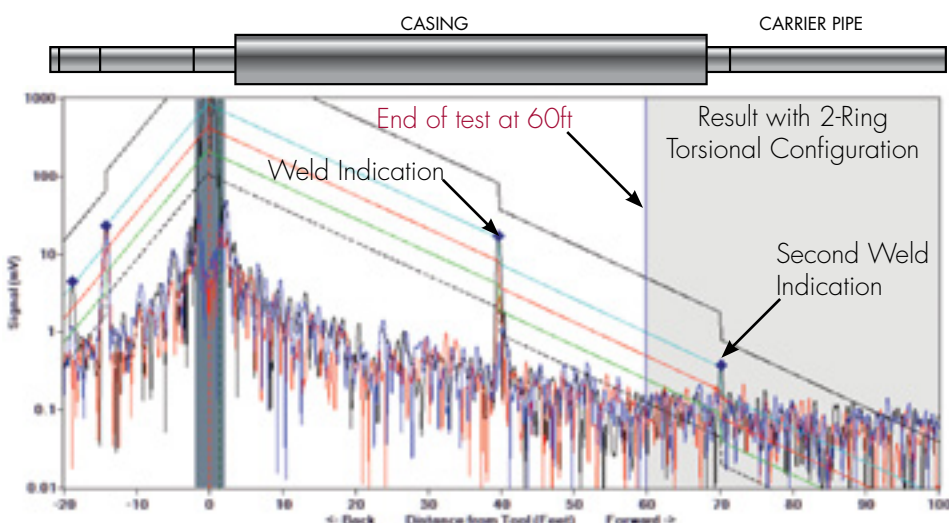
Figure 2 A-Scan result obtained using a non-standard three-ring torsional GWT collar configuration. A 13ft improvement in coverage of the cased segment is obtained per PHMSA's guidelines.

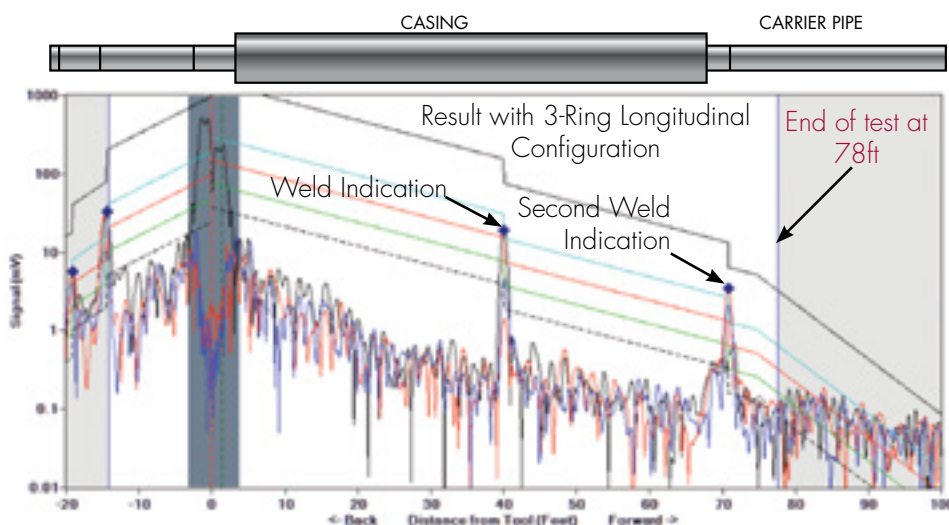
Figure 3 A-Scan result obtained using a non-standard three-ring longitudinal GWT collar configuration. A 31ft improvement in coverage of the cased segment is obtained per PHMSA's guidelines.

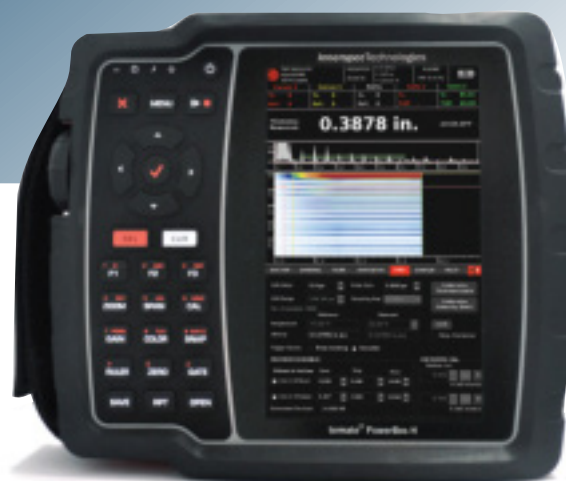
Figure 4 The temate® PowerBox H ultrasonic pulser (top) and an assortment of EMAT sensors and dry- and air-coupled sensors (bottom).

The temate® PowerBox H, pictured in Figure 4, coupled with a horizontal shear-wave EMAT, is capable of generating high-frequency torsional waves in piping components. High-frequency guided waves are useful in situations where the area of interest falls within the dead-zone or near-field of traditional GWT tools or where external structures contact the pipe, creating high-potential areas for crevice corrosion. EMATs also have several practical advantages in that they do not require any ultrasonic couplant, can be used in a non-contact configuration (or through coatings), work on rough and pitted surfaces, and work on both ferromagnetic and non-ferromagnetic metals.

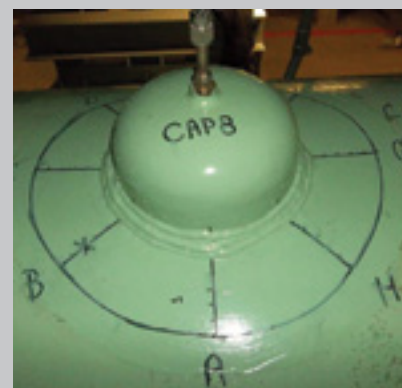
Figure 2. Typical encapsulation repair

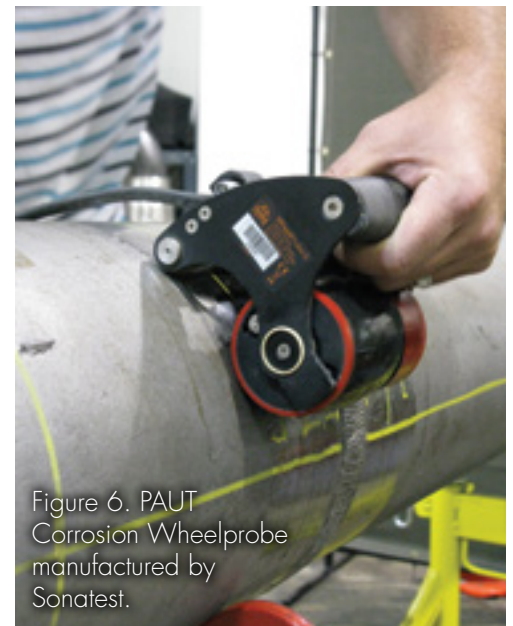
Figure 6. PAUT Corrosion Wheelprobe manufactured by Sonatest.

and capabilities. These portable wheel probes provide the capability to quickly scan an area of piping to obtain thousands of UT thickness measurements per square foot. These devices are equipped with an encoder which allows these measurements to be stored and referenced for further analysis, thus providing the capability to quickly detect and size internal corrosion.

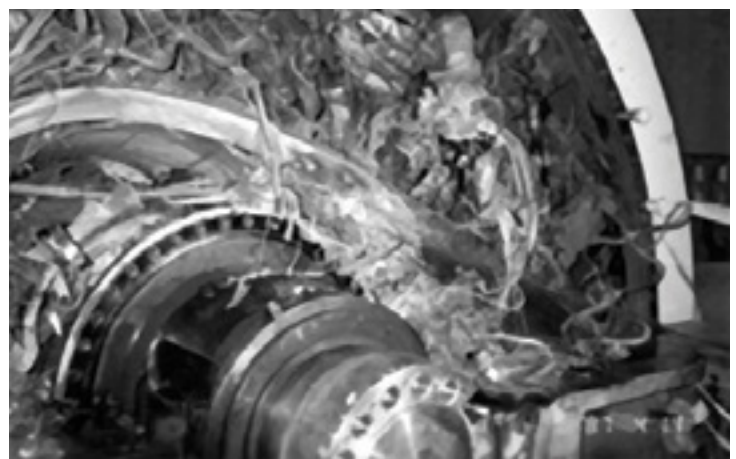
Figure 1. Catastrophic failure of Retaining Ring
