Structural Integrity
Associates, Inc.®

NEWS & VIEWS

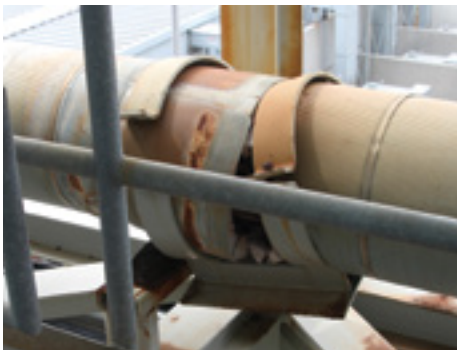
Figure 2 – Photograph of damaged over-insulation shoe support

While these supports are designed to withstand static deadweight loading of the piping, loading from dynamic events such as water hammer during startup or overloading due to other malfunctioning supports can cause damage to the insulation blocks. The clamped on shoes may also eventually become loose against the pipe insulation (if tight originally) and allow the piping to slide inside the clamp rather than the shoe sliding on the guide plate. When this occurs, the clamps may visibly appear twisted or may slide off of the insulation blocks (see Figure 2). This condition can cause increased local stress in the piping, overloading of adjacent supports that now need to carry the load from the damaged support and/or sagging in the piping, potentially diminishing the effectiveness of the drainage system.

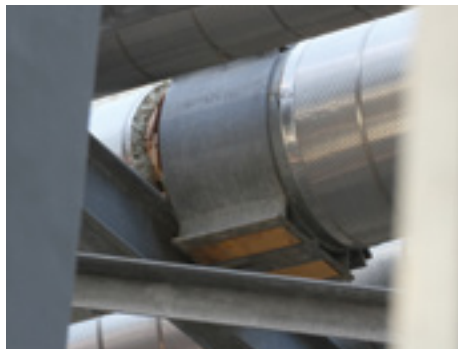
Figure 3 – Shoe support fallen off of structural steel

Dynamic events, poor design, and incorrect installation can also cause support alignment issues with shoe supports and guides. Shoe supports typically rest on structural steel, and are offset from the centerline of the steel by half of the expected thermal displacement. If this offset is performed in the wrong direction, or if water hammer or a similar event causes large displacement, the shoes may fall off of the structural steel (see Figure 3). Such an event may also cause vertical movement of the piping and result in misalignment of a guide support (see Figure 4). Similar to the damaged shoe support condition noted above, these conditions can result in local stress increases, damage to surrounding supports and can adversely affect the slope of the piping relative to drains.

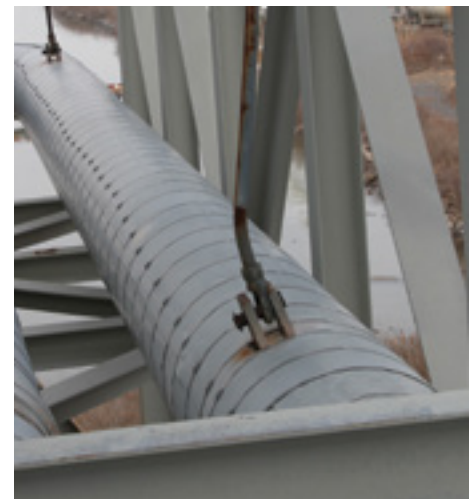
Figure 5 – Buckled rod due to compressive overloading

Rigid rod supports are typically used to support vertical dead weight loads in tension for conventional and combined cycle HEP systems. In compression, these rods tend to buckle under relatively small loads, causing a permanent bend in the rod (see Figure 5). When such damage occurs, the cause of the compressive load should be identified prior to replacement of the rod. If the compressive load was caused by a static

load or a dynamic event that cannot be controlled or prevented from reoccurring, the rod may need to be replaced with a strut that can withstand both compressive and tensile loading.

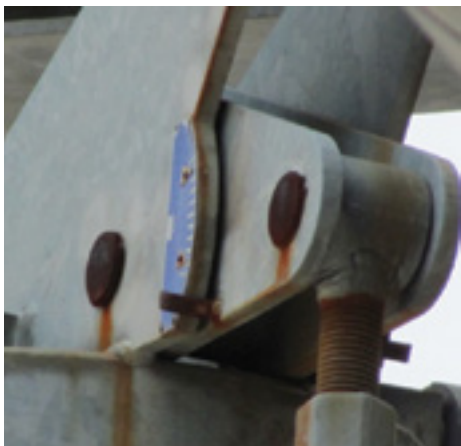
Figure 7 – Bottomed out constant load hanger

Over time, creep and other factors can cause movement in the piping, resulting in supports operating above or below their design positions. In general, this is not a significant concern with respect to piping stress, as long as the hangers are still within their operating range. In some cases, supports may bottom out – effectively acting as vertical rigids constraining additional downward movement, or top out – either constraining additional upward movement or providing no support/restraint, depending on hanger arrangement. Figure 7 is an example of a bottomed out constant load hanger.

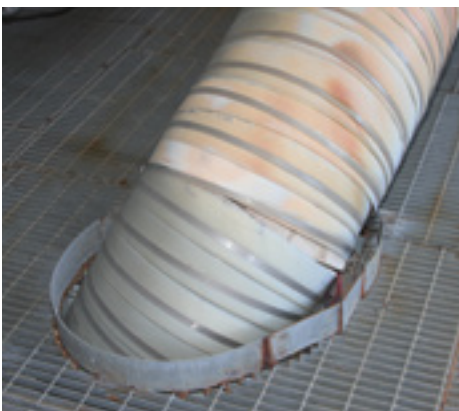
Figure 11 – Piping contacting grating at floor penetration

penetration and a structural column. Such conditions can result in higher local stress in the piping due to the added restraint, damage to the structural component and damage to the piping insulation, exposing the piping to the ambient environment. This issue is commonly found at grating/wall penetrations and structural steel.

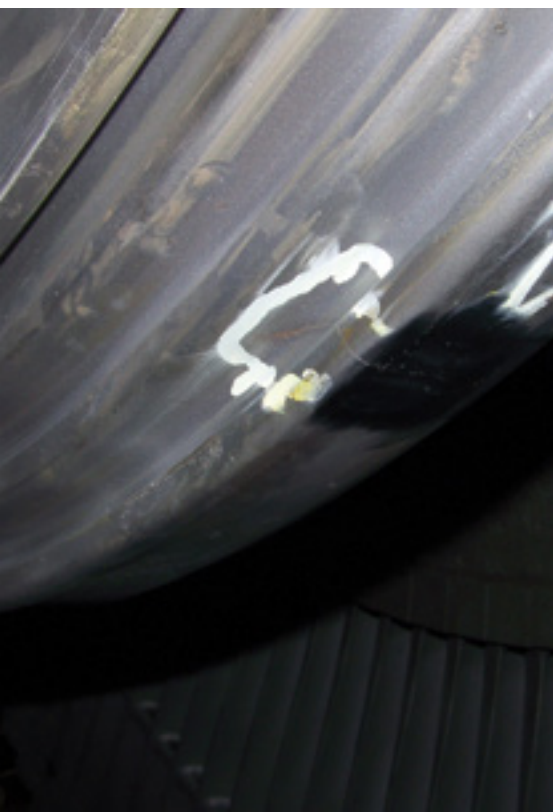
Radial-Axial Crack on a Disk Rim
Note the crack morphology, i.e. unbranched and planar, and skewed in the shank

Once initiated, cracks tend to propagate through the rim, and left undetected, work their way into the shank and to the lower hooks. Some crack depths of one, to one and a half inches from the rim have been measured.

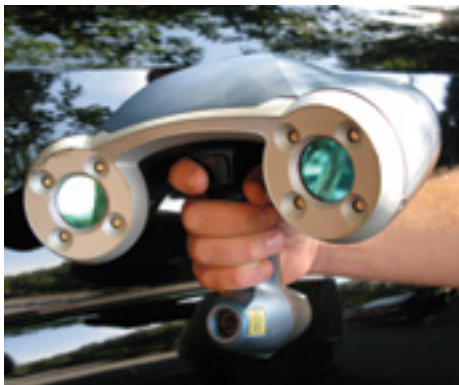
Laser profilometer

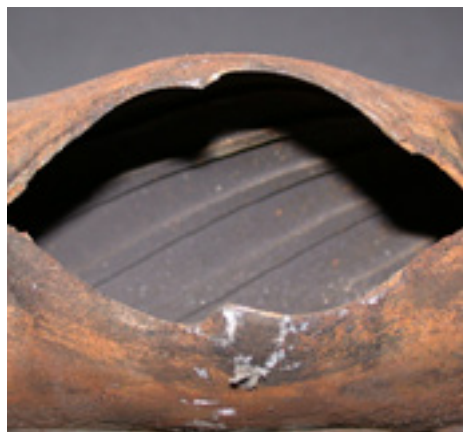
Figure 1. Waterwall tube showing swelling, and a thin-lipped, fish-mouth rupture.

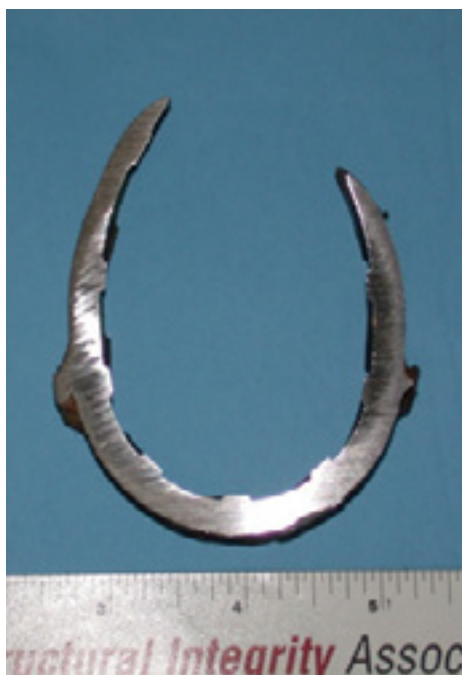
Figure 2. Cross-section through rupture.

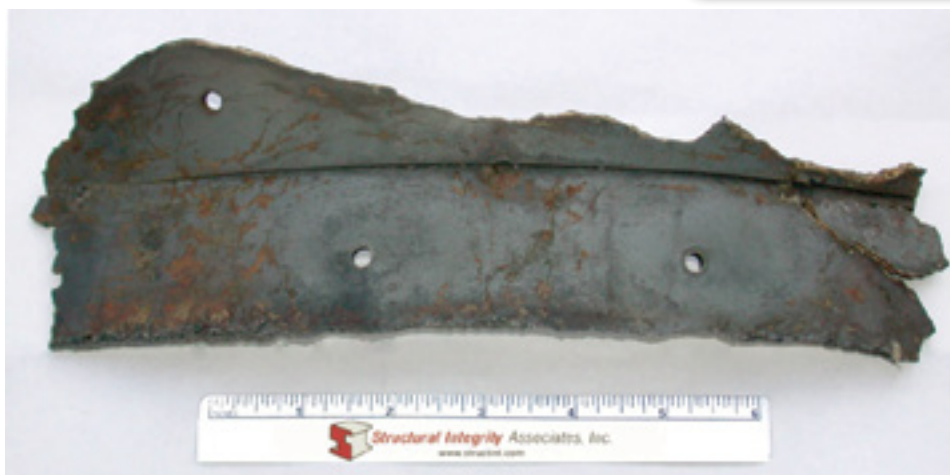
Figure 1. The OD surface of the burner ring sample showing corrosion and cracking.

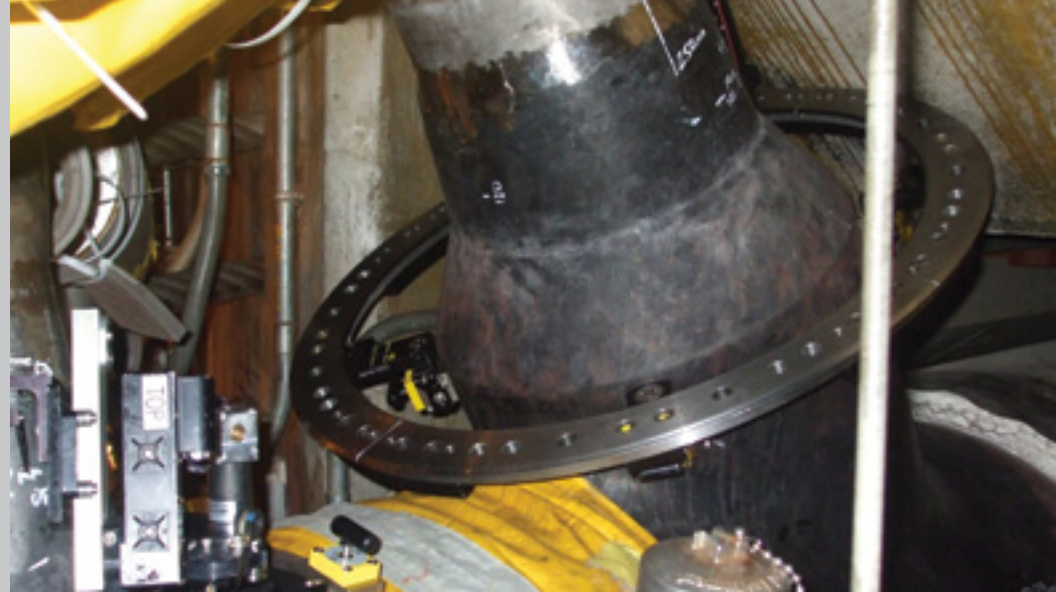
SI's Safety Injection scanner assembly (centered in photo) is shown installed in proximity to the small-diameter scanner and ready for the examination of a Safety Injection DM weld.
