Structural Integrity
Associates, Inc.®

NEWS & VIEWS

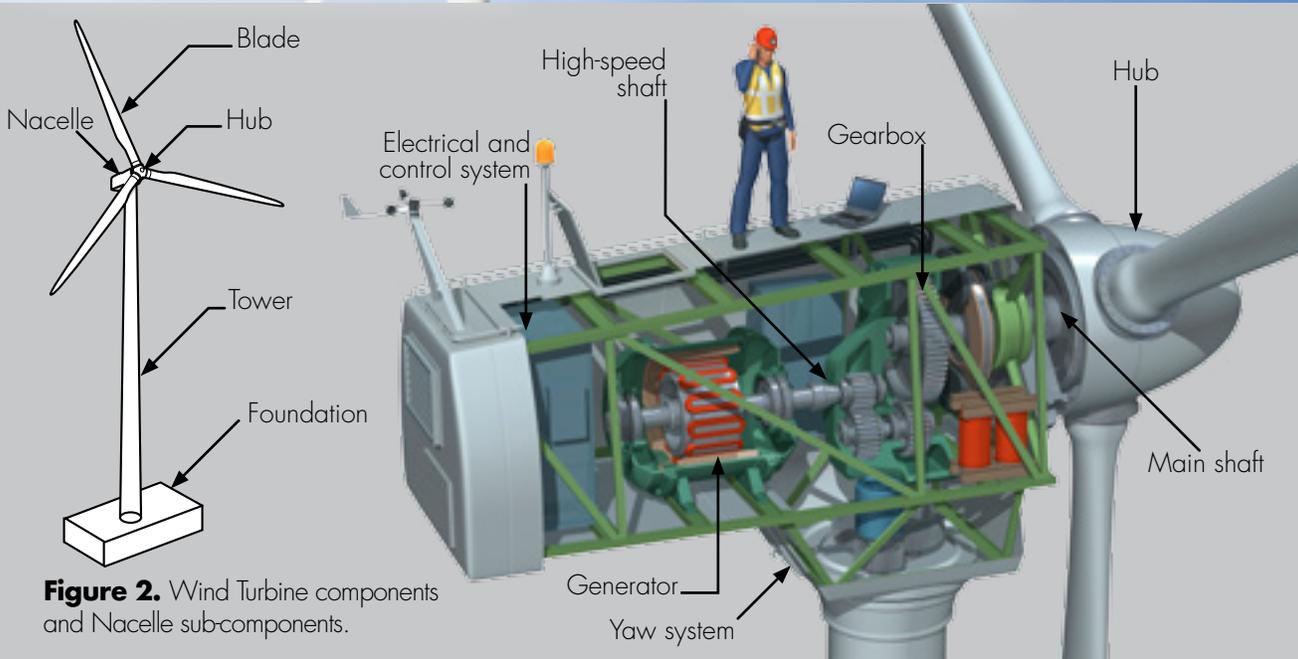
Figure 2. Wind Turbine components and Nacelle sub-components.

To date statistics show more turbine failures and higher maintenance costs than expected, which has caused this to become a major concern to a lot of owners and operators. A wind turbine consists of various components as shown in Figure 2. In the last few years, blades, gearboxes and generators have been reported to have the highest rate of failures and/or repair/replacement downtimes (See Figure 3).

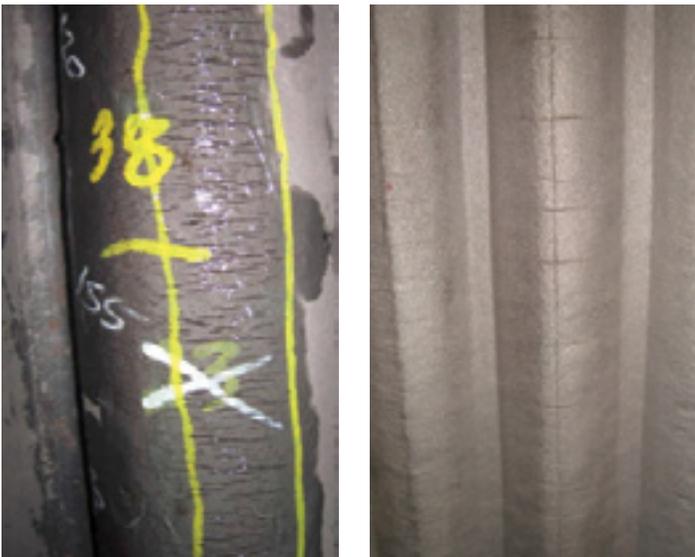
Figure 1. Cracking Severity

As shown in Figure 1, the visual severity of fire side circumferential cracking can vary considerable; from numerous closely spaced cracks numbering 20-30 cracks per inch, to sparse cracking that numbers only 2-3 per inch. In addition to the numerous and closely spaced cracking, additional challenges for NDE include hundreds of tubes with damage and many linear feet of tubing to examine (Figure 2). As a result, Structural Integrity developed a two-stage approach that has proven effective in identifying and sizing the deepest cracks; ECT to screen for cracks greater than 0.050” deep and PAUT to size those greater than 0.050” cracks. The advantage of this approach is that ECT is fast and requires no couplant so it provides a means to rapidly screen numerous feet of tubing to isolate the most severe (deepest) cracking. This approach typically leaves a much-reduced area to perform detailed sizing using PAUT. Sizing with PAUT is typically performed by bouncing or skipping sound waves off the tube bore as shown in Figure 3. While this works effectively for smooth bore tubing, rifle bore tubing creates another unique challenge, as illustrated in Figure 4. The existence of rifle bore tubing in the boiler at a client site provided the impetus for reevaluating the current PAUT approach to determine the feasibility of sizing cracks in this tubing.

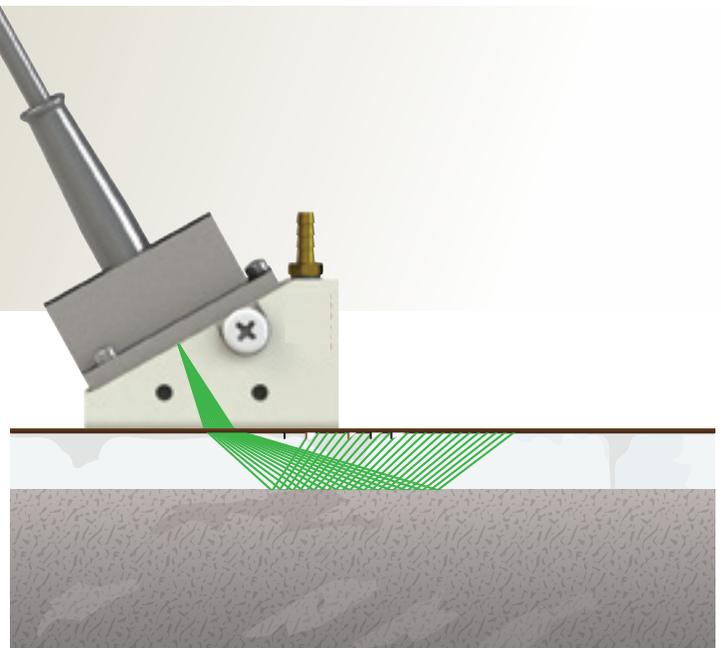
Figure 3. PAUT Crack Sizing in Smooth Bore Tubing

Historically, this application was performed using a small footprint probe that did not require contouring the wedge of the probe to couple to the radius of the tube. These probes, which had been successful on smooth bore applications, are easy to manipulate and skew on the tube surface. However, because of their small aperture (total element surface area) they are limited in focusing ability. As previously mentioned, most sizing must be performed on the second leg of sound to ensure the sound beam reaches the crack and crack tip. The focal range of these small aperture probes is shorter than the metal path required for focused sound to reach the cracked Outside Diameter (OD) surface of the tube. To further complicate the examination, the geometry of the Inside Diameter (ID) surface of rifled bore tube caused the sound beams to bounce off the ID bore at irregular angles, as seen in Figure 4. Therefore, not only were the small aperture probes not able to focus sound at the depths necessary to reach the cracked OD surface, but the rifled ID bore caused this limited sound field to bounce in multiple directions, thereby only allowing small “windows” of unfocused sound to reach the OD crack area.

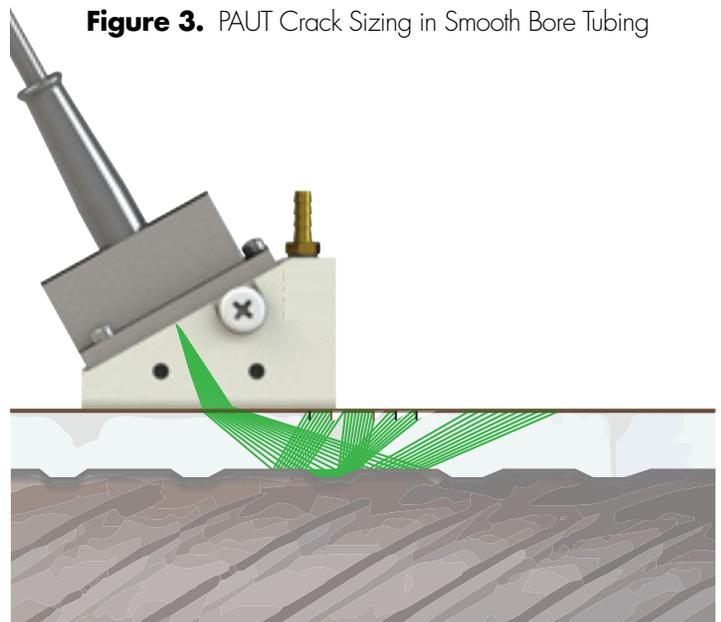
Figure 4. PAUT Crack Sizing in Rifled Bore Tubing

To improve the PAUT sizing technique, larger aperture probes were evaluated using a combination of software simulation and laboratory testing to prove that the longer focal zone could effectively reach the cracked OD surface after bouncing off the ID surface. This testing confirmed the larger aperture provided a greater amount of sound energy and the geometry of the ID bore surface of a rifled bore tube would have less negative impact on the amount of sound energy reflected to the cracked OD surface.

Laboratory testing confirmed, at best, the smaller aperture probes could only resolve notch tips at the shortest possible metal path (i.e. the lowest angles), but did not have sufficient aperture to detect tip signals at higher metal path distances (i.e., higher angles). While using small aperture probes and low angles worked effectively for smooth bore tubing, the limited "windows" to skip sound in rifled tubing combined with the limited effective angles and short range of the smaller aperture probes resulted in the possibility of missing crack tips and erroneous sizing measurements.

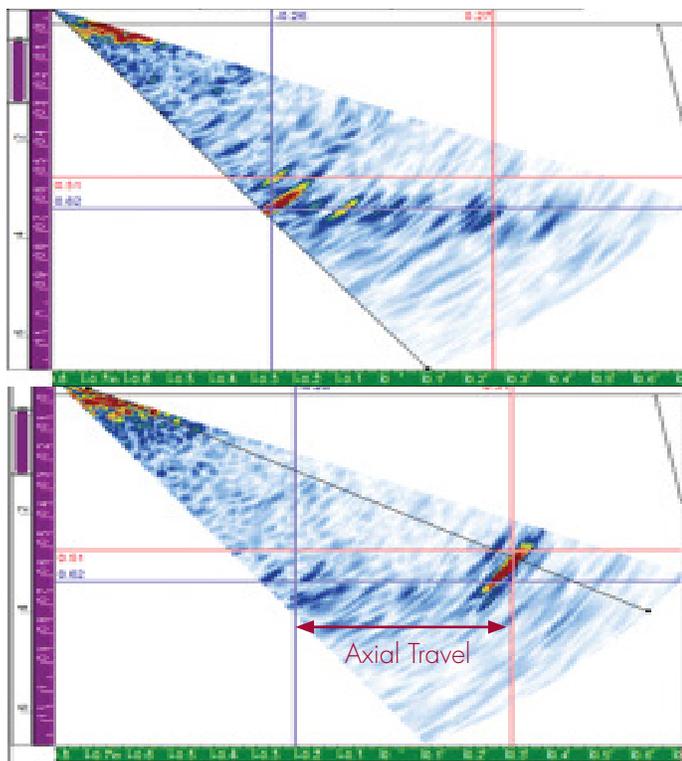
Figure 6. Response from Notch in Field Removed tube from 35° (TOP) to 60° (BOTTOM) using larger aperture probe.

improved opportunities to observe the crack tip over a greater range of angles which enhances the ability to size cracks. As an example, on a field removed tube using the larger aperture probe, the tip of a notch imbedded in a group of shallow cracks is readily detectable over an angular range of 35° to over 60° in the sector scan with indications that travel for over 1/2-inch as the probe is indexed axially (Figure 6). For the smaller probes, effective angular range was typically 35° to 45° with potential axial travel less than 1/4-inch and was truncated by the rifling which greatly reduced the chances of locating and resolving the crack tip.

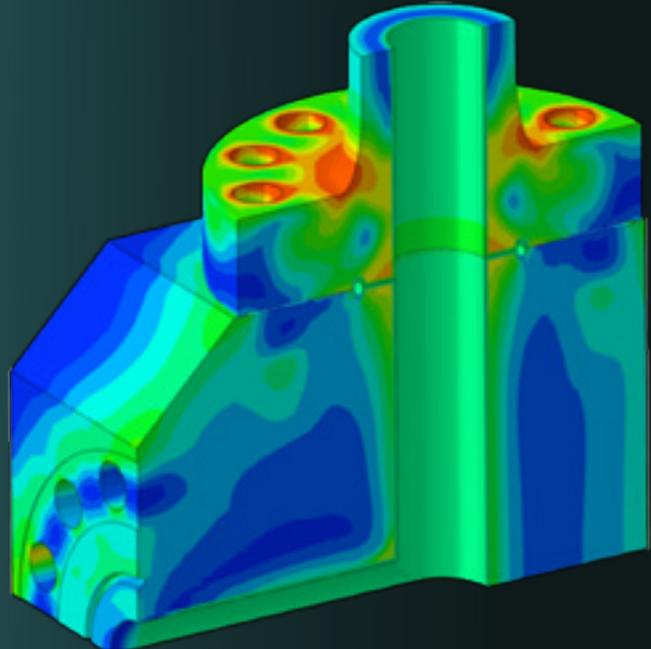
Figure 1. 20 ksi 5 inch Tee and Flange Assembly (Bolts not Shown)

The API 17 TR8 is a technical report intend to guide the design of high-pressure high-temperature (HPHT) subsea equipment. Structural Integrity was contracted by DeepStar (CTR 12302) to provide an independent usage of the 17 TR8 to evaluate a representative deepwater component – a 20 ksi 5-inch tee and flange assembly shown in Figure 1.

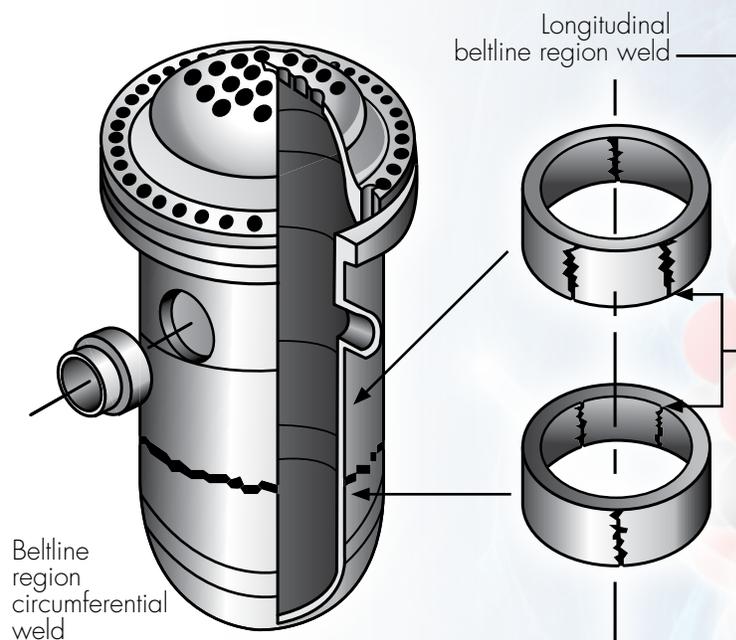
A Typical PWR Reactor Pressure Vessel Showing Beltline Region Including Welds

As plants continue to operate for 60 years or more, the region of materials in the vessel considered to fall within the beltline will expand to other components including nozzles, welds, forgings and areas outside the traditional scope of the beltline. This presents new challenges for determining vessel integrity margins since the material properties for these additional materials must be characterized and demonstrated to be in compliance with the ASME Code and NRC regulations for plant operation. These vessel integrity concerns include Pressure-Temperature (P-T) limit curves, Pressurized Thermal Shock (PTS), and evaluation of low Epper Shelf Energy (USE) materials. More detailed

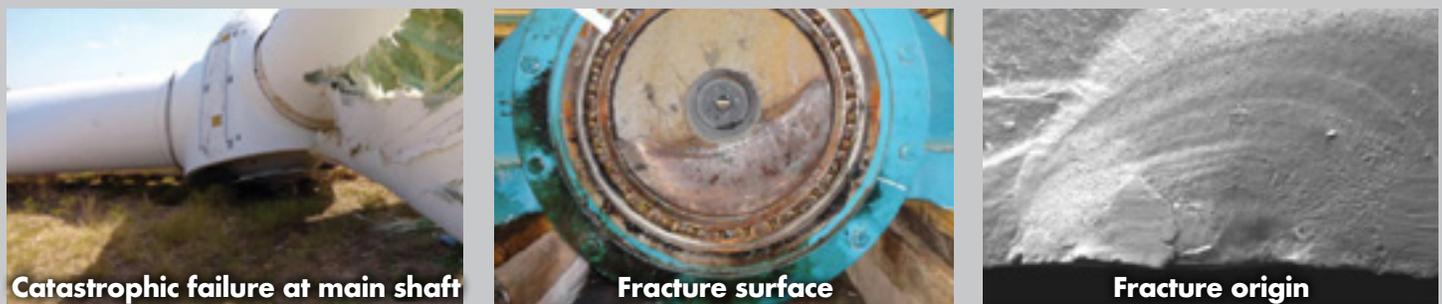
Figure 2. Macro and microscopic inspection of main shaft

Fractography: visual and macroscopic examination of the fracture features can pin-point specific areas of interest for detailed destructive and microscopic analysis. Recently, we were retained to provide analysis of a wind turbine failure where the main shaft fractured causing the hub and blades to fall to the ground. Figure 2 shows an example of macroscopic inspection of the shaft's fracture surface that pinpointed the fracture origin area. This area was then cut-out and inspected in a Scanning Electron Microscope (SEM).

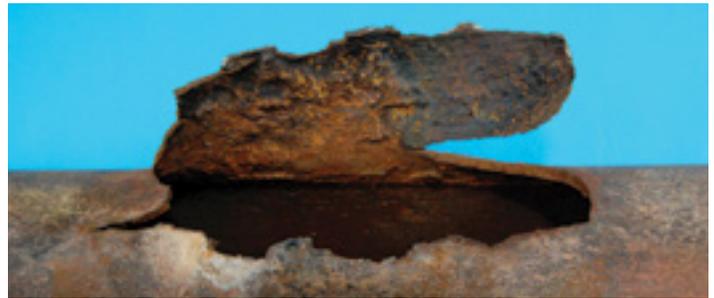
Window-Opening Rupture with internal gouging

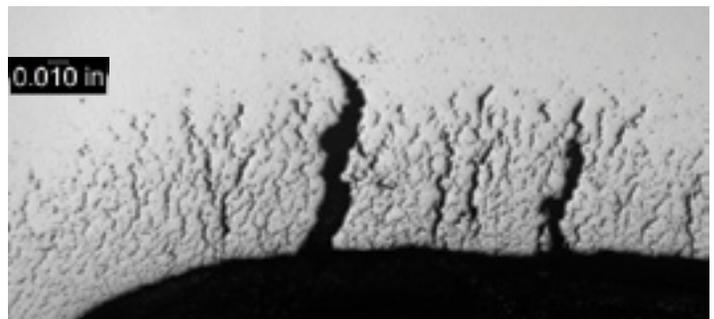
Cross-sectional view of gouge with fissures at ID surface (unetched)

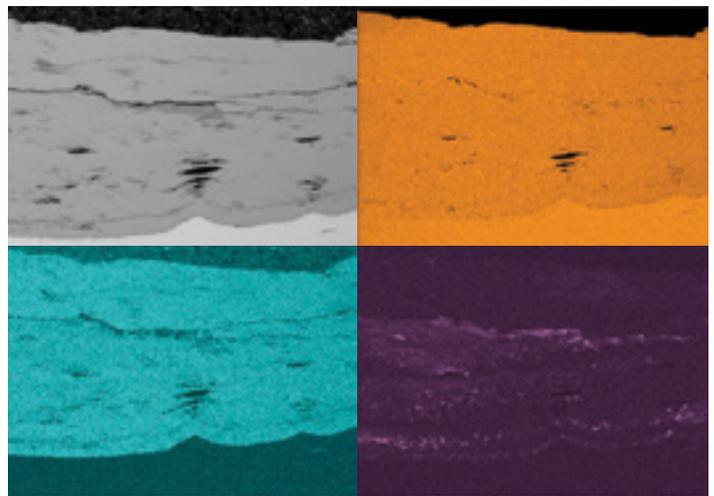
SEM image of ID Deposits (top left), EDS Iron Map (top right), EDS Oxygen Map (bottom left), EDS Chlorine Map (bottom right)
