Assessing and Controlling Corrosion in Air-Cooled Condensers

R. Barry Dooley, J. Denis Aspden, Andrew G. Howell, and Francois du Preez

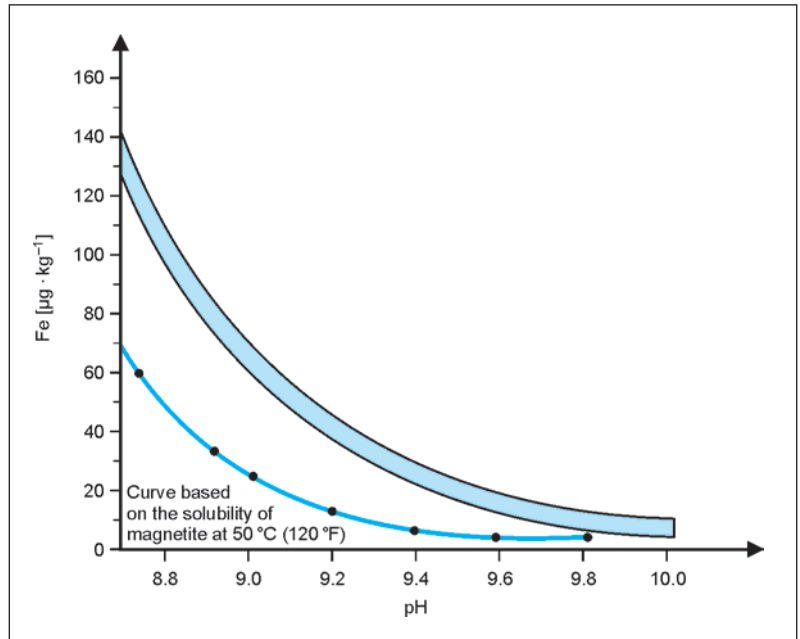
Data gathered from several organizations around the world has resulted in the development of the Dooley/Aspden relationship for Fe in the condensate at the condensate pump and pH associated with units having ACC [3]. This is illustrated in Figure 4, which also shows the corresponding curve for magnetite solubility extracted from Sturla's mag-

The band in Figure 4 is about $5 \mu\text{g} \cdot \text{kg}^{-1}$ wide to allow for uncertainty associated with the data from many organizations, but does have a strong track record around the world for units with ACCs using only ammonia conditioning for pH control. The relationship shows that these plants require a condensate/feedwater pH of at least 9.8 to achieve acceptably low iron levels at the condensate pump discharge. Alternatively, operating at the normal pH range associated with normal oxygenated treatment of between 8.0 to 9.0 would be absolutely disastrous for the ACC as has been illustrated [7,8]; high levels of corrosion will ensue at the tube entries and failures in the ACC can be expected. The high levels of iron will also completely over-

Figure 4 also shows the solubility of magnetite extracted from Sturla [6] at the approximate temperature of the tube entries of an ACC (50 °C (120 °F)). The practical corrosion curve in the figure is elevated above this normally accepted magnetite solubility relationship by some considerable amount and shows for instance that at pH of 8.8 the ACC relationship is higher by 40–50 $\mu\text{g} \cdot \text{kg}^{-1}$ and at pH of 9.2 it is higher by about 30 $\mu\text{g} \cdot \text{kg}^{-1}$. Only at pH of 9.8 and above do the curves become convergent. This suggests that the corrosion process at the lower pH range is faster or more aggressive than a normal classical two-phase FAC process [9] which may relate to the severe turbulence created by the tube entries.

What is evident from the table is that when a plant is using conventional oxygenated treatment (OT) at pH 8.5 the delta pH, the pH at solution temperature – neutral pH (last column), is only 0.26. It has been established by workers in the nuclear industry that a minimum delta pH of 1 unit (at solution temperature) is required to mitigate two-phase FAC. The table shows that to achieve this, the condensate/feedwater pH needs to be close to 9.8, which supports the Dooley/Aspden relationship shown in Figure 4.

Figure 4: Iron levels measured at condensate pump discharge on units with ACC and only using ammonia for pH control. The iron solubility data which is extracted from Sturla [6] at 50 °C is shown only as an example as actual operating temperatures at the ACC tube entries may be higher, as discussed in the text.

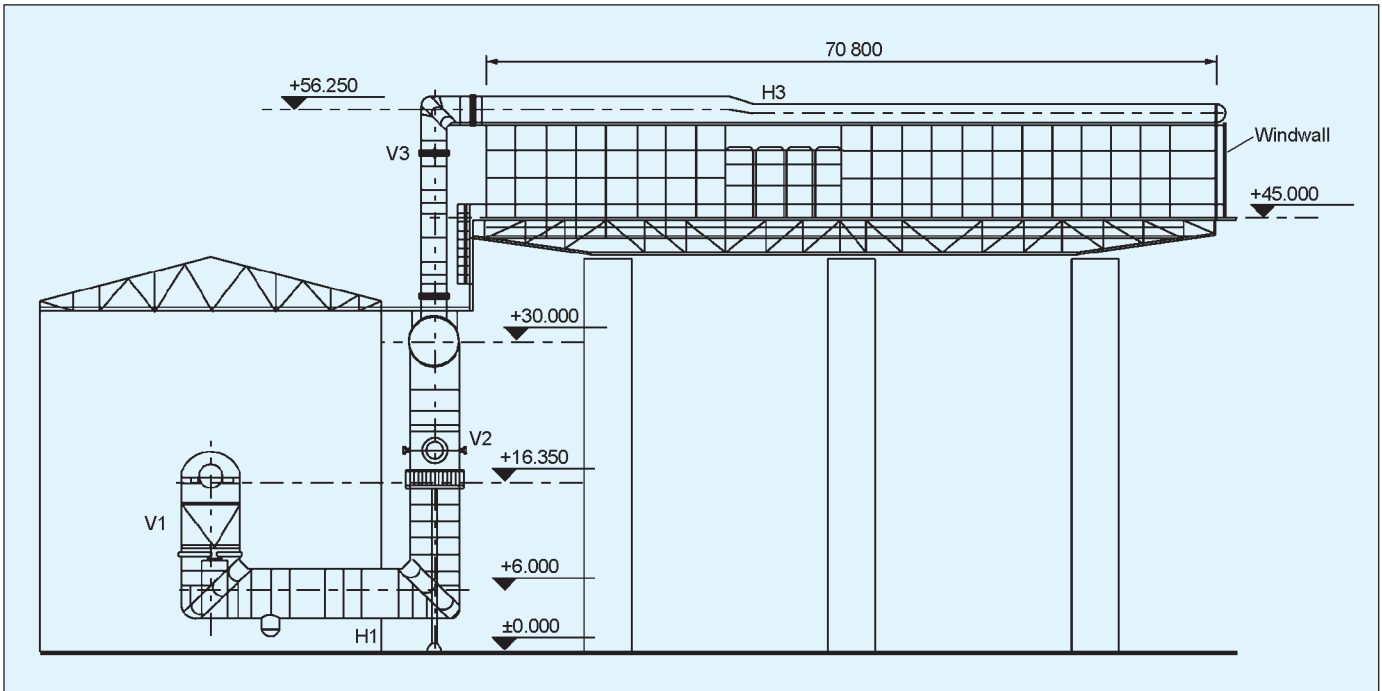
Figure 6:

The Matimba ACC exhaust ducts consist of rather complex arrangements of vertical and horizontal duct sections connected by a series of 90° bends, which in most cases are fitted with guide vanes to minimize the steam side pressure drop. Figures 6 and 7 illustrate the side and front views of the ACC duct arrangement to convey the exhaust steam from the LP turbine exhaust to the condensing elements.

The two LP turbine exhausts are downward facing and the first vertical duct section (only one V1 is shown in Figure 6) is designed as a transition piece from a rectangular to a 5 m (16.4 ft) diameter round steam duct. The first guide vane bend connected to the transition piece diverts the steam in the horizontal direction (H1). After penetrating the turbine house wall another guide vane bend turns the steam direction in the vertical direction. Two vertical risers (only one V2 is shown in Figures 6 and 7) convey the steam upwards to an elevation of 30 m (98.4 ft) above the zero meter level, where the flow is distributed by two horizontal distribution pipes (only one H2 is shown in Figure 7) to 8 risers (4 risers per side) (V3) of 2.5 m (8.2 ft) diameter each,

Side view of the Matimba ACC ducts. Duct V1 takes the two-phase steam mixture from the steam turbine. V1, V2, V3, and H1 are considered to be the lower ducting of the ACC in the DHACI nomenclature. H3 and the ACC tube entries are considered to be the upper sections of the ACC.

Figure 13:
Minor bare metal (white) areas on black background as observed in the duct section H1 (see [Figure 6](#)). DHACI B.

Duct section (Figures 6 and 7)	% red area	% black area	% bare metal (white)
V1	0	95	5
H1	40	50	10*
V2	60	40	< 1
H2	70	30	< 1
V3	75	25	< 1
H3	85	15	< 1

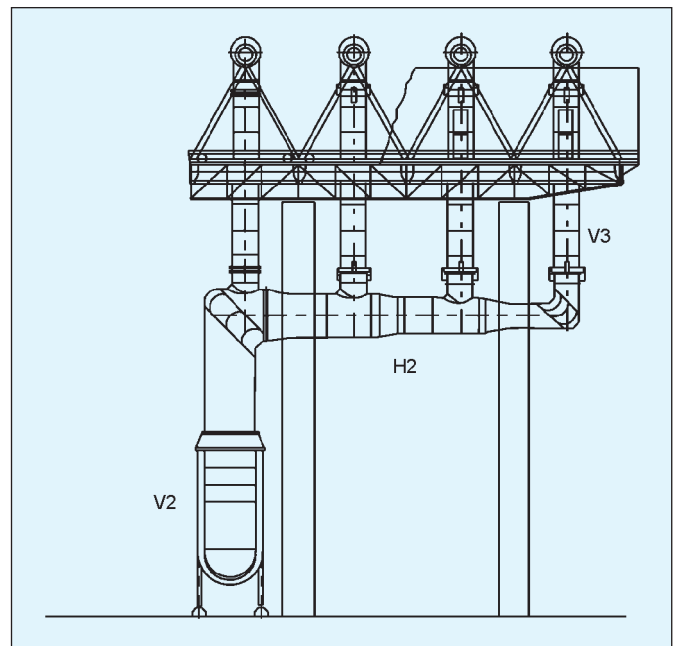
Figure 7:

Front view of the Matimba ACC ducts. H2, V2 and V3 are considered to be the lower ducting of the ACC in the DHACI nomenclature. H3 (above the A-frames) and the ACC tube entries are considered to be the upper sections of the ACC.

Figure 14:
Corrosion pattern in branch H2-V3 (Figure 7). DHACI C.

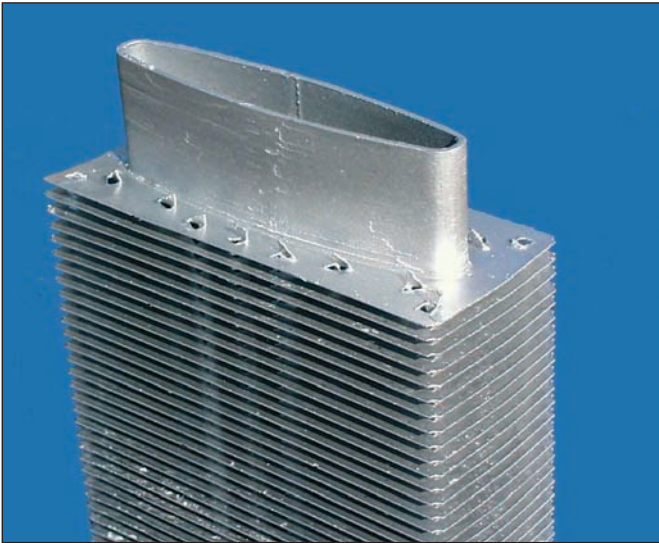
Condensation of the exhaust steam occurs in bundles of finned heat exchanger tubes. The latter is characterized by rectangular fins fitted mechanically on an elliptical tube core as shown in Figure 8. A corrosion resistant bond between the fin root and tube is achieved by hot dipped galvanizing of the fin/tube. Heat exchanger bundles are constructed by arranging two tube rows in the air flow direction (A-frame). 48 axial flow fans per turbine unit of 9.1 m (29.8 ft) diameter each driven by a 270 kW electric motor force ambient air through the finned tubes as cooling medium.

Figure 8:
Matimba ACC heat exchanger tube. The tubes are 9.5 m (31.7 ft) long. The rectangular fin dimensions are 120 and 50 mm (4.7 and 1.96 in).

Of immediate concern during the initial Matimba inspections was the perforation of the relatively thin wall, 1.5 mm (0.059 in), of the elliptical fin tube at the tube entry. Any perforations would result in an air leak into the vacuum space with an adverse effect on condenser performance. [Figure 9](#) shows a perforation in a tube entry surrounded by a large white corroded area. This white area is the same as the "bare metal areas" described in the introduction and is shown in more detail in [Figure 1](#).
